Committee: Planning Agenda Item

Title: Proposed tree works at UDC Offices

London Road Saffron Walden

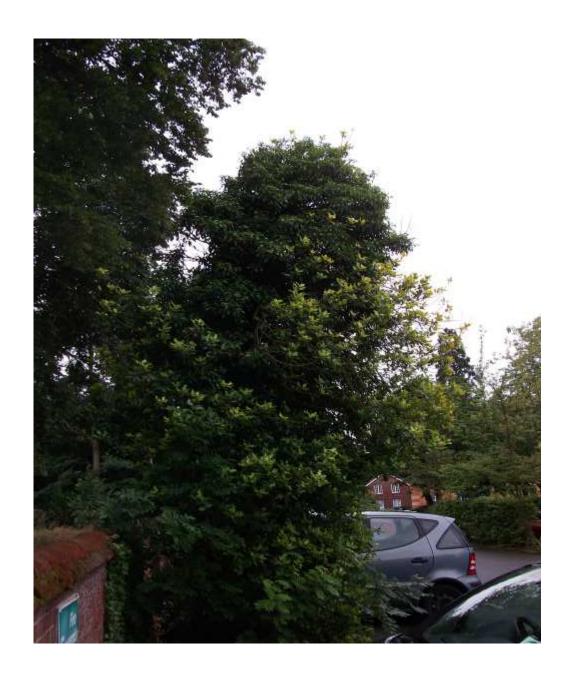
- 5. The proposed tree work is required to allow for additional car parking, and management of trees on the site.
- 6. The proposals included the felling of a holly, a horse chestnut, and a sycamore tree. The holly is approximately 7m in height and in very poor condition; its crown having been compromised by invasive ivy growth. The horse chestnut is a juvenile specimen approximately 5m in height. This subject is not an outstanding specimen, having a thin crown and lacking vigour. The sycamore is a multi-stemmed self set subject of approximately 3m in height, it is poorly formed. The removal of these trees is not considered to significantly impact on the integrity of the structural landscaping of the site.

Holly tree proposed to be felled.

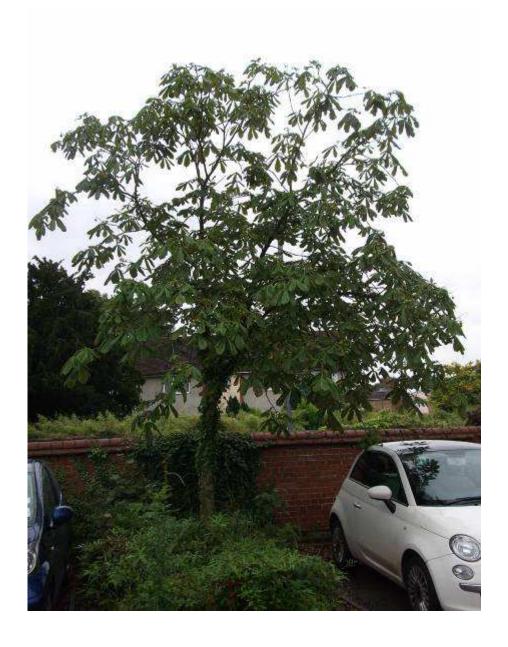
Horse chestnut tree proposed to be felled.

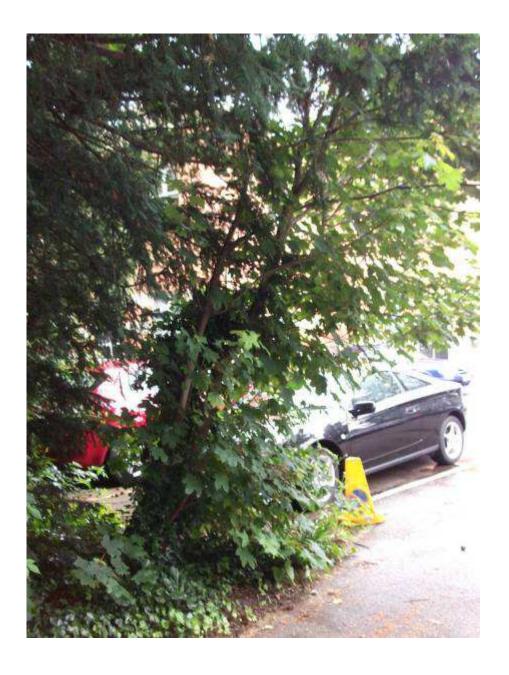
Sycamore tree proposed to be felled.

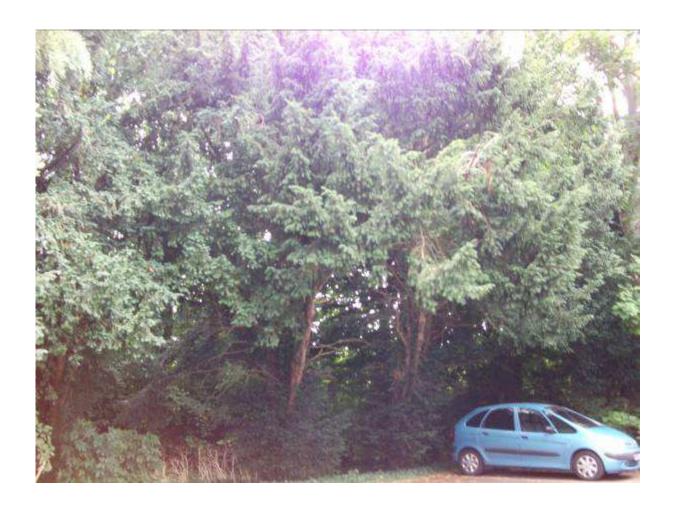
Yew trees proposed to be reduced to 5m in height and faced-up.

- 7. It is proposed to reduce to 5m in height and cut back lateral growth to the main stems of 7 Yew trees. These trees are situated adjacent to The Lodge car park. This work will encourage new growth and density whilst reducing the amount of detritus falling from overhanging branches on to the adjacent car parking area.

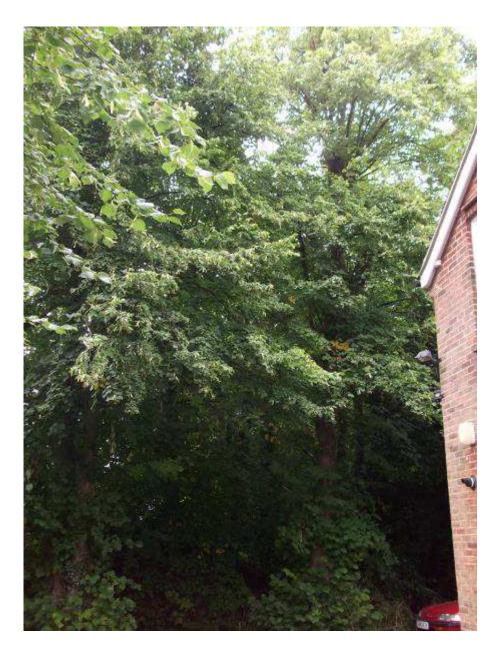
Lime trees proposed to be re-pollarded.

- 8. 29 lime trees situated along the western boundary of the site are proposed to be re-pollarded.to reduce the risk of failure occurring at the previous pollard cut points. The epicormic side growth is also proposed to be removed.

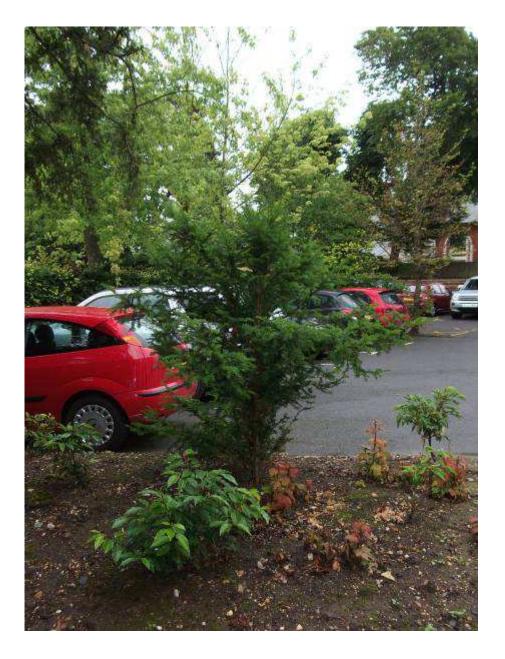
Yew tree proposed to be lifted and transplanted.

- 9. A young yew tree is the main car is proposed to be lifted and transplanted in a suitable position in the site.
