Manuden Conservation Area Appraisal and Draft Management Proposals, 2012

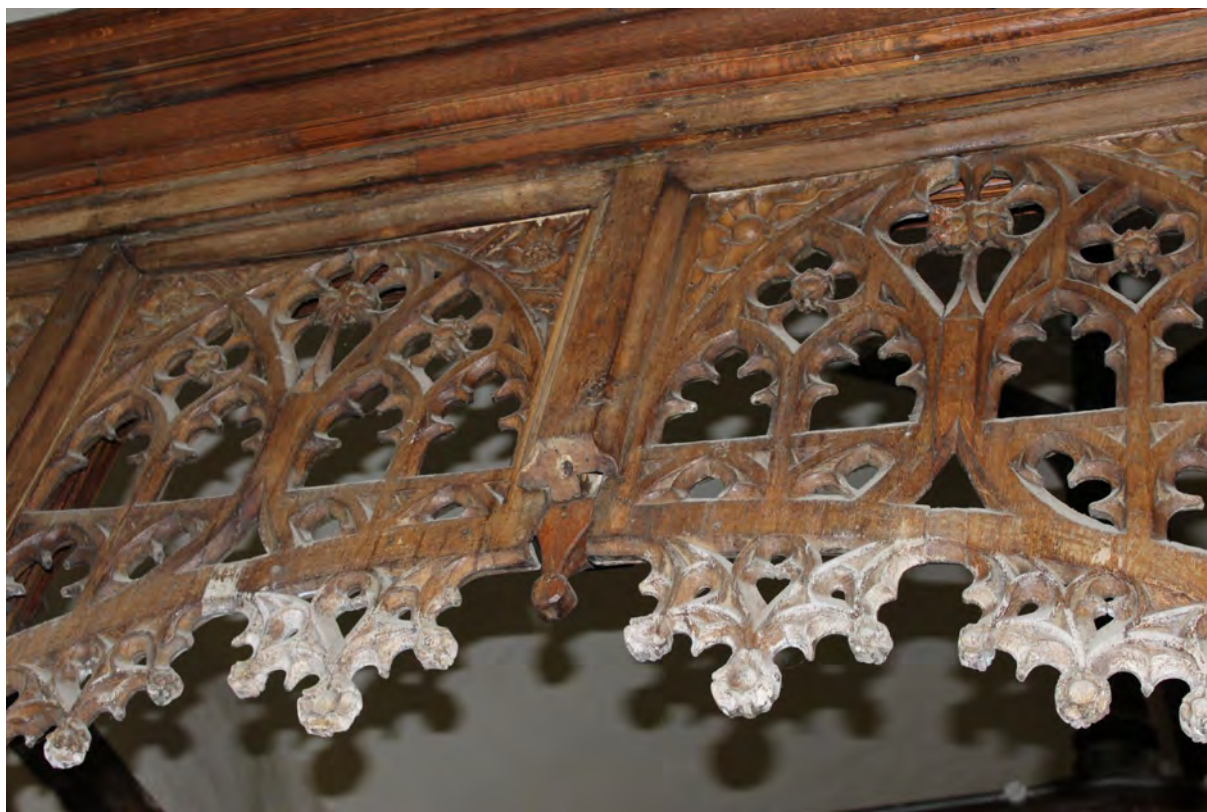
Picture 1.3 Part of the early 15th century chancel screen

and nave roof. One of the most important medieval survivals in the church is the early 15th century chancel screen; featuring fine carvings and tracery work, it is one of the finest examples of its type in Essex and described by Pevsner as 'sumptuous for Essex'.

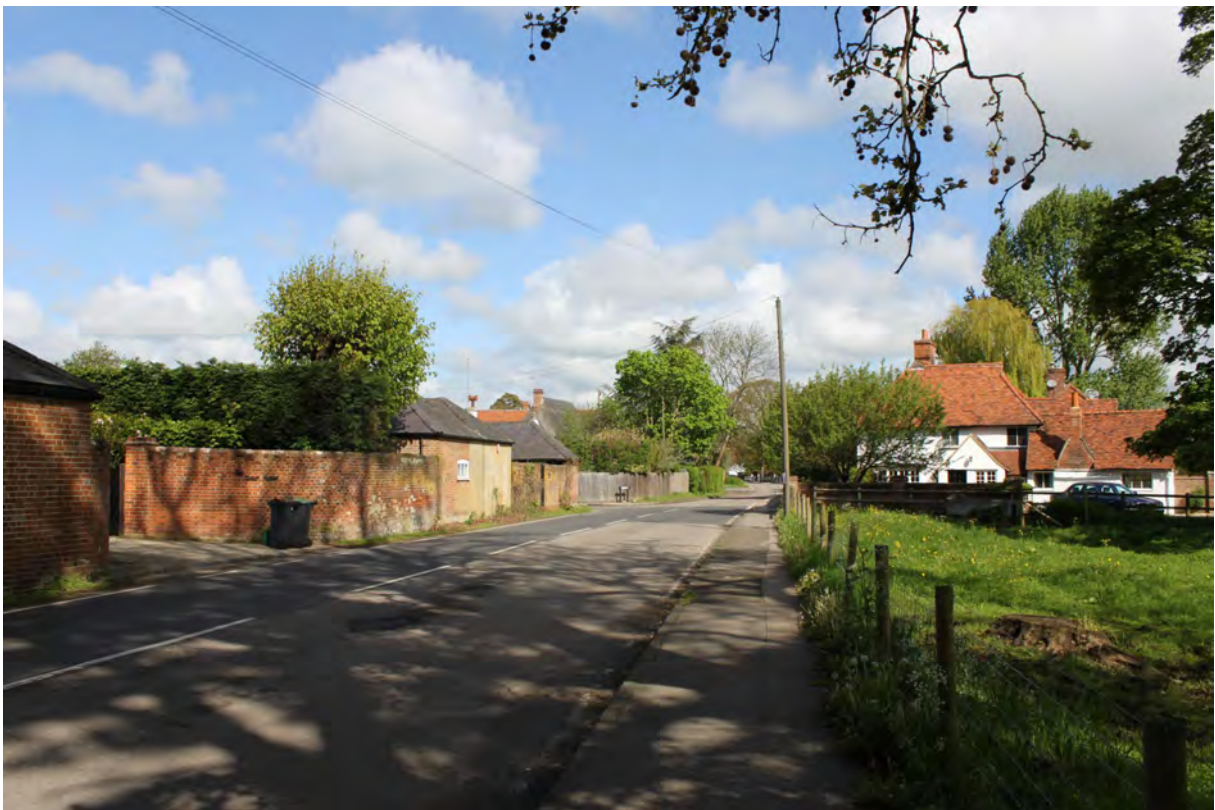
Picture 1.10 Cobbs No. 62 The Street

1.74 Cobbs (62 The Street) is a timber-framed and plastered building of early 16th century origin (Grade II). It is two storied with a two window range of three-light leaded casements on the front. Wings extend to the east at the rear and there is a modern addition on the north-east. The roof is tiled, hipped, with small gables at the north and south ends and a large central chimney stack. To the rear of this is an outbuilding of late 16th century date (Grade II). It is a timber-framed and plastered building with some exposed timber-framing and a tiled roof. The 1st Edition Ordnance Survey map shows that these two buildings once formed part of a larger complex which had been demolished by 1920.

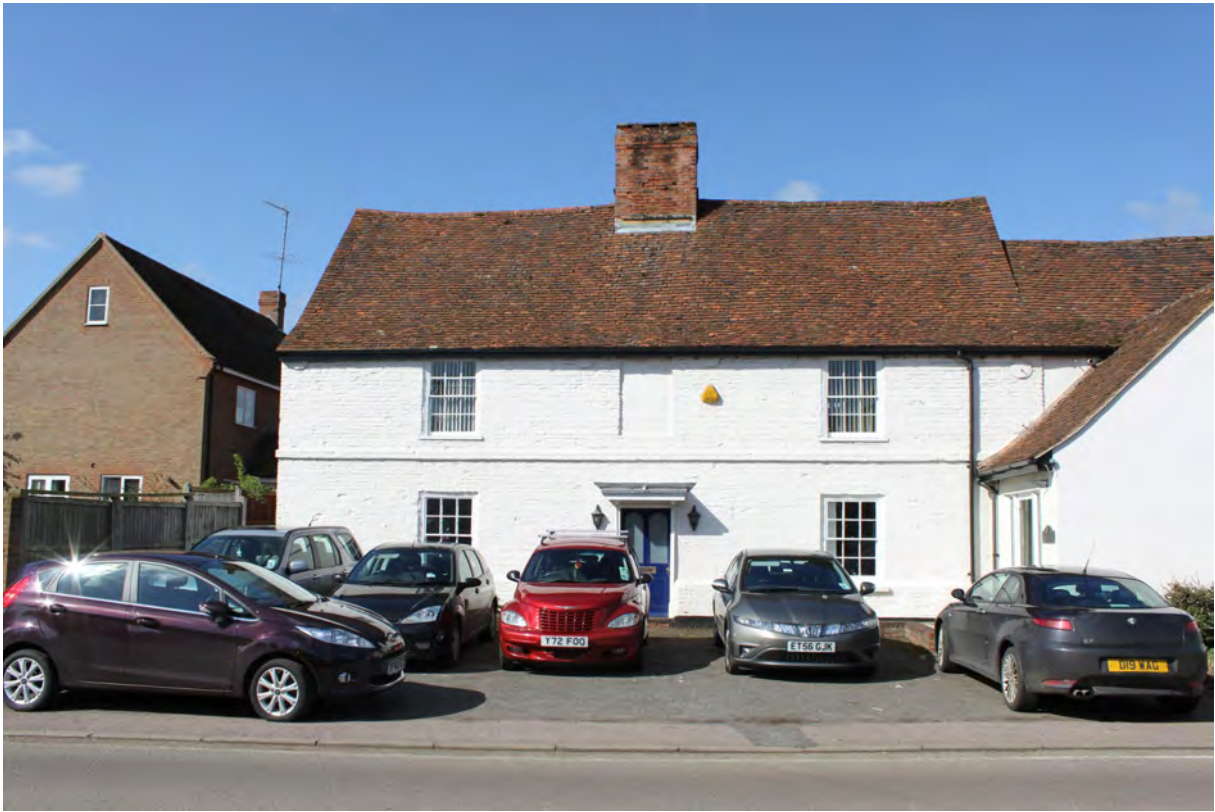
1.80 There is an issue with traffic and parking on the road causing congestion. The parking in front of the former Jolly Waggoners also detracts from the street scene during working hours. Some of the modern infill is unsympathetic in scale and character, and care should be taken with future applications in ensuring that the overall size of the development, including roof-lines and surface treatments are in sympathy with the other properties in this area.

Picture 1.11 Parking in front of the former Jolly Waggoners

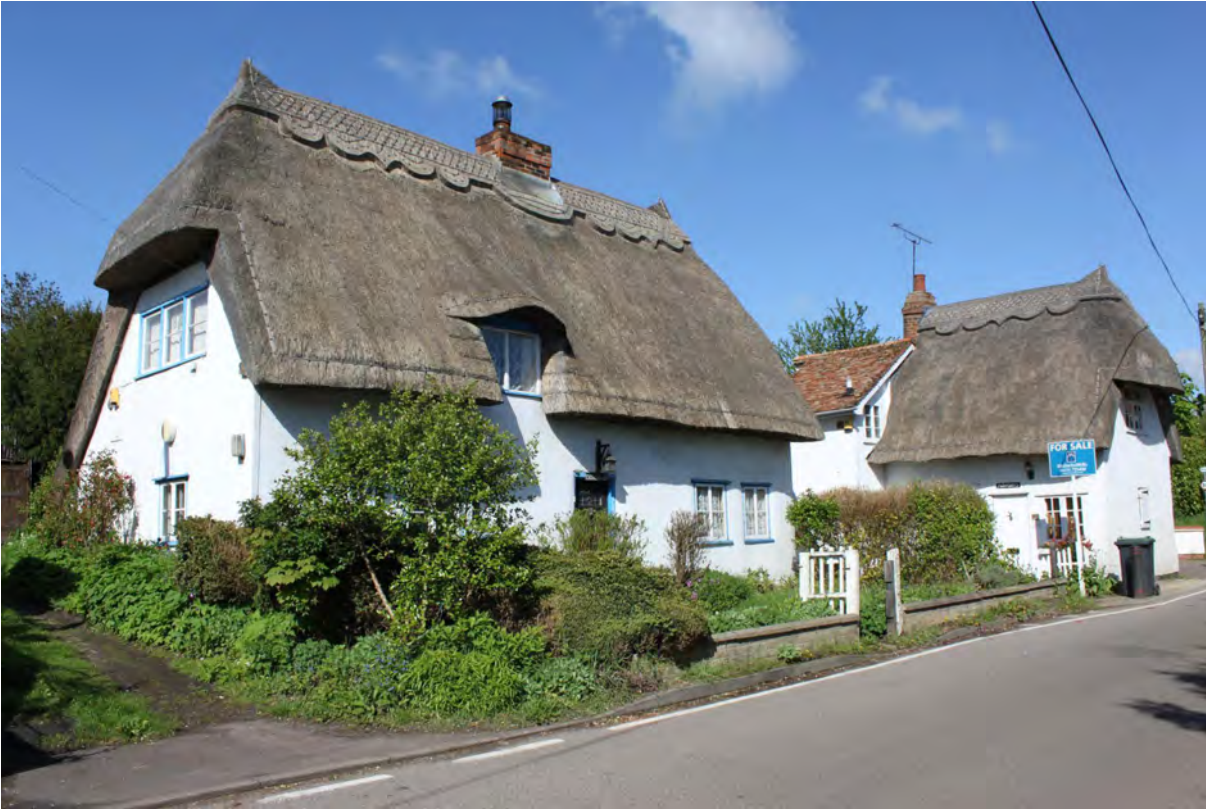
1.82 This area extends from No. 85 The Street as far as the entrance to the Playing Fields. The road rises gently northwards, and has a slight curve to it. At the northern end of the proposed extension there is an important group of listed buildings. Oakdale is a 17th-18th century renovated timber-framed and plastered building. It has one storey with attics and casement windows. The roof is thatched, half-hipped, with one dormer on the front and a central chimney stack. Next to it is 99 The Street, a tiny 17th-18th century renovated timber-framed and plastered building with later additions on the south-west end. It is one storey high with attics and casement windows. The roof is thatched; half hipped at the north-east end. The addition is two-storied, with a tiled roof. Chapel Cottage is located to the rear of No. 99; it is a 17th-18th century, renovated timber-framed and plastered building. It has two storeys, with a two window range of casements. The roof is thatched; half hipped, with a central chimney stack. Laurel Cottage is located on the other side of The Street. It is an 18th-19th century renovated timber-framed and plastered building. It has two storeys, with a three window range of casements. The roof is thatched, with an external chimney stack located at one end.

Picture 1.12 Oakdale and No. 99 The Street

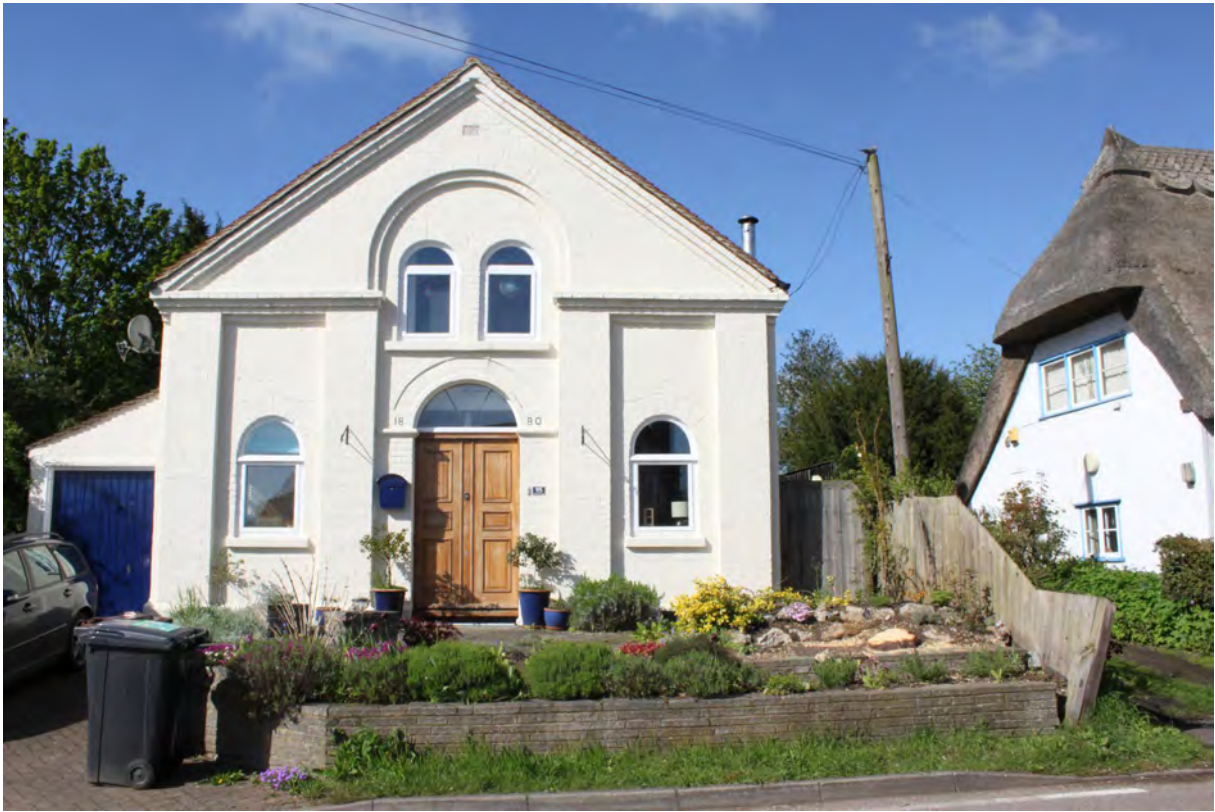
Picture 1.13 The former Methodist Chapel

1.83 There is a group of other non-listed buildings that contribute to the character of this proposed extension to the conservation area. The former Methodist Chapel, a painted brick-built building dating to 1880, with arched windows and door on its gable-ended frontage, is typical of many small-scale rural chapels and forms an important part of the historic narrative of Manuden. It is now a private home (No. 95 The Street). Nos 85-89 are all late 19th century or early 20th century in date, No. 85 in particular with its garden contributes to the overall historic appearance of the area.

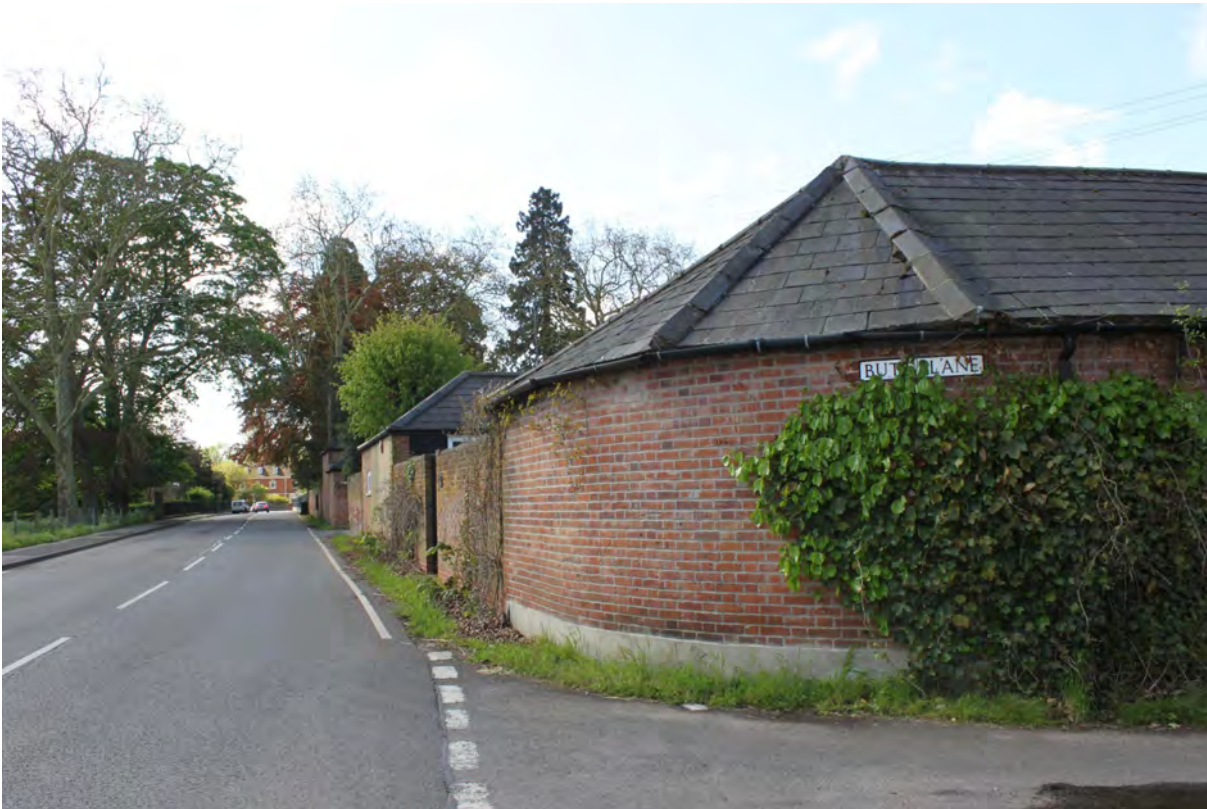
Picture 1.15 View of The Orangery walls at Butt Lane

1.98 The Orangery building itself is located further back from The Street, on the boundary of Butt Lane. Its high, red brick elevation lines the boundary of Butt Lane and is an important part of this grouping. The wall is capped, with a pilaster at each end, and the glass conservatory can be seen from the junction.

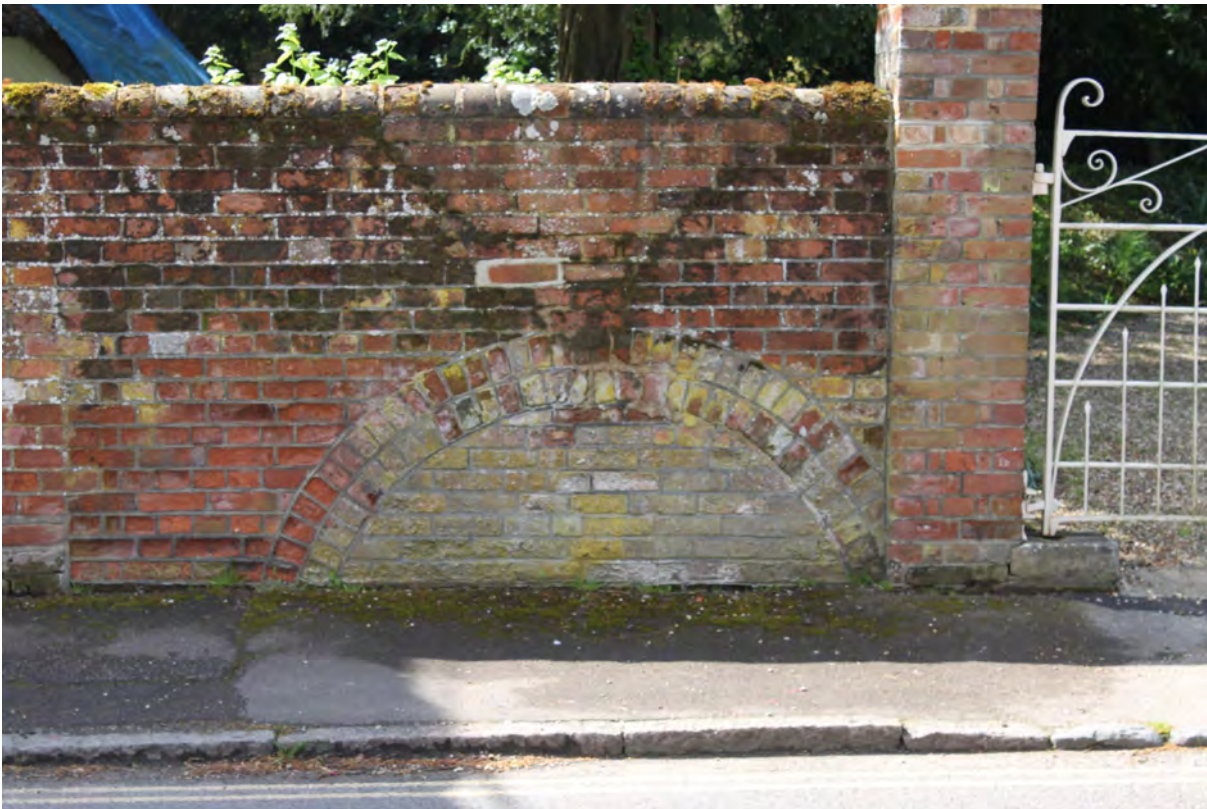
Picture 1.17 Brick archway feature in wall at Cleeve Hall

1.105 The most southern end of the wall fronting Cleeve House has an interesting brick archway built into the wall; the origins of this are unknown.

1.104 The wall at Cleeve Hall is an important historic feature and has important group value with the House and surrounding area. The red brick wall has been altered by the inclusion of a new gate and high pilasters; this could have caused the cracking that is seen in some places. The new brickwork on the original main entrance has been replaced in a sympathetic manner. Being such a visual focal point in the conservation area; it is important that this wall is maintained appropriately.

1.111 The wall at the outside of Cleeve Hall is starting to crack at the gate pillar. The wall has been altered in places and a new entrance gate has been added. New brickwork does not precisely match the original brickwork, although this should weather in time. Efforts should be made to ensure that any further repair work is carried out in an appropriate manner.

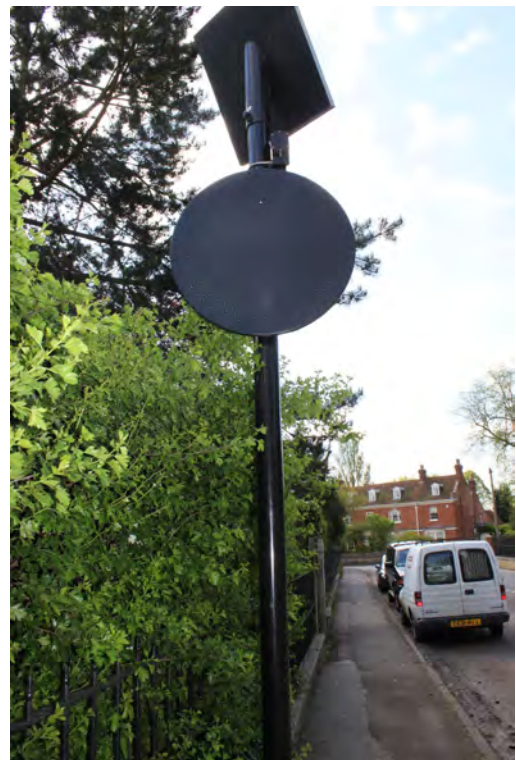
1.109 Speeding traffic on this linear stretch into the village poses a hazard, particularly as the road bends sharply at Cleeve Hall. While measures should be taken to ensure that the speed limit is adhered to, the erection of a flashing 30mph speed sign detracts from the street scene.

Picture 1.18 Speed sign outside Manuden House, The Street

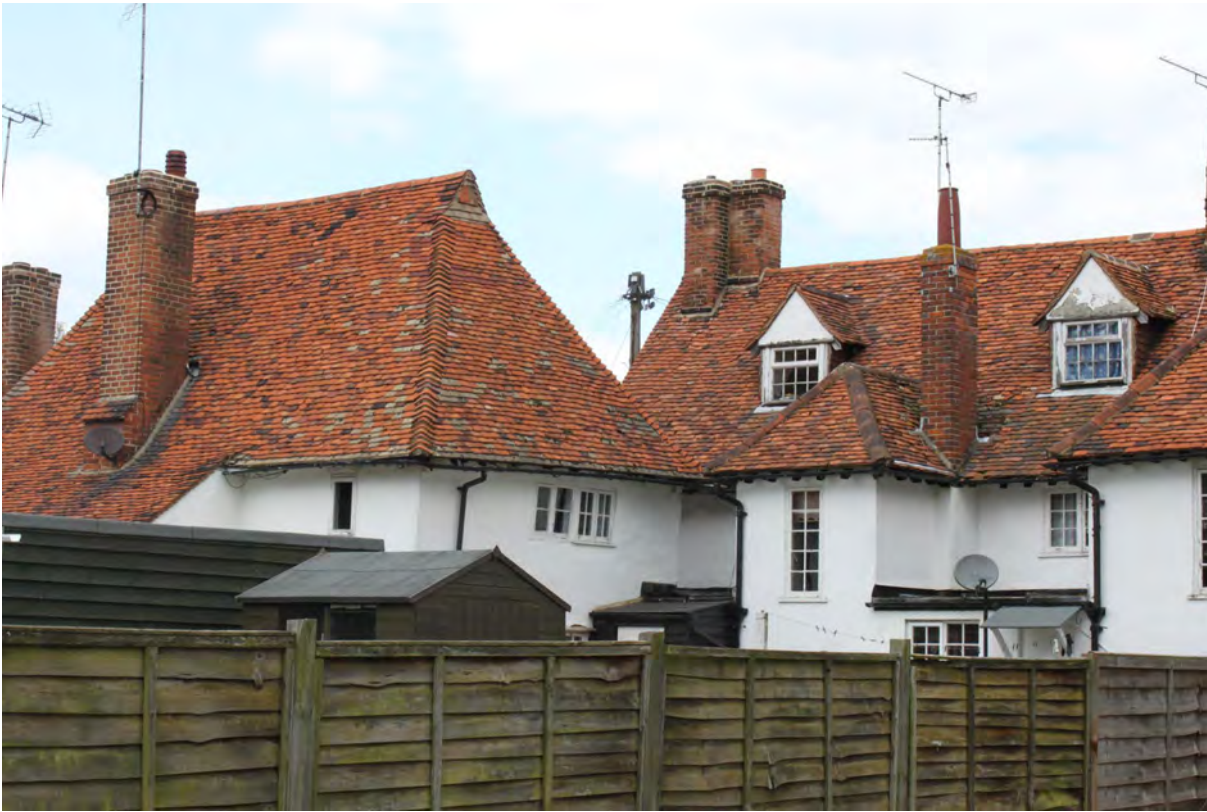
1.128 The Street to the north of the church is largely fronted by listed buildings. Adjoining the north-west corner of the churchyard is the Poor Houses (Nos 45-49). This comprises an early 16th century timber-framed and plastered house, forming a long two storeyed range with attics. The upper storey is jettied on the north front on curved brackets and was formerly jettied on the south front also, which faced on to the churchyard. The roof is tiled, and at the east end there is a 17th century external chimney stack. The front has three doors and three dormer windows, but the main window range is not symmetrically laid out. One of the almshouses is currently unoccupied and care will need to be taken to avoid building deterioration and vandalism occurring.

Picture 1.22 Roof-scape to the rear of the Poor House, as seen from the Churchyard

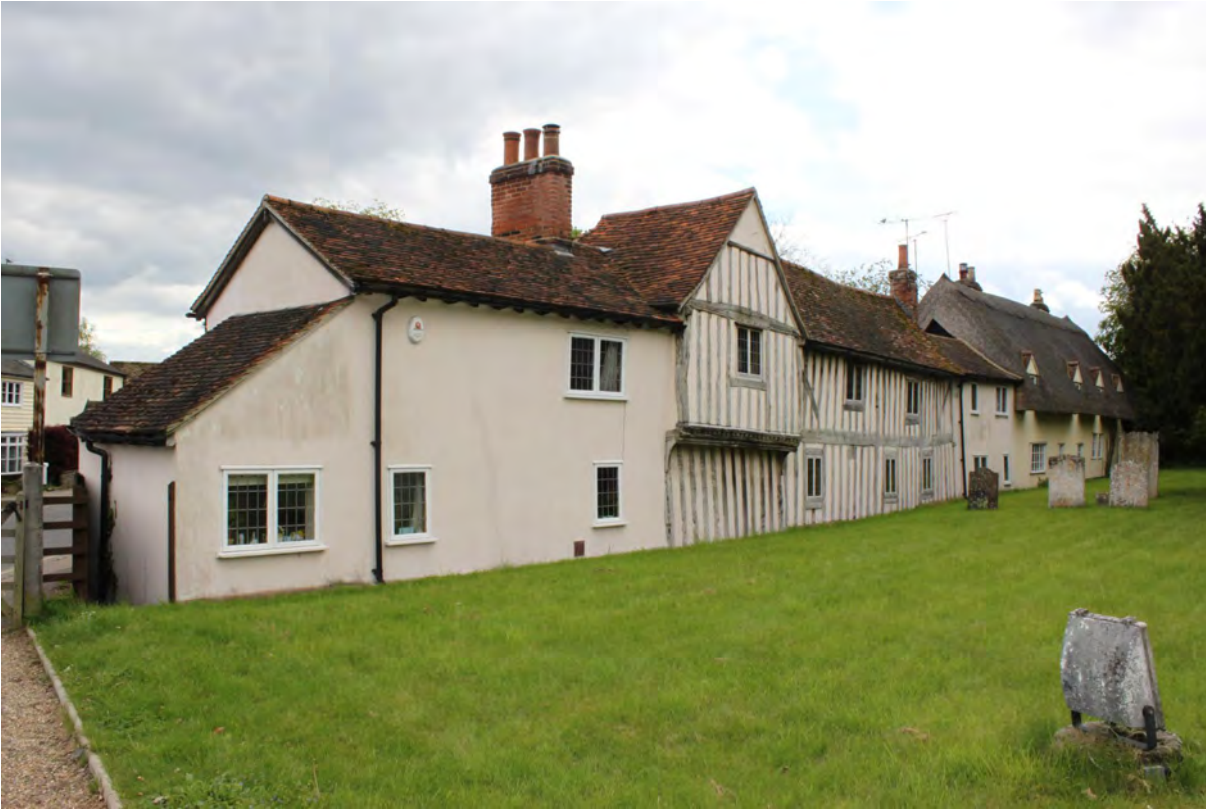
Picture 1.23 Benrose and No. 37 The Street, as seen from the churchyard

1.135 The southern side of the churchyard is formed by Benrose and No. 37 The Street, which together form an extremely picturesque group. Benrose is an early 16th century timber-framed and plastered house with a cross wing at the east end. It was altered in the 18th century and renovated, with modern additions. The timber-framing is exposed on the north side and the cross wing is jettied on the upper storey on a moulded and carved bressummer. No. 37 was formerly a range of three 18th century timber-framed and plastered cottages now renovated and formed into one single-storey tenement. Both properties are set end on to the road, and their frontages are largely obscured behind garden vegetation, although there are attractive glimpses of both them and the gardens over the garden gates.

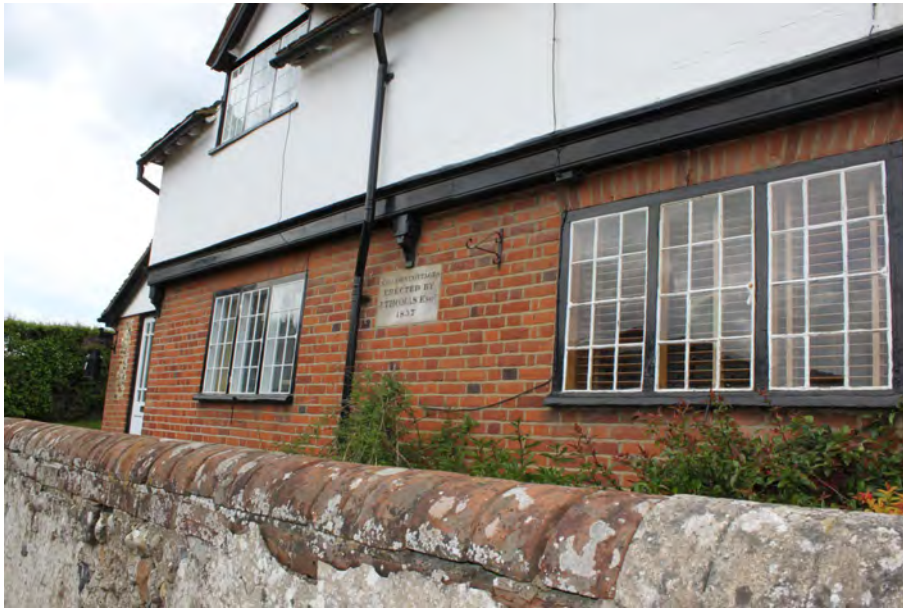
Picture 1.24 The date plaque on Manuden Cottages

1.136 Manuden Cottages comprises six blocks of almshouse cottages, each a pair, built by J. Thomas in 1857. They have two storeys, the upper storey projects slightly and is plastered. The ground storey is of red brick. Each block has a 2 window range of casements. The southern 2 blocks have some original iron casements. The roofs are tiled, double-pitched, with 2 gabled dormers on the front and one at the rear and 2 central chimney stacks one on each ridge. The laundry house for the group survives (now part of No. 13). They are set back from the road by a couple of feet behind a flint-and-brick wall.

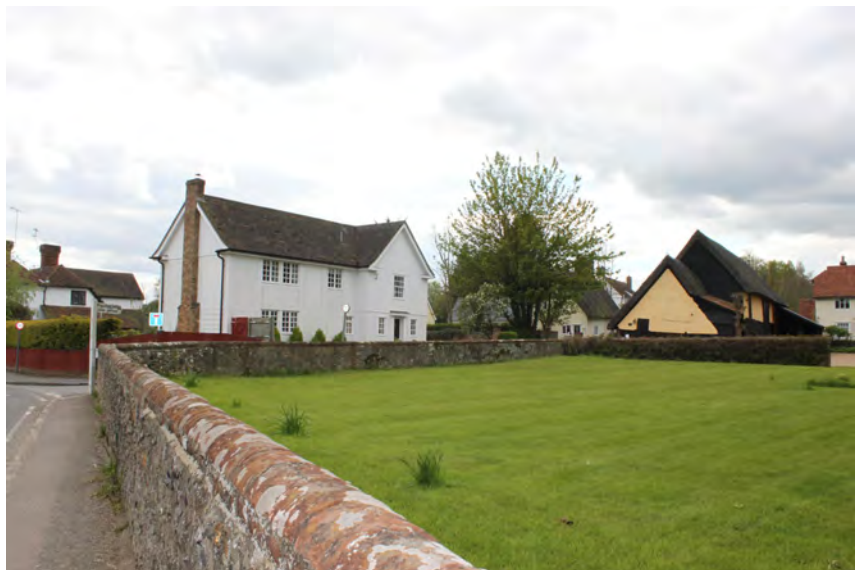
1.137 The Bury and its two barns forms an attractive group. It is setback from the road facing onto the former village pond, but is readily visible from The Street. The Bury is a timber-framed and plastered farmhouse with a cross wing at the north end. The external features are 18th century in date, but the interior is said to be a framed building of c.1560. To the north of the former farmyard is a thatched 17-18th century timber-framed and weather-boarded barn, and forming the southern side of the yard is a large 16-17th century timber-framed and thatched tithe barn, partly plastered and partly weather-boarded. The Bury is backed by mature trees and extensive gardens.

Picture 1.25 Looking across the former village pond to The Bury

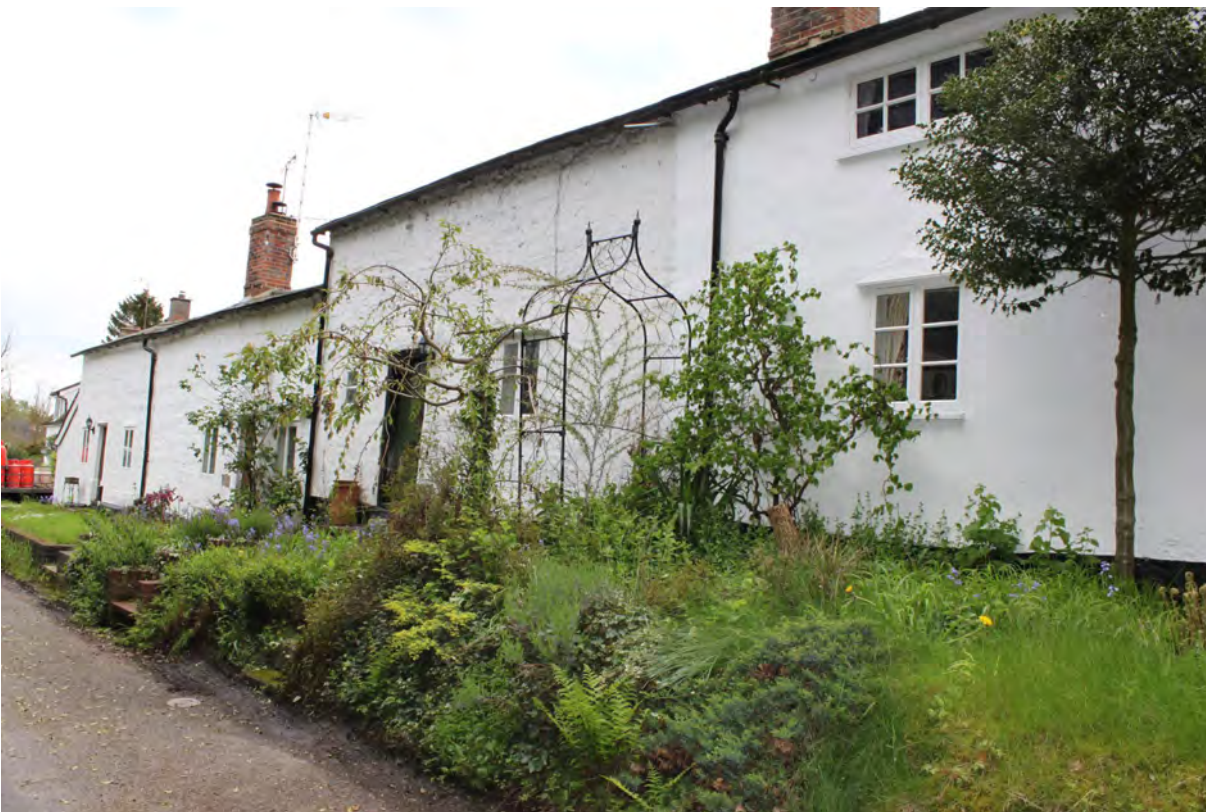
Picture 1.26 The clay lump terrace on Mallows Green Road

1.139 On Mallows Green Road Adams Cottage and Tylers Cottage is a thatched, timber-framed and plastered house, now divided to two cottages, with 18th century external features, and possibly an earlier frame. They have attractive gardens to the side and rear and several mature trees. Nos 9-17 Mallows Green Road are a very interesting survival of a range of early 19th century clay lump workers cottages, Nos 15 and 17 are plastered. They are one storey on the north front and two storeys on the south front, with small casement windows and a slate roof. They are set above the road by a couple of feet, with a small strip of garden separating them from the road.

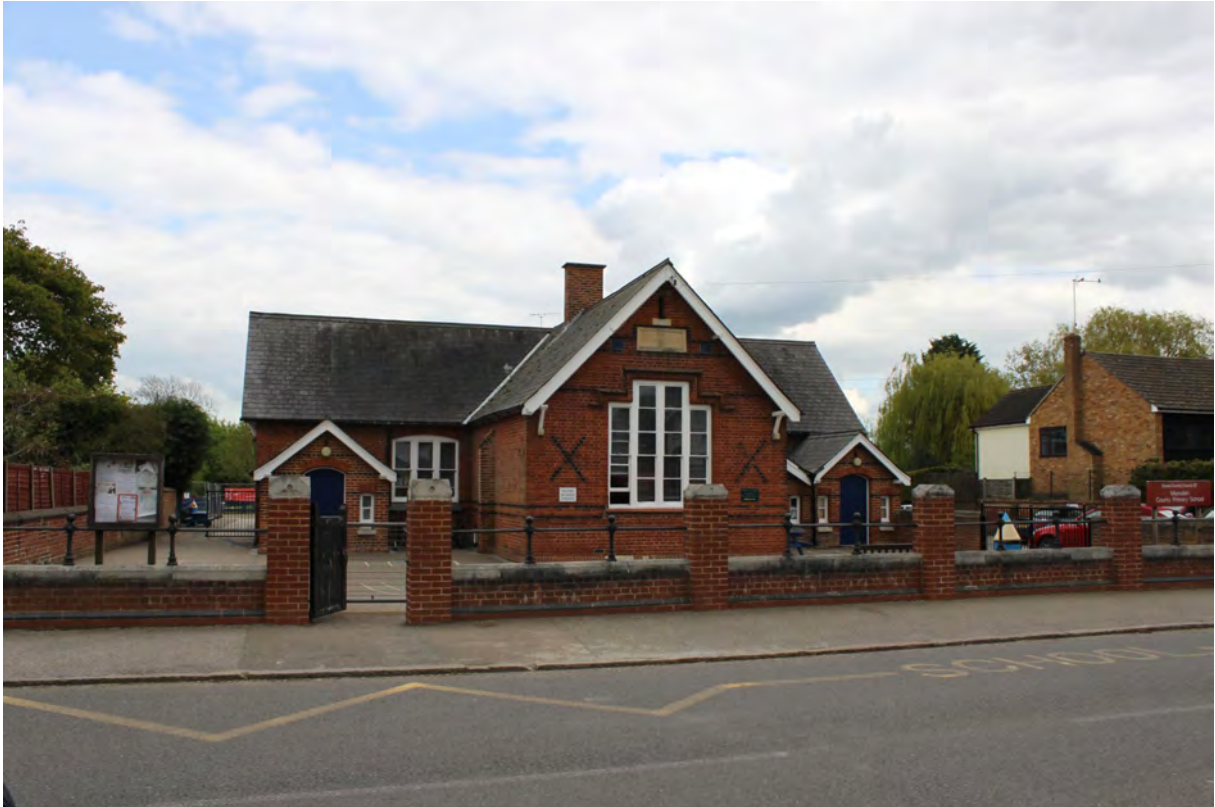
Picture 1.27 Manuden primary school

1.140 The school is a late Victorian red brick building, with a central gable end with a large window facing onto the road flanked by two wings, each with an entrance door, and a foundation date of 1877 set into the gable. It is a typical example of late 19th century village school architecture and is an important part of both the history and community of Manuden. It is set back from the road in a tarmac school-yard, with a low red brick boundary wall topped by iron railings. A modern extension (very late

20th/early 21st century) is sited to the rear; it is largely screened from the road by the historic building. There is a small tarmac football pitch and grass playing-fields to the rear.

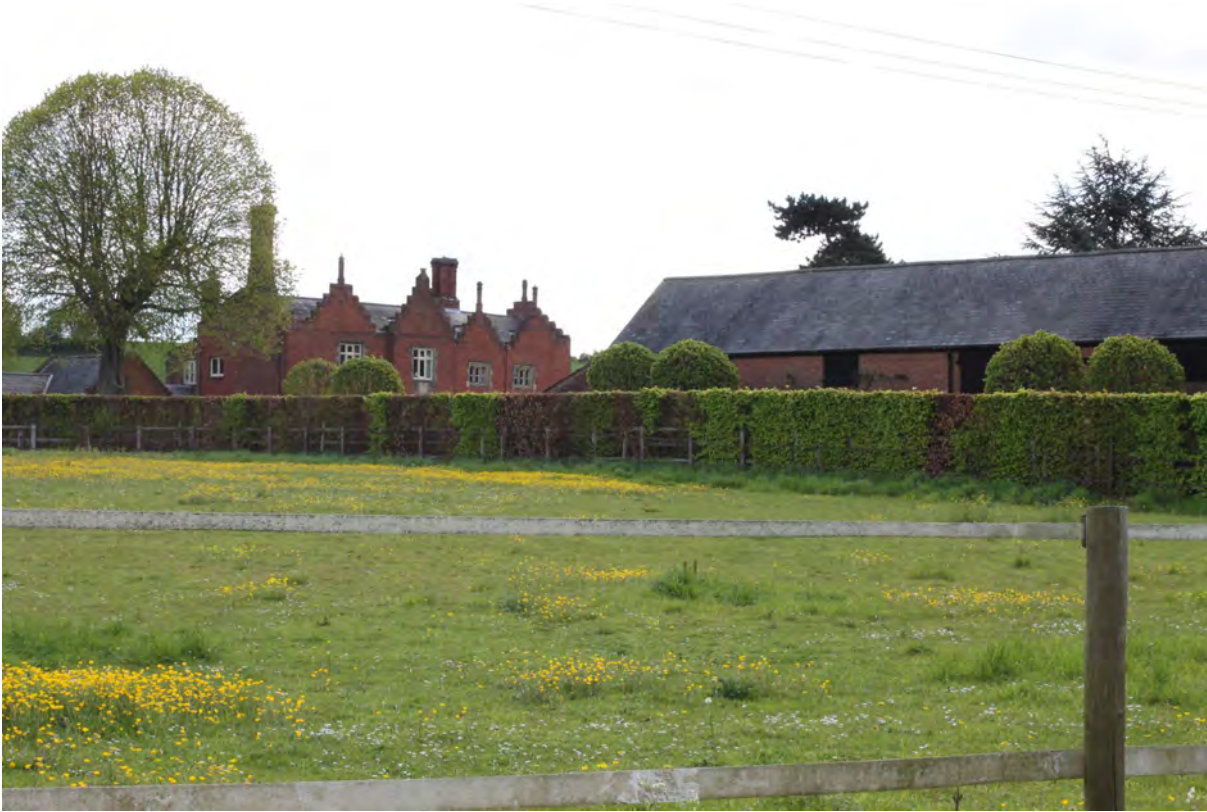
1.153 Manuden Hall is the only listed building in this area. It is an impressive building in both scale and architectural form. The building has its origins in the sixteenth century, although most of it was destroyed by fire in 1889 following widespread discontent related to the spread of mechanisation in farming. Although the façade looking onto Pinchpools Road is largely obscured by trees, most of what is visible is part of the original medieval building. The west front has four crow stepped gables, on the south front there are two original crow stepped gables with pinnacles. The windows are stone dressed gables, some with stone mullions and transoms. The chimney stack at the north side is original.

Picture 1.28 View of Manuden Hall from Pinchpools Road

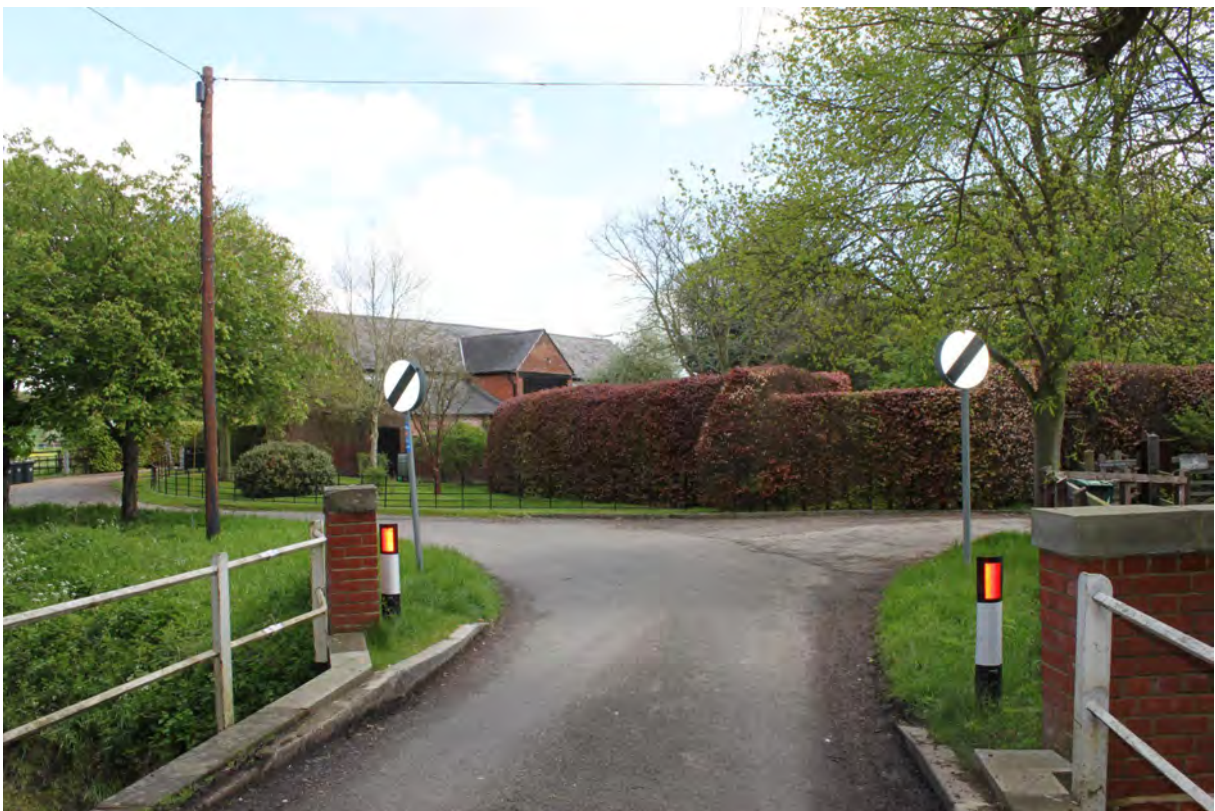
Picture 1.29 Traffic signs on the bridge leading from The Street to Pinchpools Road

1.162 Care should be taken to ensure that the bridge is properly maintained and that excess signage does not impinge upon the rural character of the conservation area.

1.163 Brambles and nettles on the bridge should be dealt with.

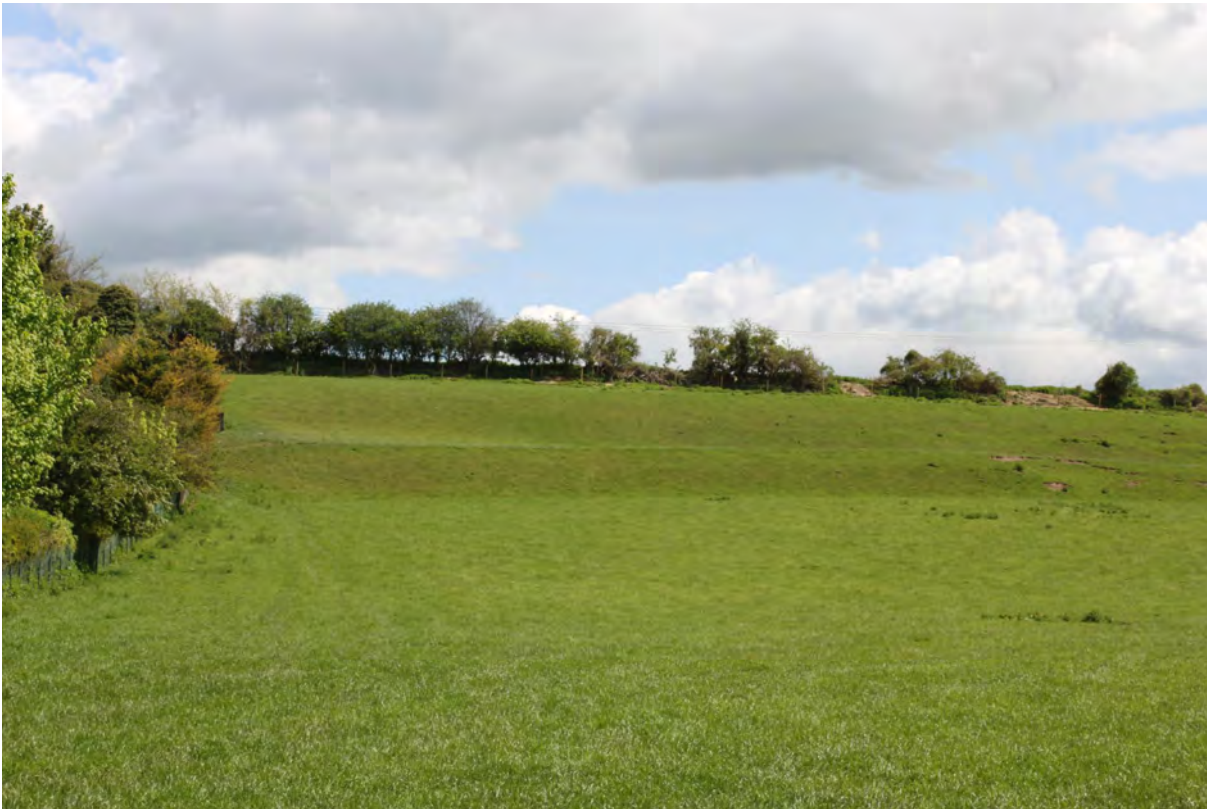
Picture 1.30 Medieval strip lynchets on The Downs

1.164 It is recommended that the conservation area boundary is extended southwards, to include The Downs, to encompass a significant archaeological landscape. The cluster of buildings at The Downs are not listed, but Downs Croft and the Old Lime Kiln Cottage are depicted on the 1881 OS map and Meadowbrook is very late 19th century in date. All three are nestled into a former chalk pit. Medieval strip lynchets run from Downs Cottages parallel to the River Stort and are a well preserved example of their type. This form of archaeological earthwork is rare in Uttlesford and Essex as a whole, and as such should be preserved. The field between Manuden Hall and the medieval strip lynchets has a number of low earthworks, which may indicate below ground archaeology, probably related to Manuden Hall.

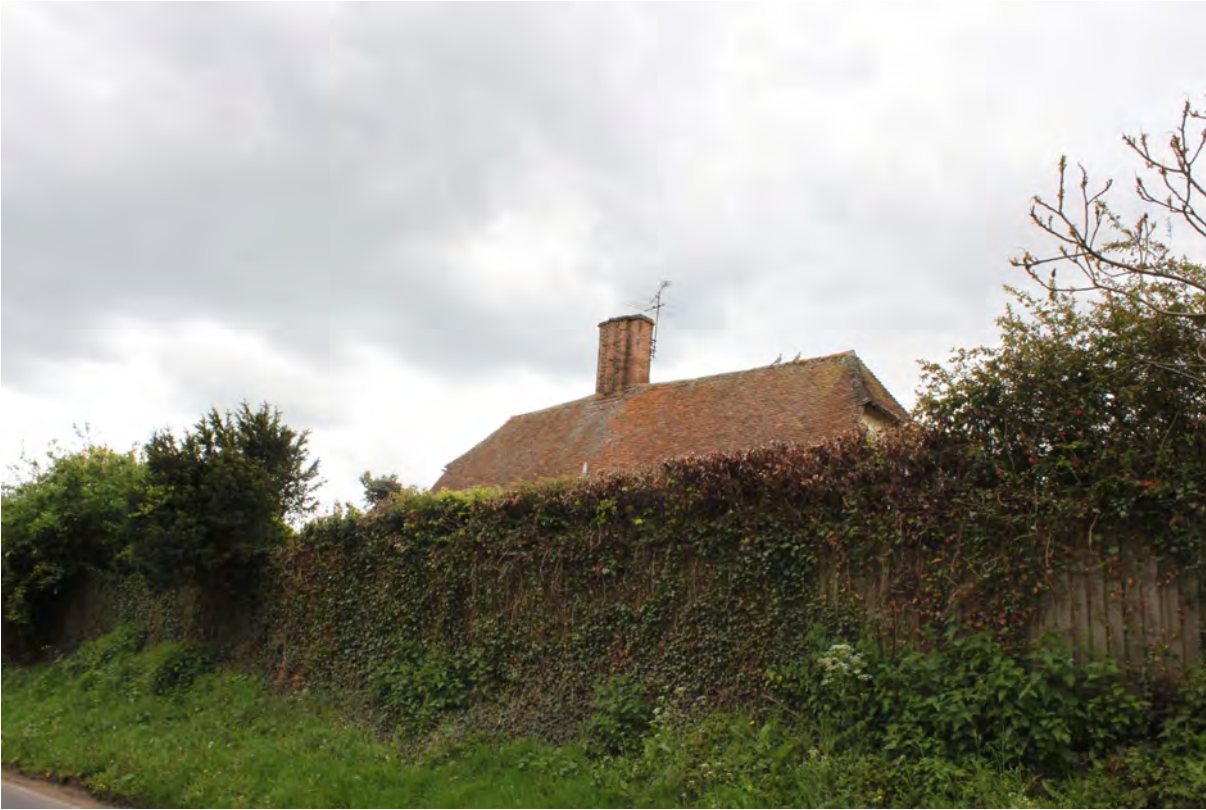
1.172 Further down Carters Hill, the roof of Hill House can be seen above the hedgerows. Hill House dates to the early part of the 17th century and is a timber-framed and plastered building with two storeys. The upper storey is jettied on the whole front with exposed joists and five curved brackets.

Picture 1.31 Roof of Hill House, Carter Hill
