Uttlesford District Council

Listed Buildings at Risk Register

A report on the Listed Buildings under
threat in the Uttlesford District

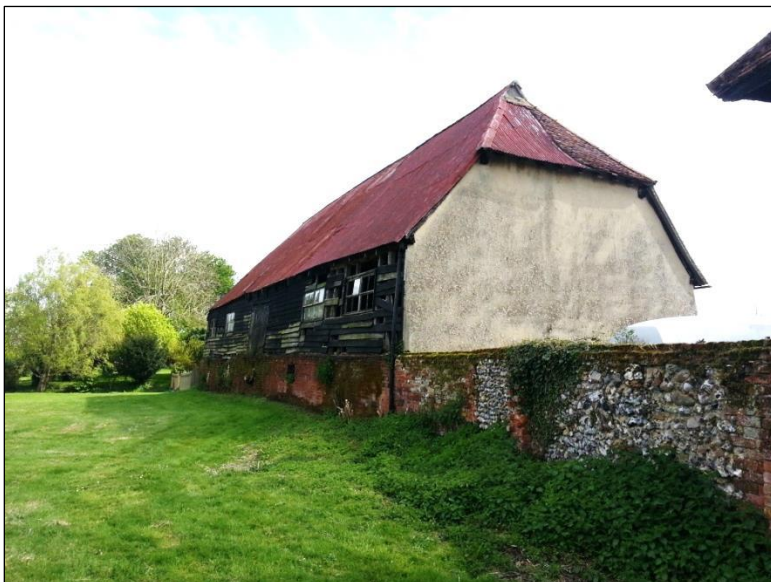
Barn at Chickney Hall, Chickney

Barn. Mid C14, aisled. Timber framed and weatherboarded, with red plain tile hipped roof. 5 bays long with C17 half hipped midstrey. Arch braced tie beams, jowled arcade posts, and splayed and bridled arcade plate scarfs. Passing braces, and reversed assembly at eaves. Jowled aisle ties. Original Crown post roof rebuilt as side purlin in early C17.

Roof has now been 'mothballed' with new timbers inserted and corrugated sheeting to rear.

Condition Poor

- Sections of missing weatherboarding to be replaced like-for-like
- Loose tiles to be reinstated or replaced like-for-like
- Windows to be boarded
- Tree stump in rear elevation to be removed and missing weatherboarding to be made good like-for-like

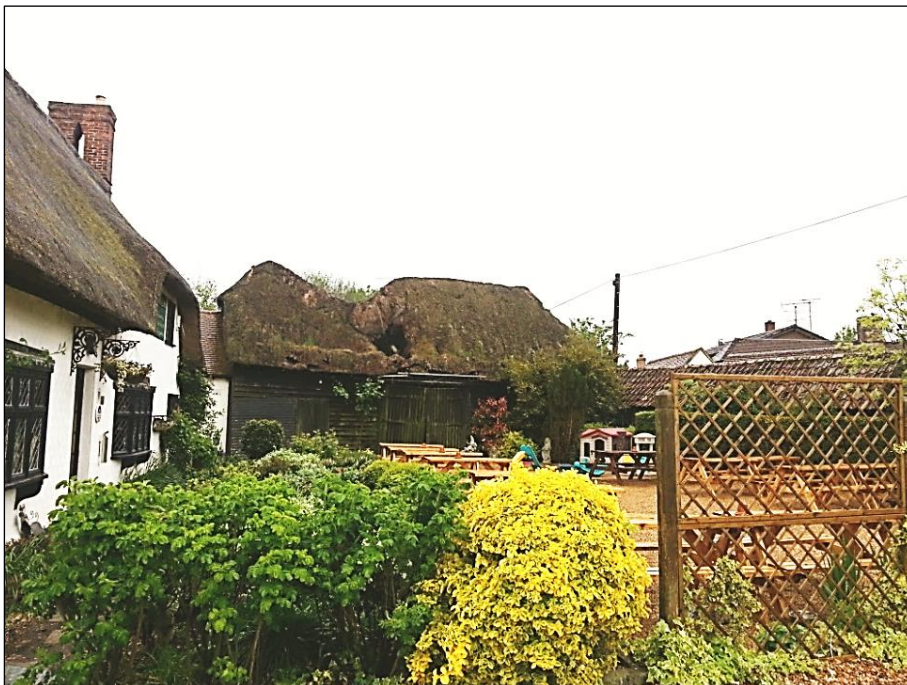
Barn at Red Cow Inn, 11 High Street, Chrishall

A 3-bay timber-framed and weather-boarded barn standing at right angles to the Red Cow Inn. Roof thatched

Roof has partially collapsed.

Condition Very Bad

- Roof to be covered
- Vulnerable areas of structure to be propped and supported

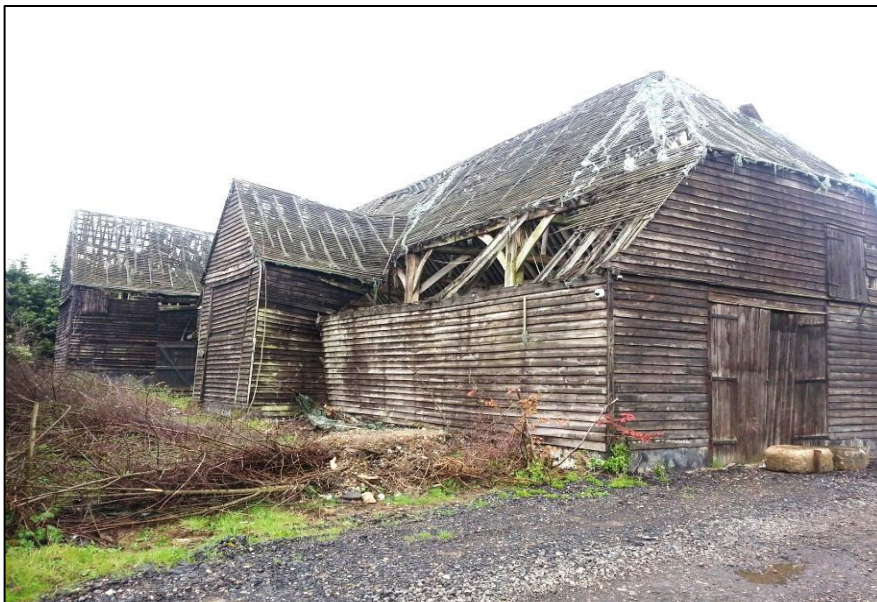
Barn North West of Home Farmhouse, Gaunts End, Elsenham

Large C17 timber-framed and weather-boarded barn with a tiled roof (there is some corrugated iron at the rear). The barn is built on an L shaped plan with a wing extending to the south at the west end and there is a gabled entrance bay on the south side.

C17 timber framed barn. Barn no longer watertight, tiles removed from entire roof leaving felt, battens and rafters exposed.

Condition Very Bad

- Roof and sections of missing weatherboarding to be covered

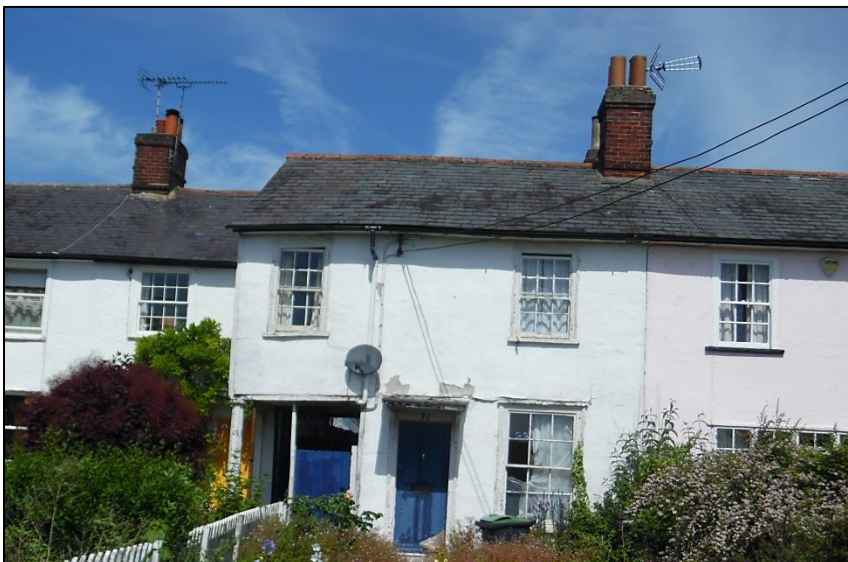
31 The Downs, Great Dunmow

Left-hand side overhang is showing signs of movement. Property is vacant.

Condition Poor

- Roof to be covered
- Vulnerable areas of structure to be propped and supported

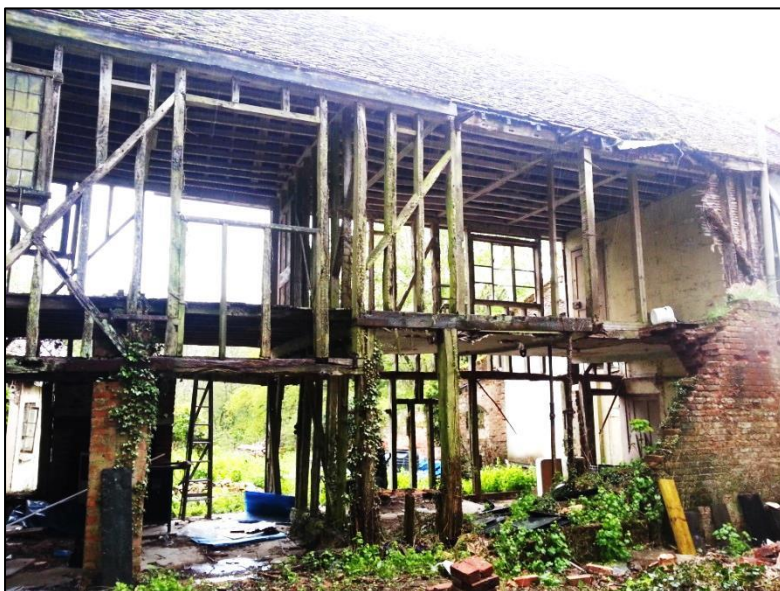
Bigods, Bigods Lane, Gt. Dunmow CM6 3BE

Part of the rear wing dilapidated. Planning Permission for restoration and extension approved but not implemented.

Condition Very Bad

- Roof and elevations to be covered
- Openings to be secured
- Loose slates to be reinstated or replaced like-for-like

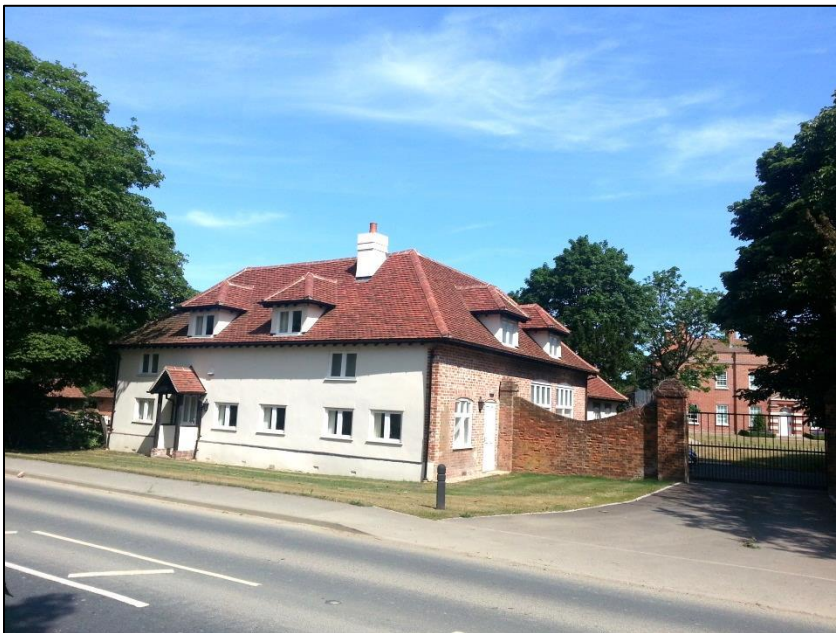
Stable and Lodge to South of Thremhall Priory, Takeley

C18-C19 red brick building built on an L-shaped plan with the stables extending to the north and the lodge extending to the west. The lodge wing is now faced in cement. One storey and attics. The stable front has 2 stable doors and a tiled hipped roof with 2 hipped dormers. Neglected for many years, but now converted to office use.

Repaired. To be removed from list

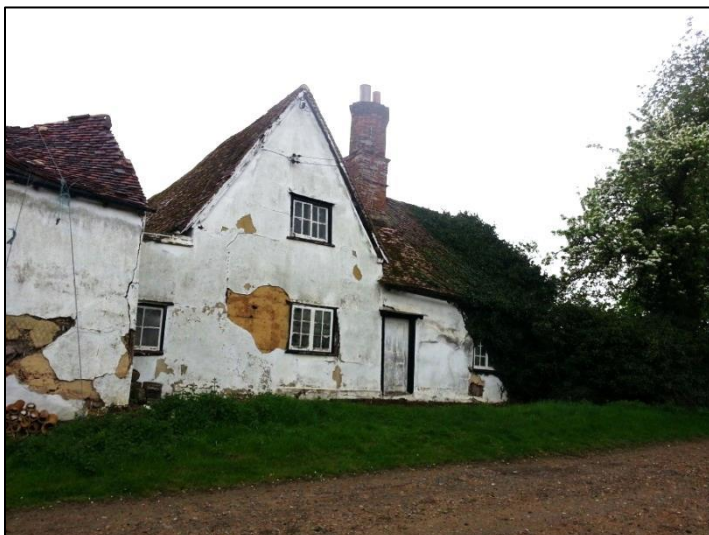
Goddards Farmhouse, Tindon End, Great Sampford

Early C17 timber-framed and plastered house built on an L shaped plan, with the remains of a moat. Two storeys. Casement windows. Roof tiled, with an original central chimney stack with grouped shafts set diagonally on a square base.

Bulging plaster on walls, sagging rafters and attached outbuilding near to collapse.

Condition Very Bad

- Vegetation to be removed
- Vulnerable areas of structure to be propped and supported
- Vulnerable sections of roof to be covered and areas of missing plaster to elevations
- Openings to be secured

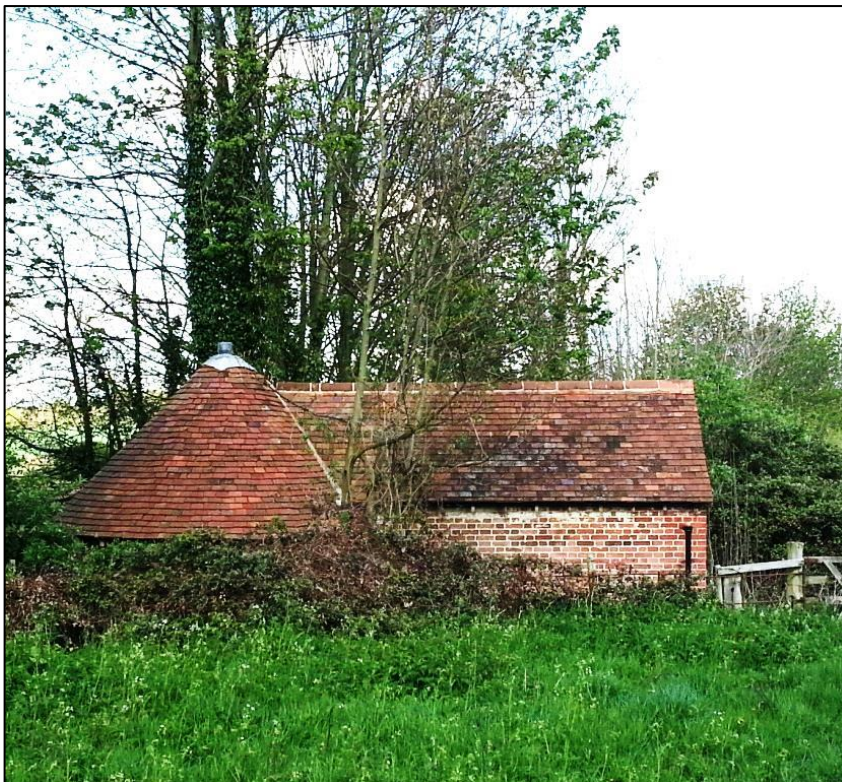
Ice House, Manuden House, Manuden

Early to mid C19. Red brick walls of both Flemish and English bond with plain clay tiles to the roof. An unusual structure with circular chamber above and below ground, conical roof and entrance porch. Plain unfenestrated walls to the chamber with a timber frame roof and timber finial. Pitched and gabled entrance porch has a flat gauged brick arch and entrance door with a half round relieving arch over. Unused and neglected for many years.

Repaired. To be removed from list.

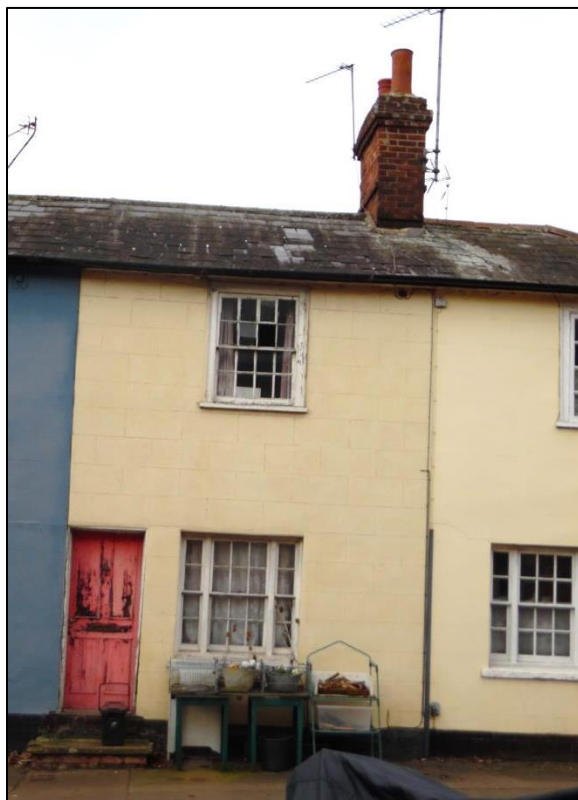
31 Castle Street, Saffron Walden

Missing render to rear elevation with timber frame exposed. Lintel missing above rear, ground floor window and doorframe missing to rear door.

Condition Fair

- Localised repairs to render using like-for-like materials

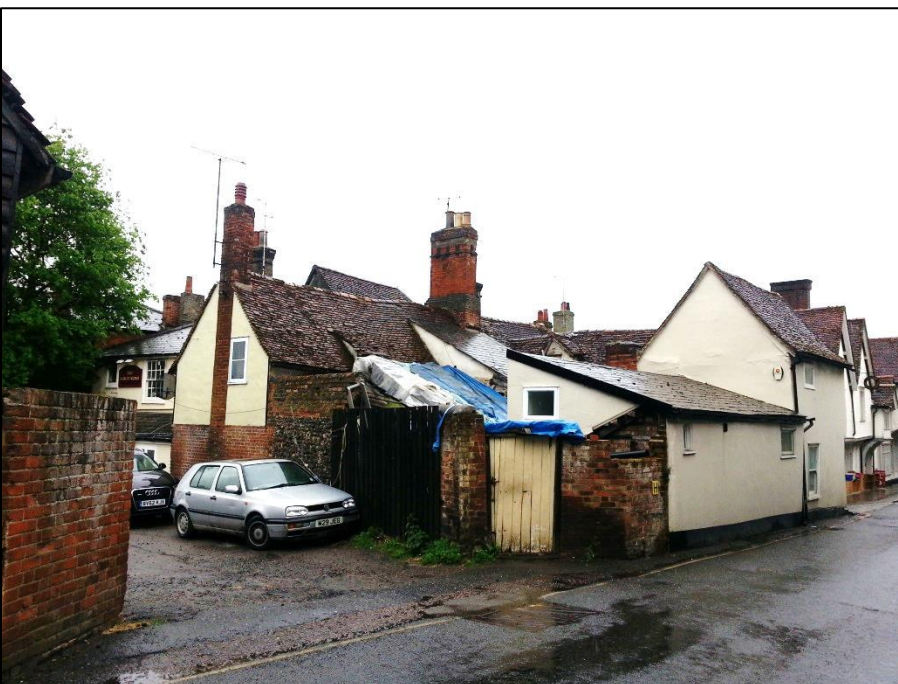
12, Market Hill, Saffron Walden

Early C16 and later timber framed building. Lack of maintenance and deterioration to rear elevation and ranges. Roof to rear inadequately protected with a tarpaulin, windows boarded to facade.

Condition Poor

- Improve temporary protection to rear roof slopes

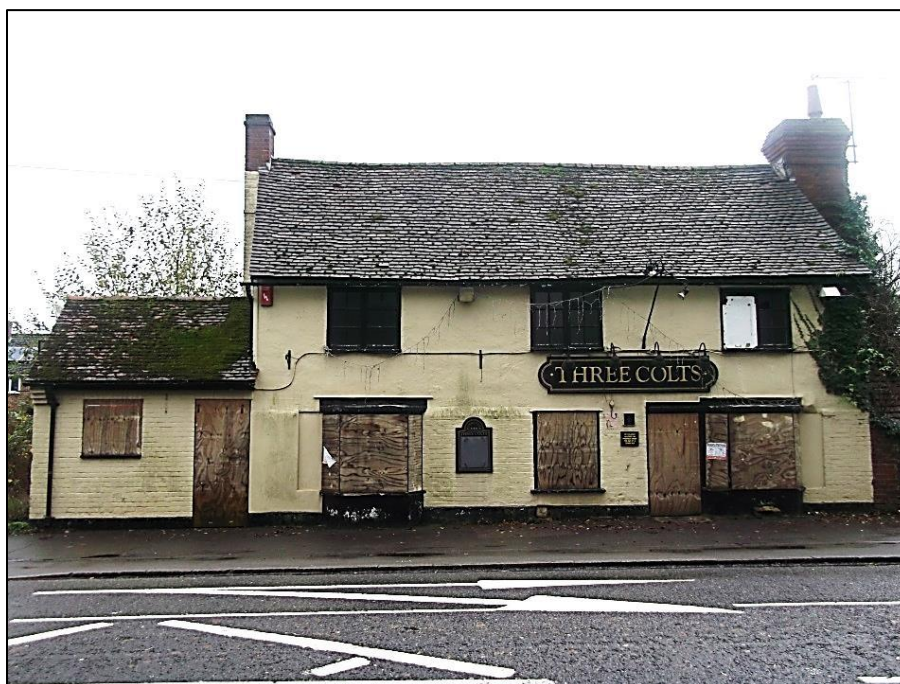
Property has been vacant and subject to vandalism. Windows broken but now boarded.

Condition Poor

- Vegetation to be removed

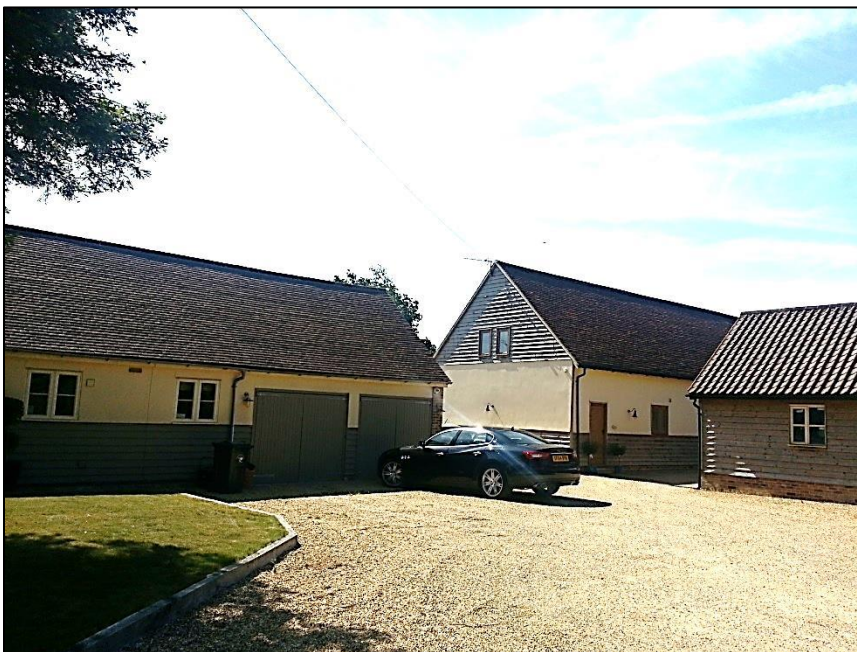
LB at Risk
The Colts Inn, 86 Cambridge Road Stansted

Suggested immediate actions: N/A

Repaired. To be removed from list.

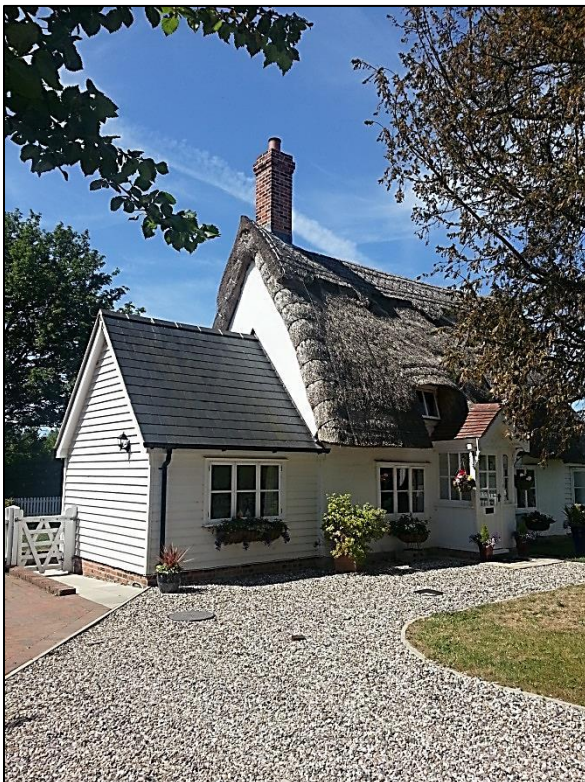
C18 or earlier cottage. Timber framed and plastered, with hipped thatched roof. One storey and attics, 4 window range, late C19 casements. One eyebrow dormer. Lean-to extensions to east and west end. Pargetted in combed panels, some of which are original. Suffered serious fire damage.

Repaired. To be removed from list

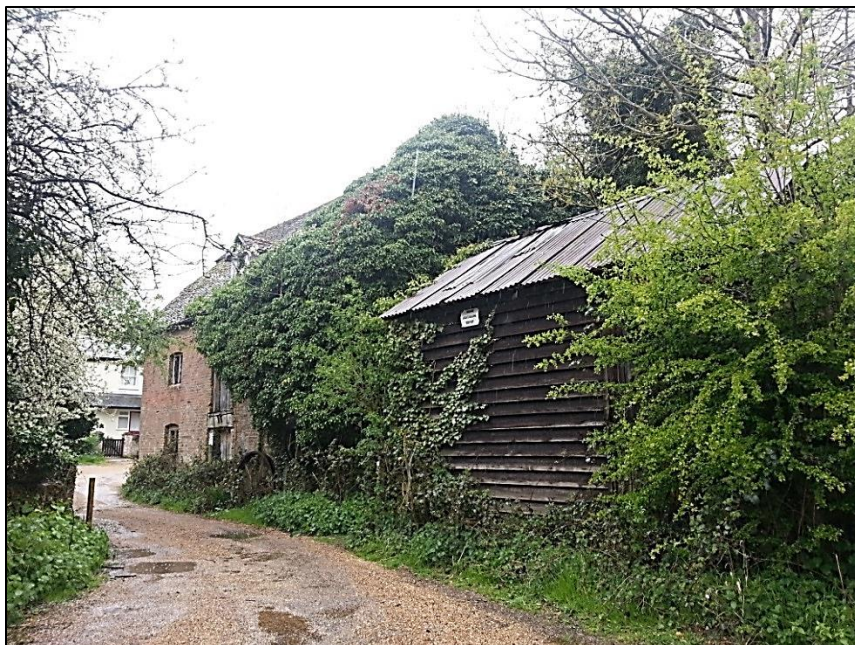
Vacant early C18 watermill with mechanism still intact but suffering from structural problems and lack of maintenance. Recommendations made by the District Council and Historic England for enabling development and conversion to residential use refused by Inspector.

Condition Poor

- Vegetation to be removed
- Vulnerable areas of structure to be propped and supported
- Openings to be secured

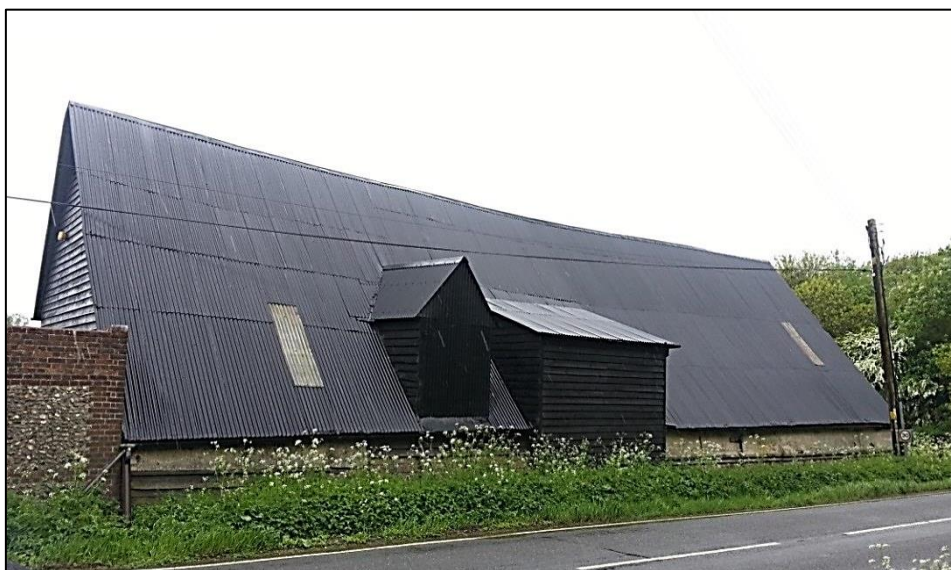
Corrugated tin roof, weatherboarding missing in places and roof appears to be no longer watertight. Repairs required. Application for residential conversion refused in the past.

Condition Fair

- Localised repairs to render using like-for-like materials

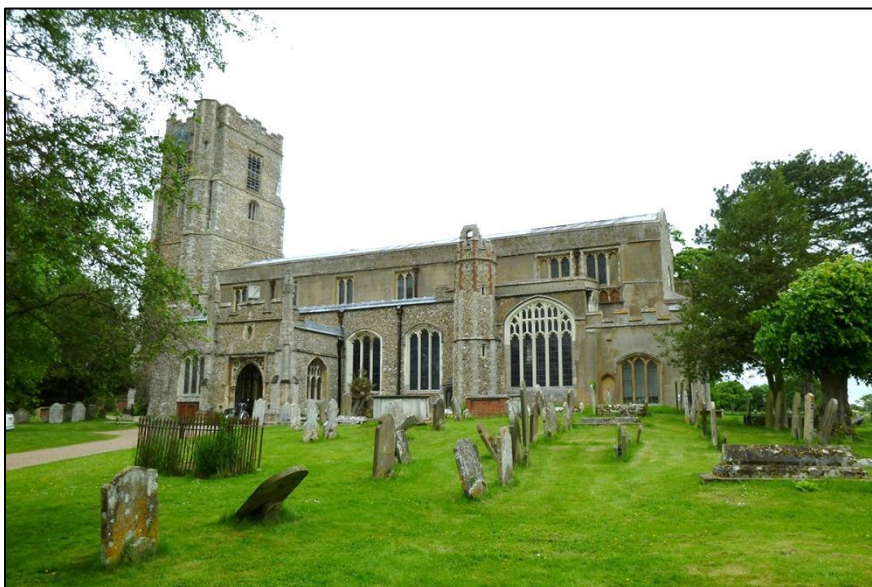
Immediate risk of further rapid deterioration or loss of fabric; solution agreed but not yet implemented.

Condition Very bad

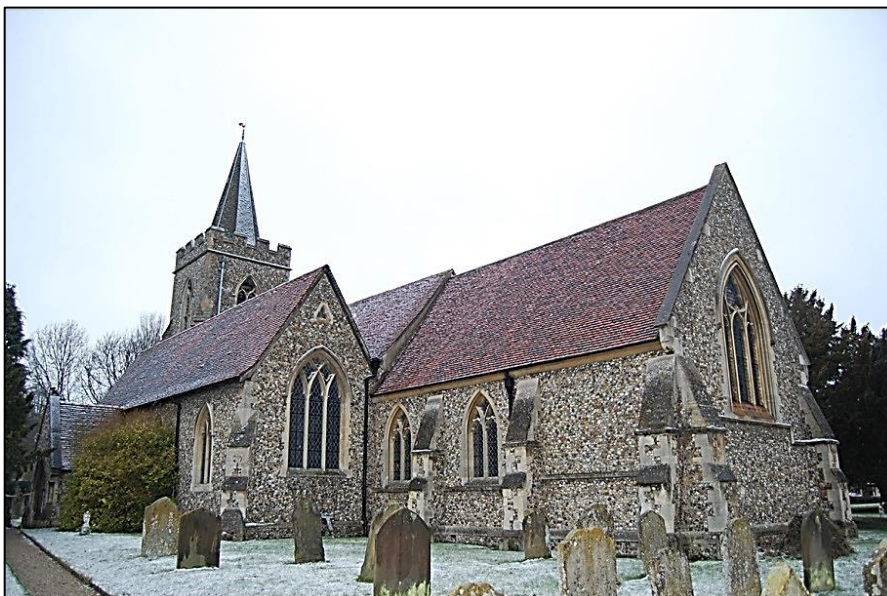
Church with probable C12 origins. C15 nave. Largely demolished and rebuilt in the 1860s. Constructed from flint rubble with stone dressings and a tile roof. The church forms the focal point of the village. Shingled spire showing signs of loss and curling of shingles; north transept (vestry) roof tiles are slipping. The latter are over a C15 roof structure with plastered ceiling and there is mould growth on the western part of the ceiling which is indicative of moisture ingress. Other tiles slipping elsewhere. Long term solution to be agreed.

Condition Poor

- Contact Historic England

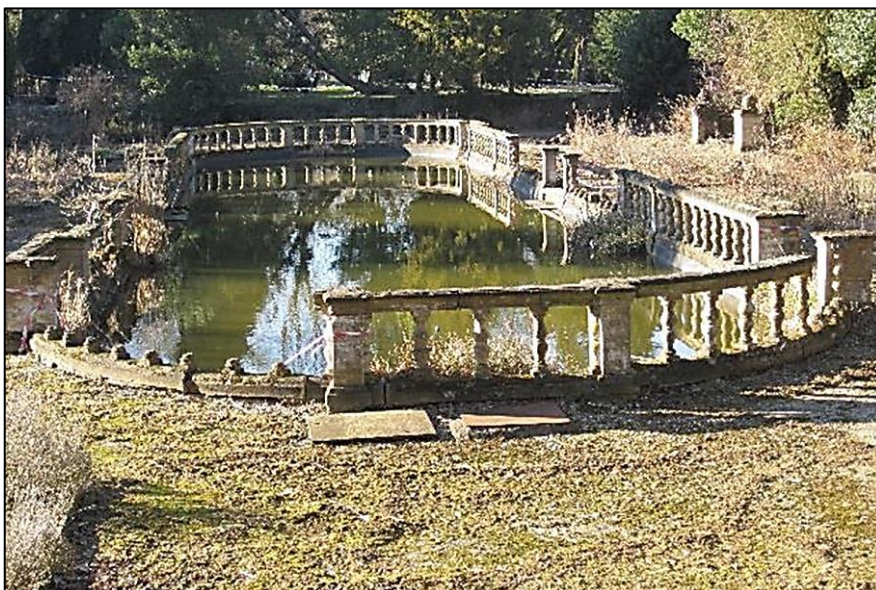
Immediate risk of further rapid deterioration or loss of fabric; no solution agreed.

Suggested immediate actions

- Contact Historic England
