# **Buildings at Risk Register**

**A report on the heritage sites under threat  
in the Uttlesford District**

**March 2017**

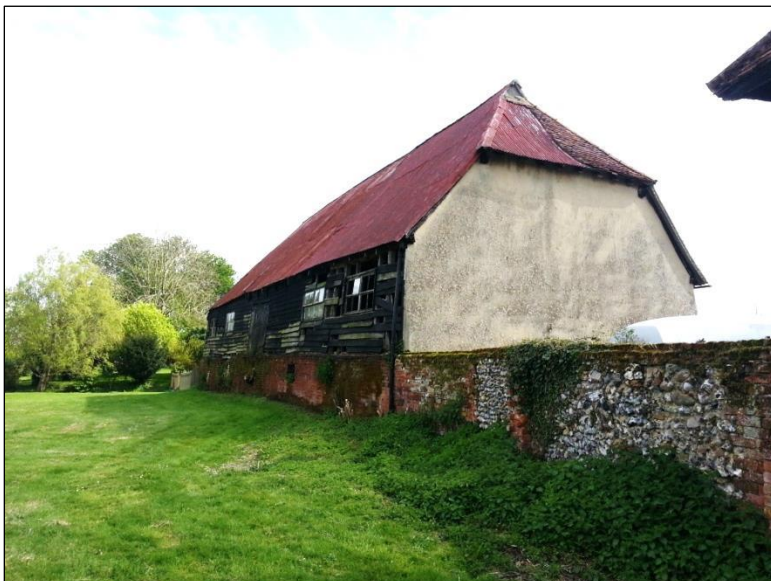
# Barn at Chickney Hall, Chickney

Roof has now been 'mothballed' with new timbers inserted and corrugated sheeting to rear.

- Sections of missing weatherboarding to be replaced like-for-like
- Loose tiles to be reinstated or replaced like-for-like and localised repairs of metal sheeting
- Windows to be boarded, or repaired
- Tree stump in rear elevation to be removed

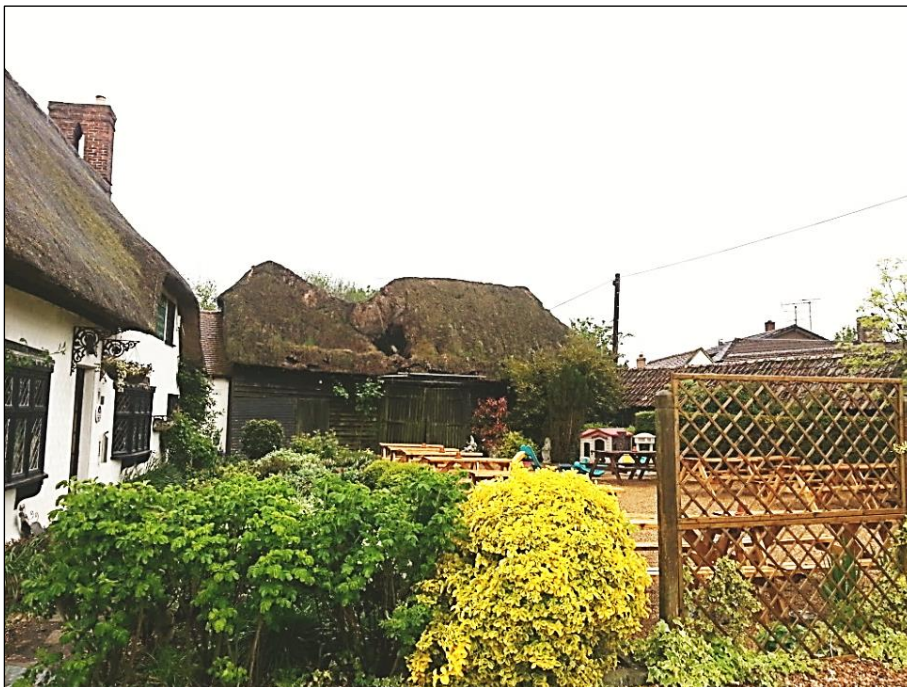
# Barn at Red Cow Inn, 11 High Street, Chrishall

Roof has partially collapsed.

- Roof to be covered
- Vulnerable areas of structure to be propped and supported

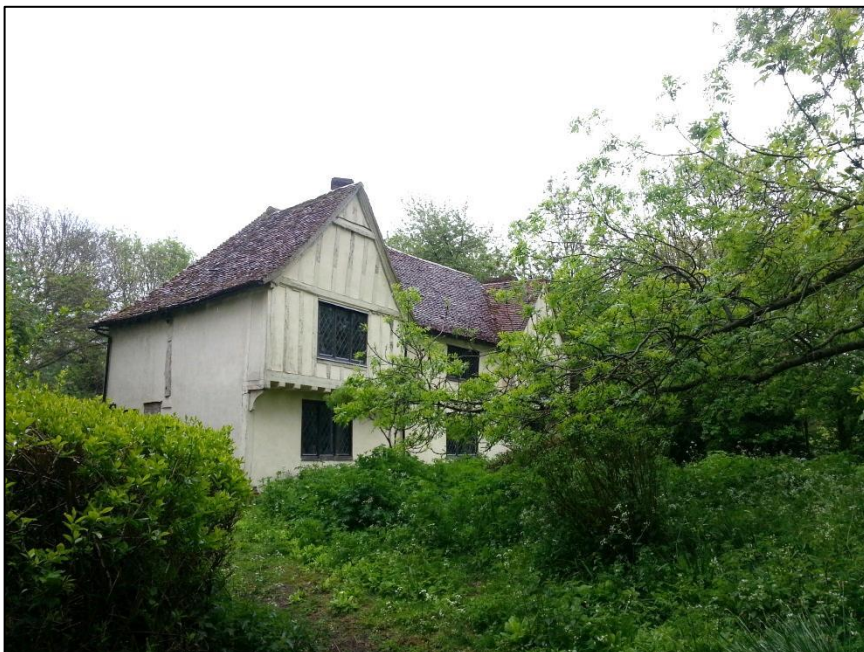
# Pigots, High Street, Elmdon

Property is vacant.

- Openings to be secured allowing for adequate ventilation
- Vegetation close to building to be removed

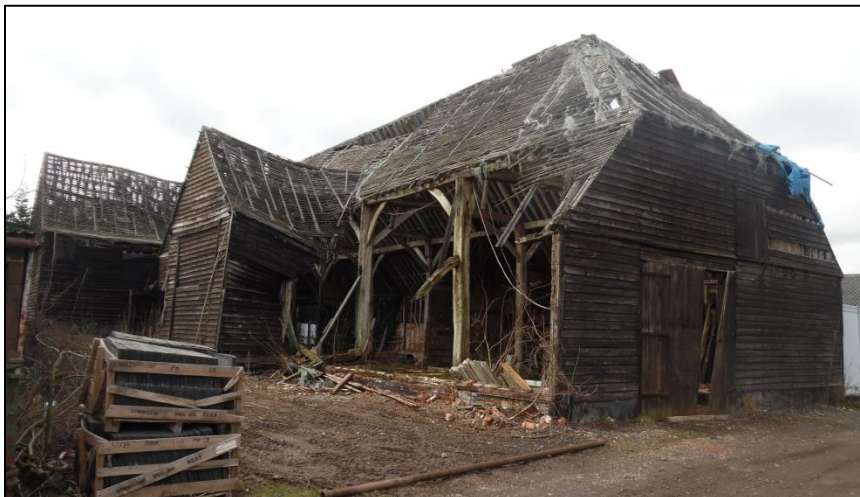
# Barn North West of Home Farmhouse, Gaunts End, Elsenham

C17 timber framed barn. Barn no longer watertight, tiles removed from entire roof leaving felt, battens and rafters exposed.

- Roof and sections of missing weatherboarding to be covered
- Openings to be secured, allowing for adequate ventilation

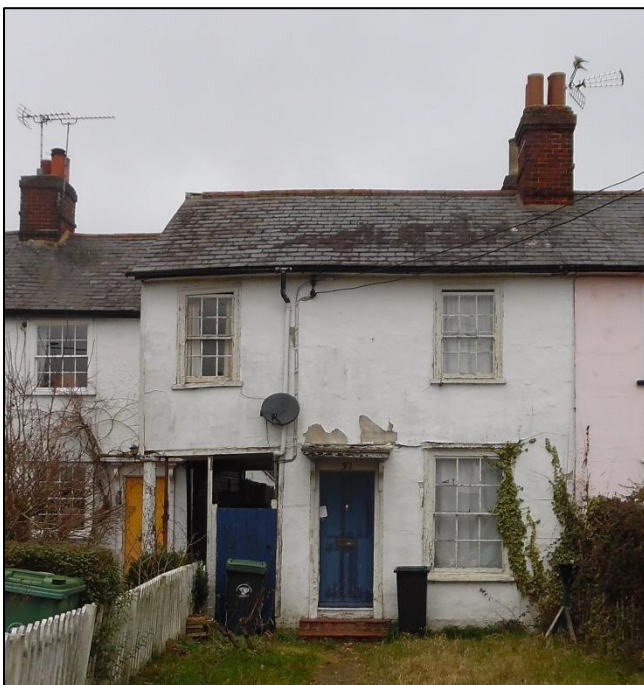
# 31 The Downs, Great Dunmow

Left-hand side overhang is showing signs of movement. Property is vacant.

- Roof to be covered
- Vulnerable areas of structure to be propped and supported

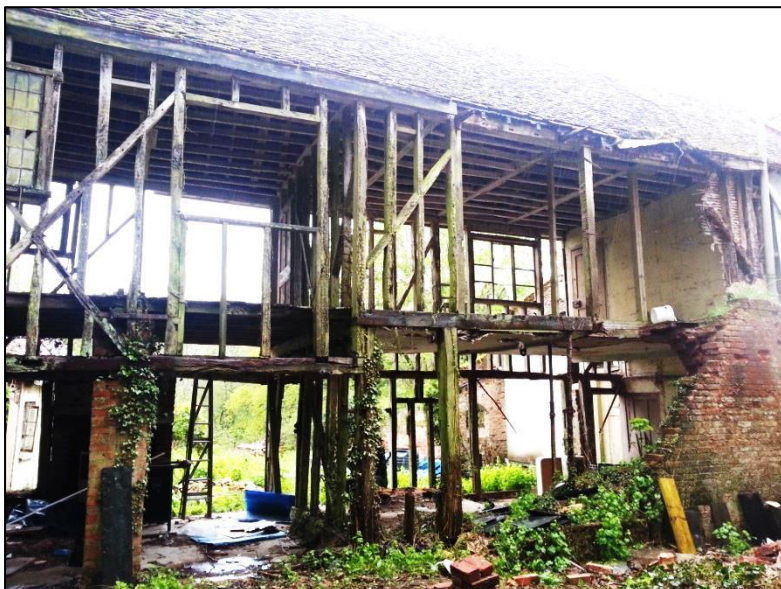
# Bigods, Bigods Lane, Gt. Dunmow CM6 3BE

Part of the rear wing dilapidated. Planning Permission for restoration and extension approved but not implemented.

- Elevations to be covered
- Openings to be secured allowing for adequate ventilation
- Loose slates to be reinstated or replaced like-for-like

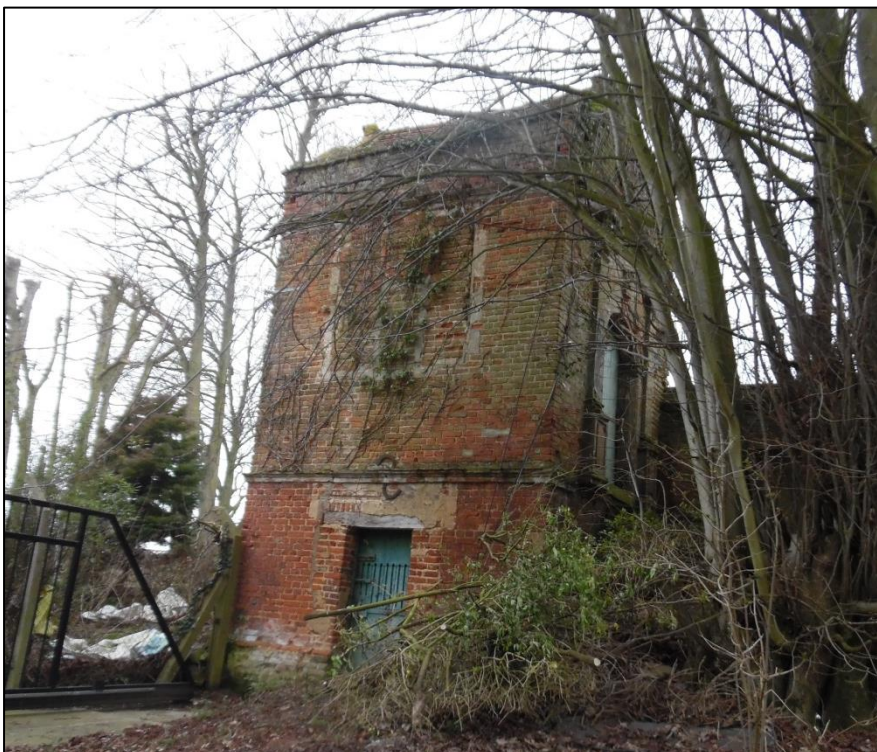
# Summer House, South West of Bigods, Bigods Lane, Gt. Dunmow

Disused structure with extensive vegetation growth

- Vegetation to be removed

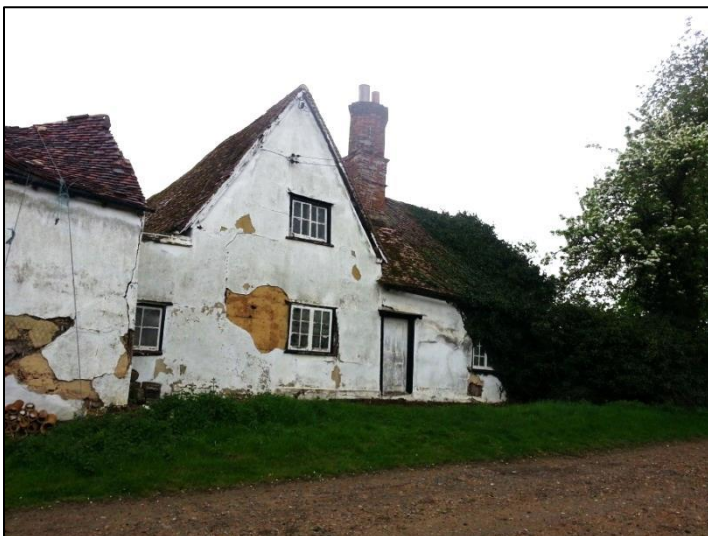
# Goddards Farmhouse, Tindon End, Great Sampford

Bulging plaster on walls, sagging rafters and attached outbuilding near to collapse.

- Vegetation to be removed
- Vulnerable areas of structure to be propped and supported
- Vulnerable sections of roof to be covered and areas of missing plaster to elevations
- Openings to be secured allowing for adequate ventilation

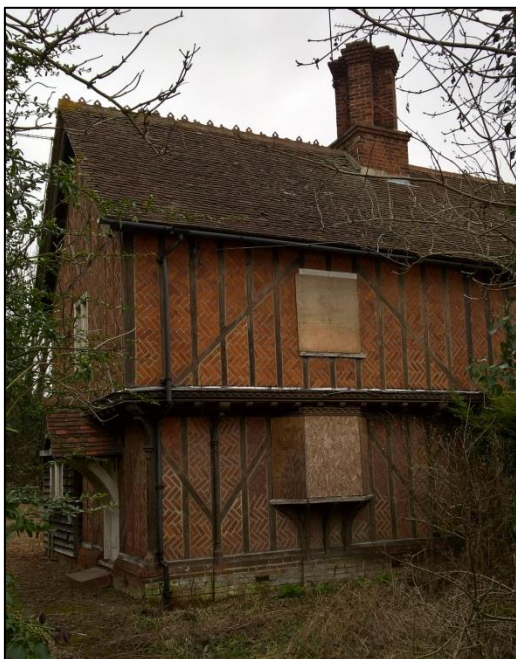
Property is vacant. Lack of maintenance causing fabric to elevations to fail. Loose brick nogging.

- Localised repairs to elevations using like-for-like materials

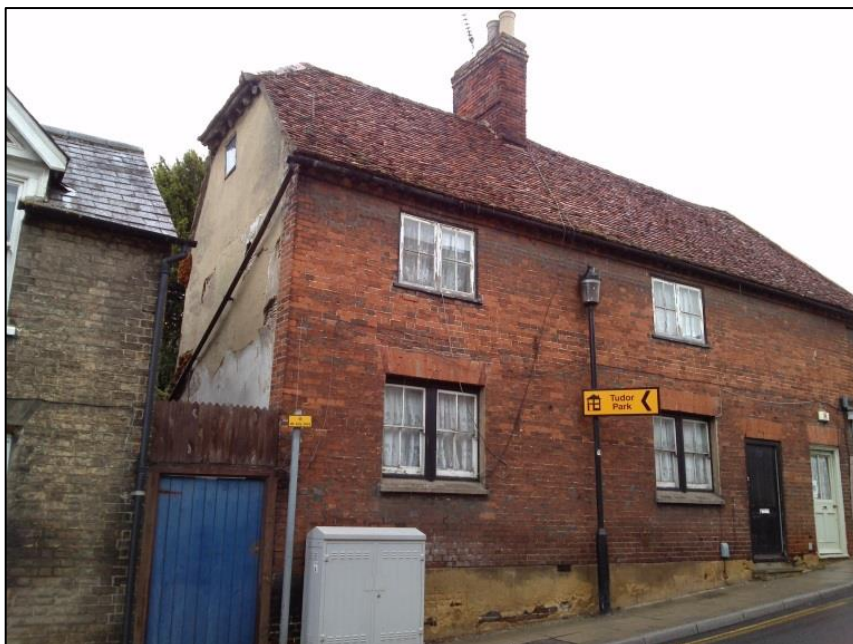
# 2 Bridge Street, Saffron Walden

Missing render to elevations and lack of maintenance to windows

- Localised repairs to render using like-for-like materials

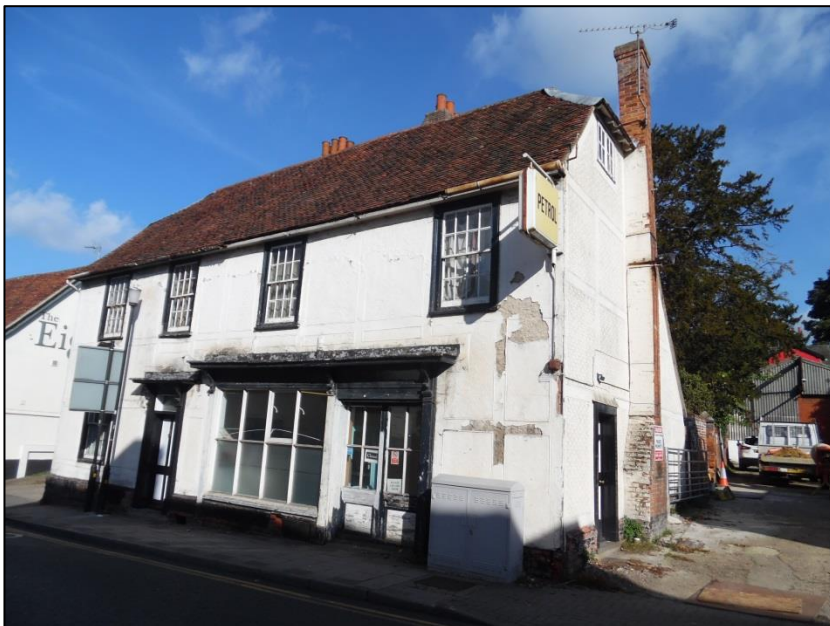
Missing render to elevations and lack of maintenance to windows

- Localised repairs to render using like-for-like materials

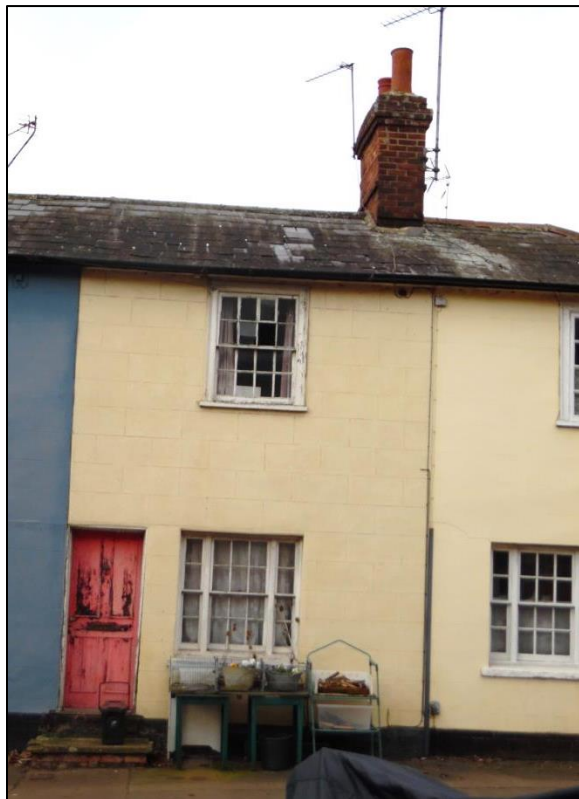
# 31 Castle Street, Saffron Walden

Missing render to rear elevation with timber frame exposed. Lintel missing above rear, ground floor window and doorframe missing to rear door.

- Localised repairs to render using like-for-like materials

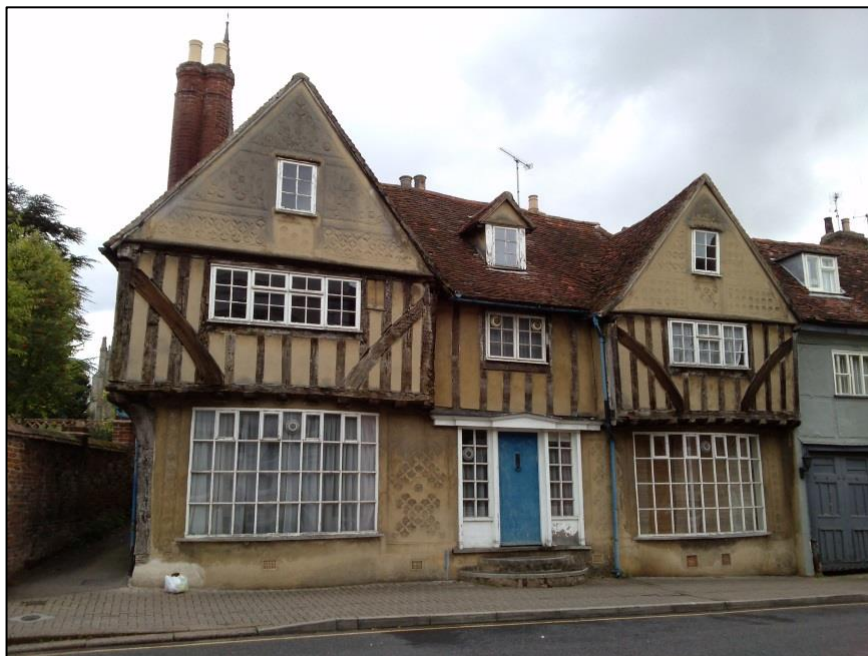
Defective roof and defective render allowing water ingress

- Localised repairs to roof in a like-for-like manner
- Localised repairs to render using like-for-like materials

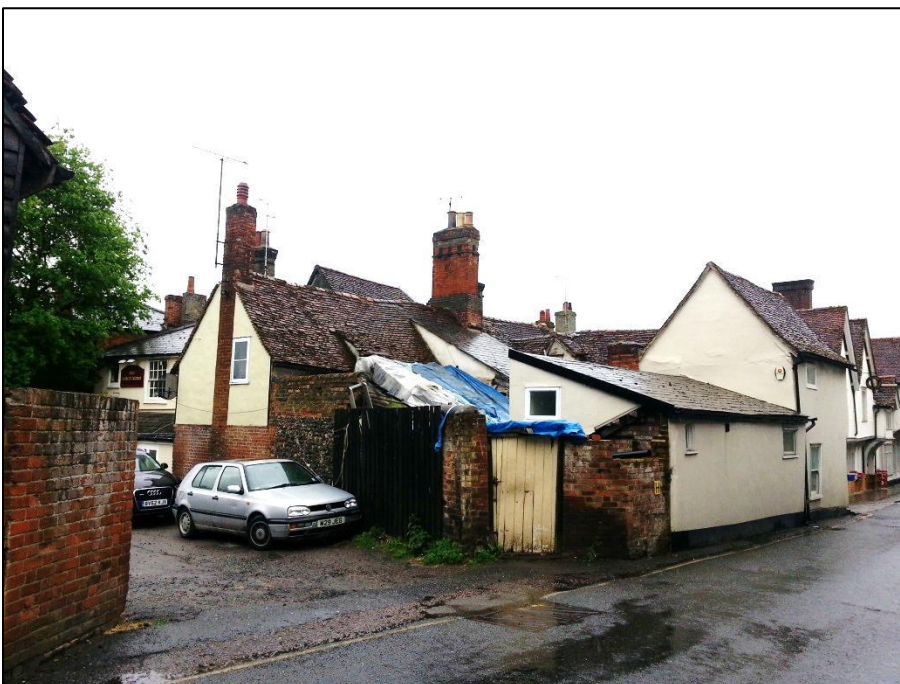
# 12, Market Hill, Saffron Walden

Early C16 and later timber framed building. Lack of maintenance and deterioration to rear elevation and ranges. Roof to rear inadequately protected with a tarpaulin, windows boarded to facade.

- Improve temporary protection to rear roof slopes

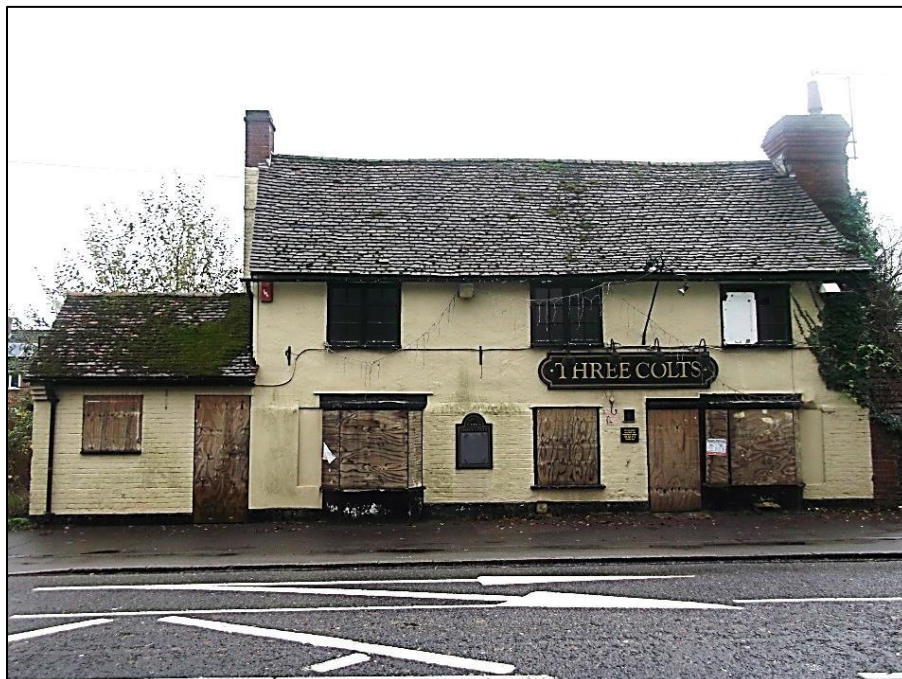
Property has been vacant and subject to vandalism. Windows broken but now boarded.

- Vegetation to be removed

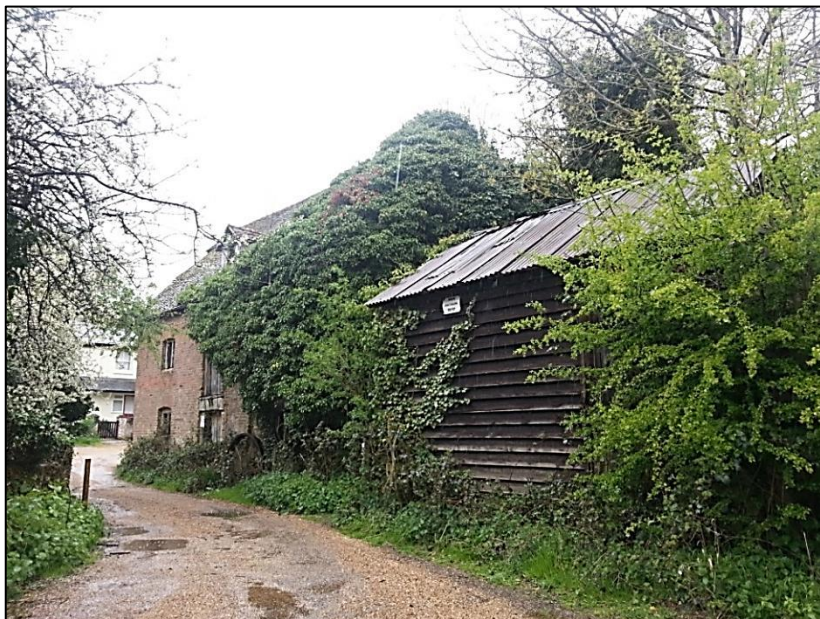
Vacant early C18 watermill with mechanism still intact but suffering from structural problems and lack of maintenance. Recommendations made by the District Council and Historic England for enabling development and conversion to residential use refused by Inspector.

- Vegetation to be removed
- Vulnerable areas of structure to be propped and supported
- Openings to be secured allowing for adequate ventilation

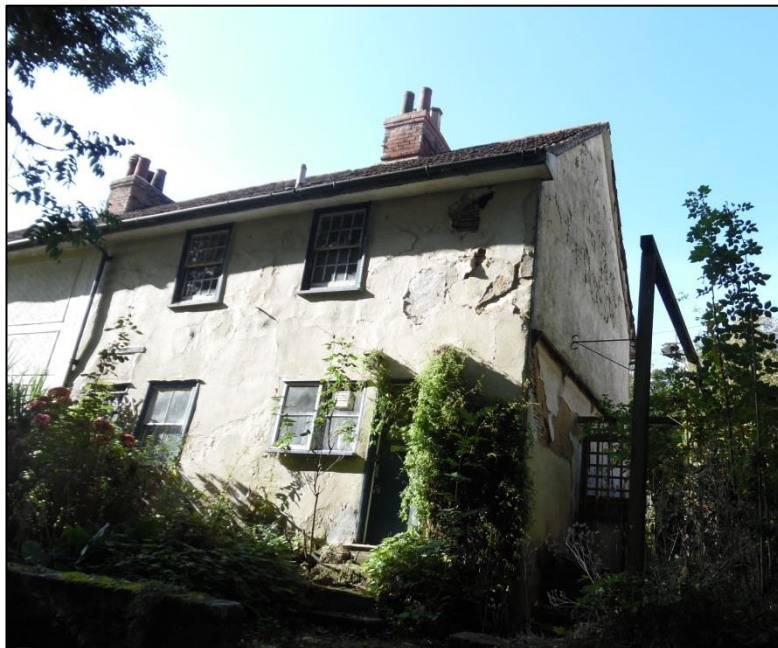
Missing render to front and side elevations with laths and timber frame exposed

- Localised repairs to the lime render in a like-for-like manner
- Openings to be secured allowing for adequate ventilation

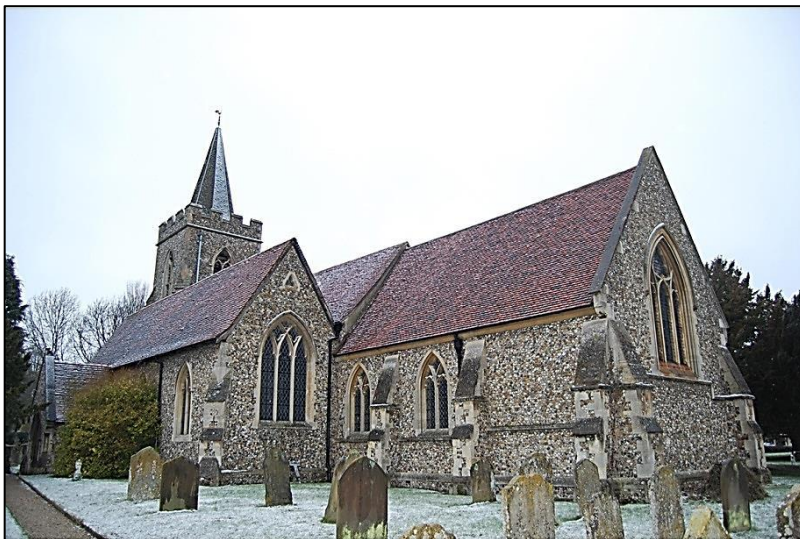
Church with probable C12 origins. C15 nave. Largely demolished and rebuilt in the 1860s. Constructed from flint rubble with stone dressings and a tile roof. The church forms the focal point of the village. Shingled spire showing signs of loss and curling of shingles; north transept (vestry) roof tiles are slipping. The latter are over a C15 roof structure with plastered ceiling and there is mould growth on the western part of the ceiling which is indicative of moisture ingress. Other tiles slipping elsewhere. Long term solution to be agreed.

Immediate risk of further rapid deterioration or loss of fabric; no solution agreed.

- Contact Historic England

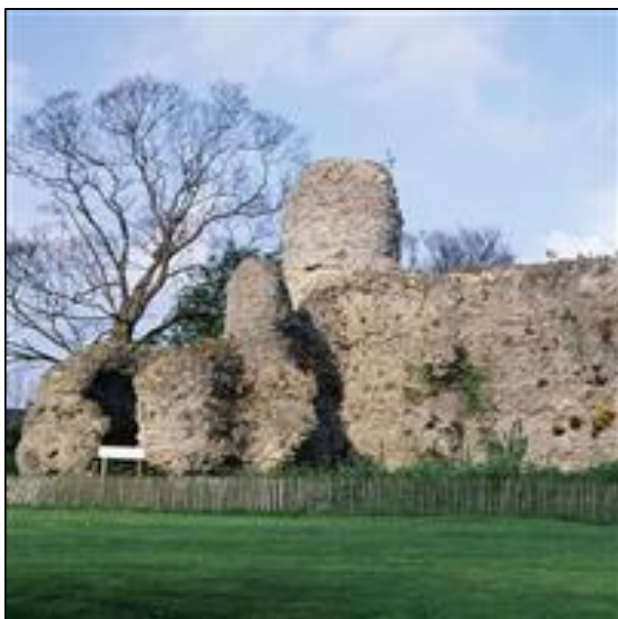
Norman castle remains consisting of roofless ruins of the keep. Unconsolidated flint rubble. Two phases of urgent repairs undertaken in 2013-14 and further repairs in 2015 undertaken to high level wall tops. Fabric at ground level on interior faces subject to vandalism. Grant aided work to north and western walls and to fore-building, to be completed in 2016. It is hoped that the owners may then embark on a further phase to complete the full consolidation of this important monument.

- Contact Historic England

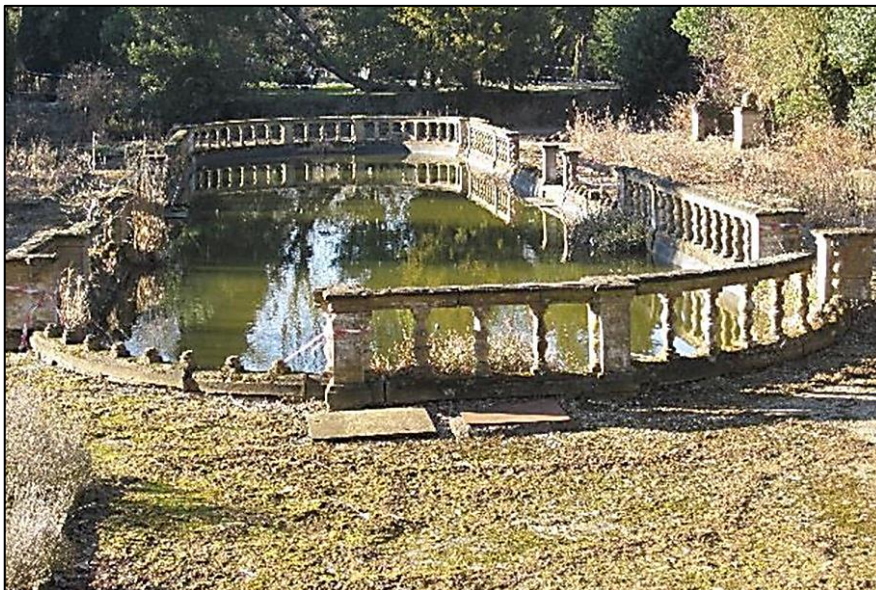
Edwardian gardens designed by Harold Peto c1902, incorporating a late C17/early C18 grove. The house was fire damaged and finally demolished in 1950. Converted service buildings and infill development remain. Built structures within the garden have deteriorated, particularly the Italian Garden but planting improving. Ownership split between private owners of house and an investment company. Garden continues to open to public in a limited manner under the direction of the charity, The Gardens of Easton Lodge Preservation Trust.

- Contact Historic England

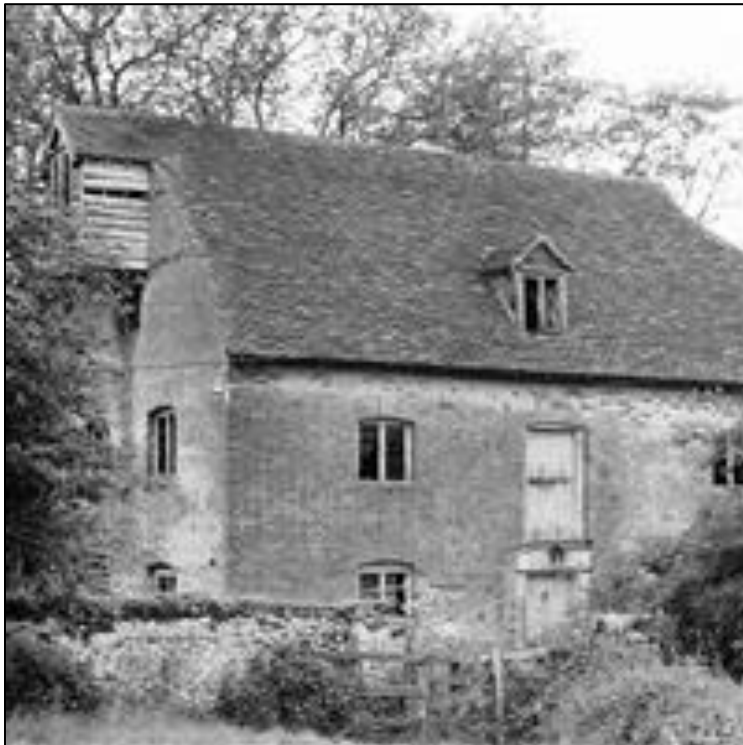
Watermill, early C18. Machinery intact. Evidence of defective roof tiles and some structural failure. In need of urgent structural repairs and repair work to make it safe, wind and weather tight. Owners have completed some repairs to exterior of building to address much of the weathering and security issues. Discussions are on-going with the owners, the local authority and a number of interested parties over options to save the mill.

- Contact Historic England
