# Hadstock Conservation Area Appraisal and Draft Management Proposals, 2014

### Introduction

**1.1** This appraisal has been produced by Officers of Uttlesford District Council to assess the current condition of the Hadstock Conservation Area, to identify where improvements can be made and to advise of any boundary changes that are appropriate. The document is in draft form and will be subject to public consultation and agreement by District Council Members.

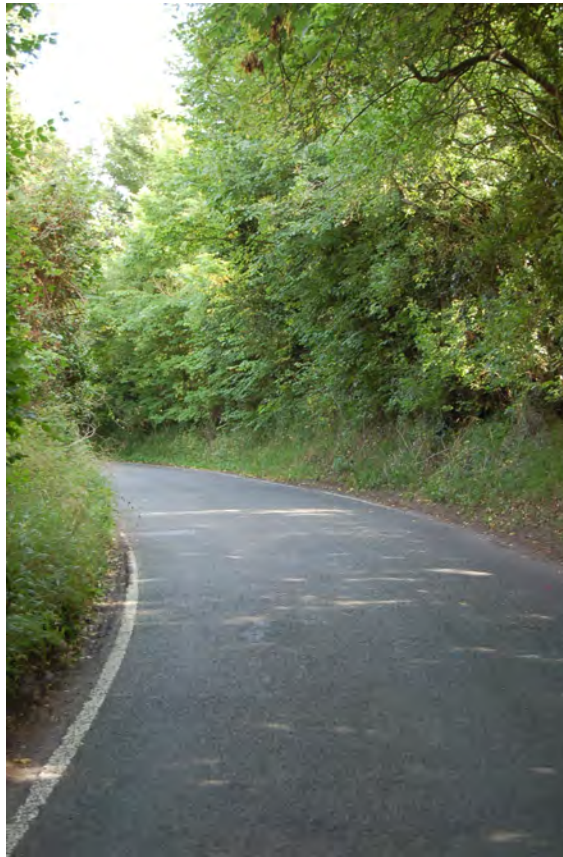
Picture 1.4 Bartlow Road - the ancient sunken lane, of Medieval or earlier origin, as it ascends from the village

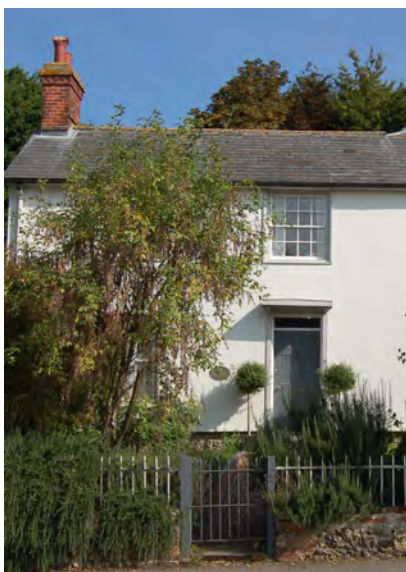
Picture 1.6 Slate, white-washed plaster and simple iron railings on a half height flint wall in Linton Road

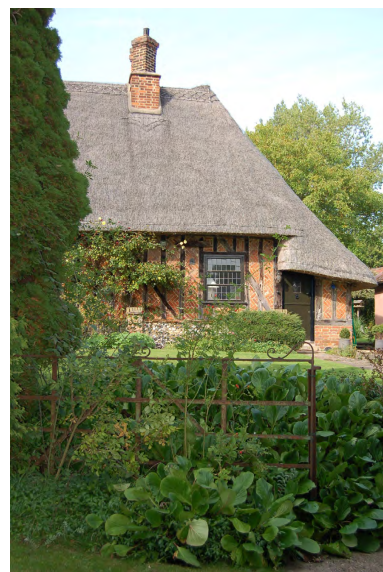
**1.83** Clay lump or batts are also found on smaller dwellings and ancillary buildings of the late 18th and 19th centuries. Blocks are typically 18 inches long and made from a mixture of clay, chalk, earth, sand, gravel, dung or straw often laid on their backs on a bed of clay mortar, sometimes with a flint base layer before being finished historically with a clay daub or, on more prestigious buildings, a lime render. Such finishes, especially where repaired and painted, can now make identification difficult. Notably in Hadstock, Sheepshead Row terrace (The Row) and the small outbuilding to Dormer Thatch are both constructed in this manner.

Picture 1.7 Brick nogging employed to dramatic effect as an infill on Dormer Thatch

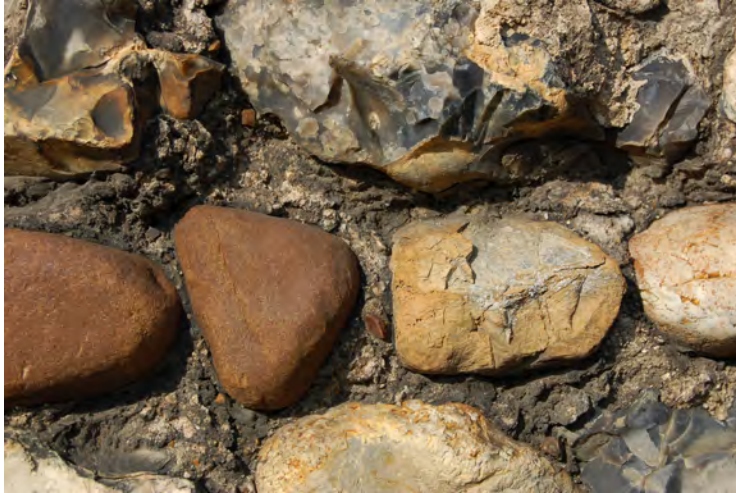
Picture 1.8 Traditional Essex flint panelling on the wall linking Kings Cottage and Walnut Cottage

**1.88** Boundary treatments are an important element in defining the street scene where they provide texture and interest to an area. Walls, many of which are constructed of flint panels supported by brick piers and capping, and fences, many of the timber picket type, are typically low to front and side elevations on public through-fares. They are either painted white or left untreated. Some larger properties are fronted by iron railings, either simply worked by local craftsmen or historically obtained from large commercial foundries.

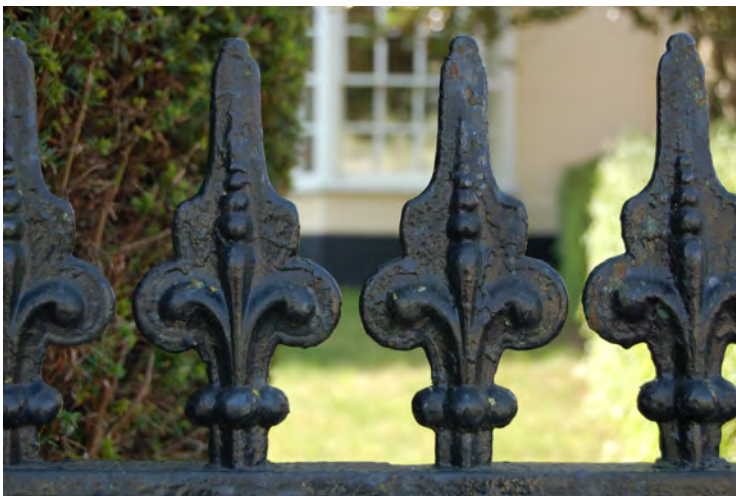
Picture 1.9 Listed railings to the front of Yew Farmhouse

**1.125** To the front of Yew Farmhouse runs a range of decorative 19th century railings on a low wall. These are of importance enough to warrant Grade II listing in their own right. On the other side of the road, Chestnut House is likewise protected from the road by run of railings, though these are of much simpler design. Other railings and gates are to be found to the front of Domer Thatch.

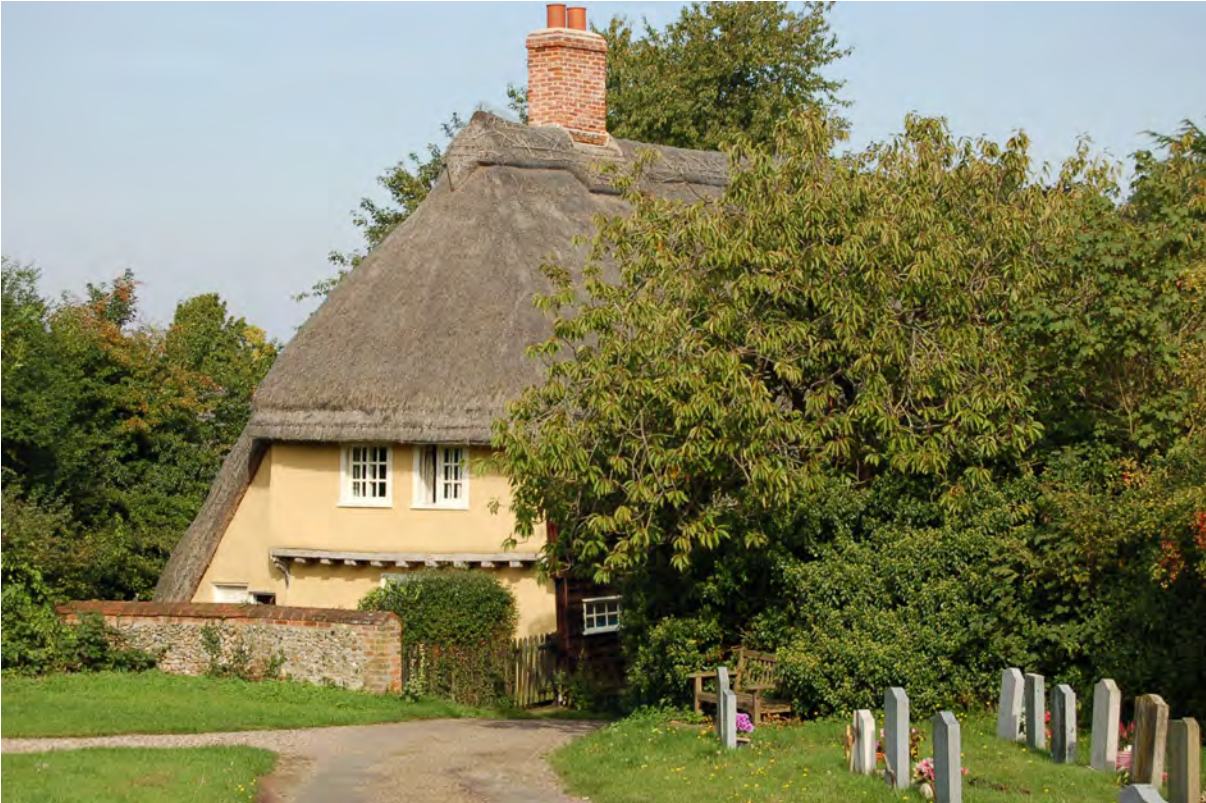
**1.104** Beam Ends (Grade II) sits at the entrance to the churchyard on Church Path and is noted by Bettley and Pevsner as "a charming C15 house with jettied s. end"<sup>(34)</sup>. The English Heritage list entry dates it somewhat later to the cusp of the 16th and 17th centuries. It is of two storeys, part attractively colour washed, the remainder boarded, windows are mainly small horizontal sliding sashes with glazing bars. Roof thatched, hipped at the north-east and south-west ends.

Picture 1.14 Beam Ends; a quintessential English cottage, attractively colour washed, thatched and with small neat horizontal sliding sashes. It sits on the rising path to the church

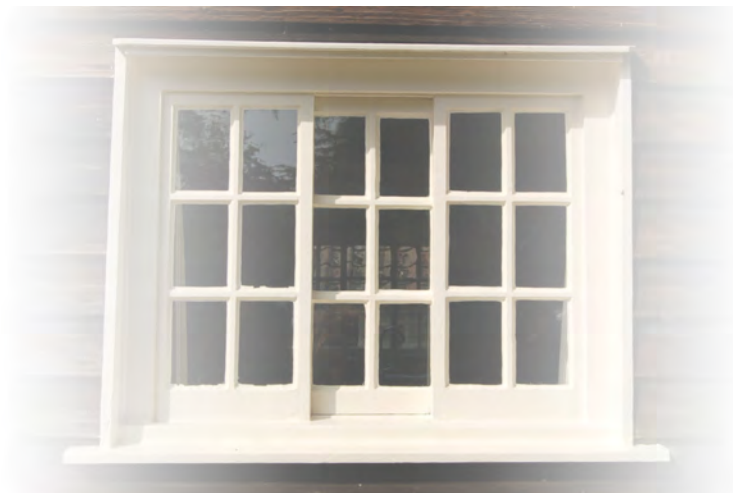
Picture 1.15 Horizontal sliding sash at Beam Ends

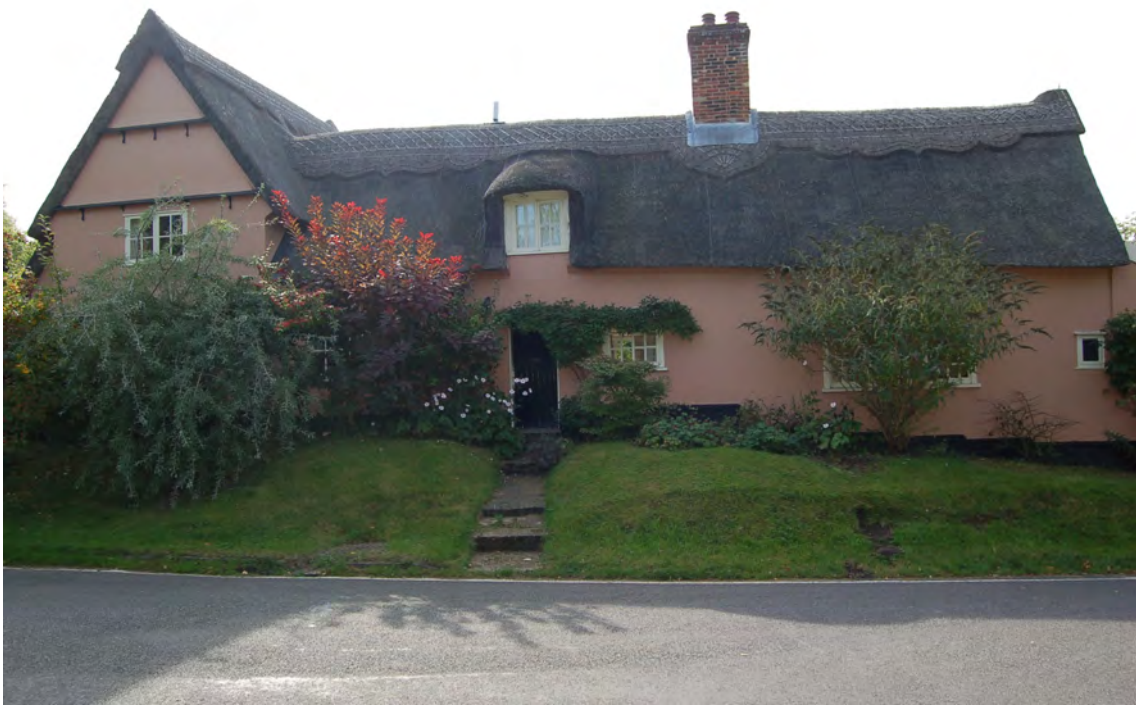
**1.106** East of Hadstock Hall "an attractive row of houses leads uphill"<sup>(35)</sup>. These comprise Pond House, Garden Cottage, The White House (dating from around 1800) and finally Hillcrest. All are Grade II. The latter dates from the 17th or 18th century and is a timber-framed and plastered building. One storey and attics. Small horizontal sliding sash windows. Boarded door. Roof thatched, with a central square chimney stack. There is a modern addition at the north-west end.

Picture 1.16 Hillcrest Cottage completes the varied progression of properties up Bartlow Road

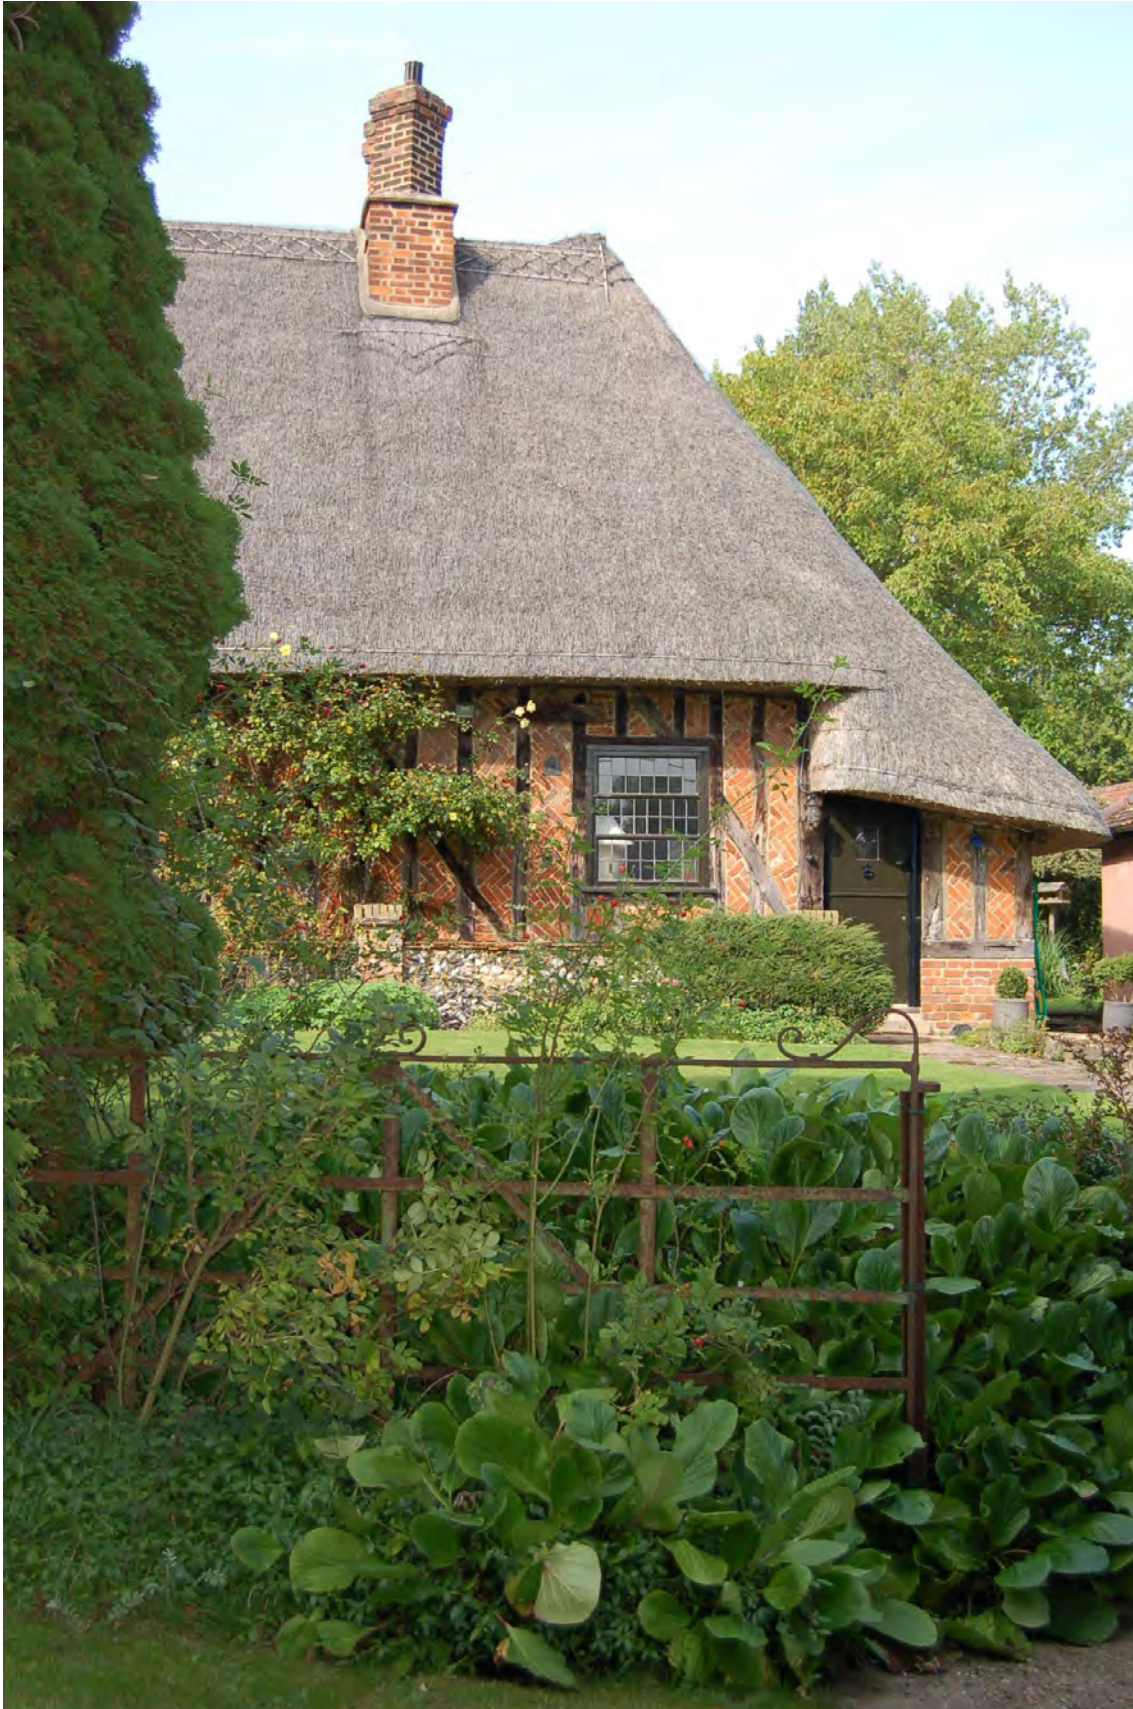
**1.107** At the furthestmost eastern extent of the Conservation Area can be found a dispersed group of three thatched properties - Hadstock Cottage, Mallyons and Dormer Thatch. These represent the end of the village proper before outlying farms are encountered. Of the trio, the 17th century Dormer Thatch is the most visibly arresting with its exposed timber-frame, now weathered to a steely grey, set against the rich red of the soft Essex brick nogging to the front elevation. Casement windows with leaded lights are 20th century additions as is a modern tiled porch which projects on the front. Roof thatched, hipped, with 3 gabled dormers and a central chimney stack with 3 square shafts set diagonally on a rectangular base.

Picture 1.17 A low thatched roof, contrasting brick nogging and decorative chimney treatments presents a most pleasing aspect

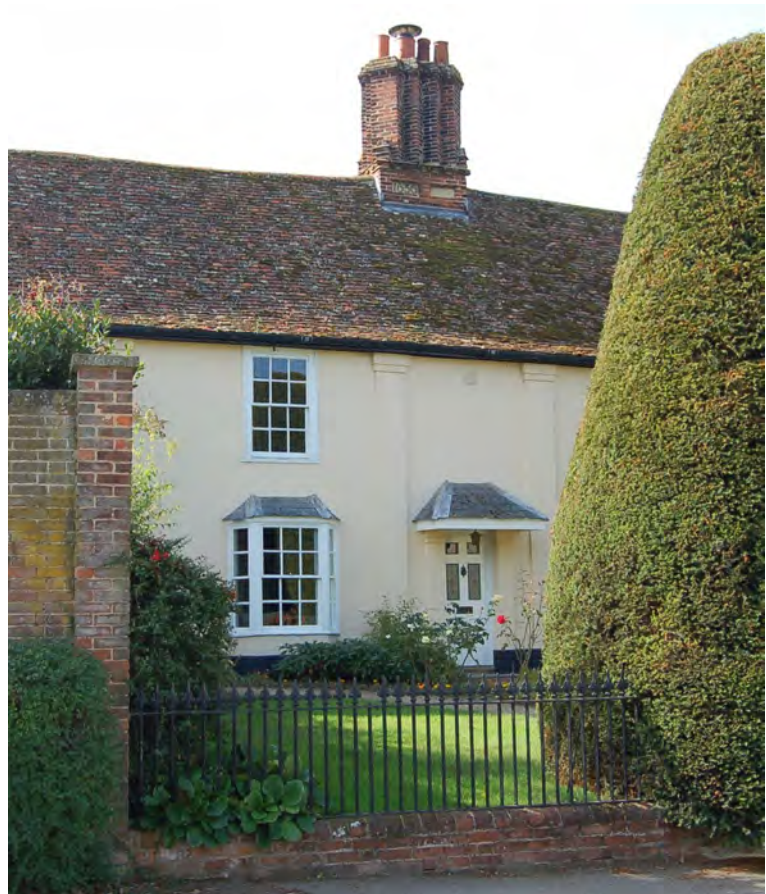
**1.110** Further down the Linton Road can be found the well appointed Chestnut House followed by numbers 1 and 2 The Cottages, these built in 1842 and formerly known as Swans Cottages. Opposite are the Kings Head pub and Yew Farmhouse, both Grade II listed. The latter is by far the most imposing in the streetscape fronted by grand railings and two huge yew trees, the original early 17th century timber-framed and plastered building was altered in the 18th and 19th centuries to the present form. The front is divided into 3 bays by stucco pilasters. Two storeys. Two window range, double-hung sashes with glazing bars. The ground storey has 2 small canted bays. A central doorway has a slate roofed hood. The roof is tiled with an original central chimney stack with diagonal shafts on a rectangular base with a sunk panel bearing the date '1636'.

Picture 1.18 Yew Farmhouse, dating from 1636, set back from the road behind grand railings and huge Yew trees

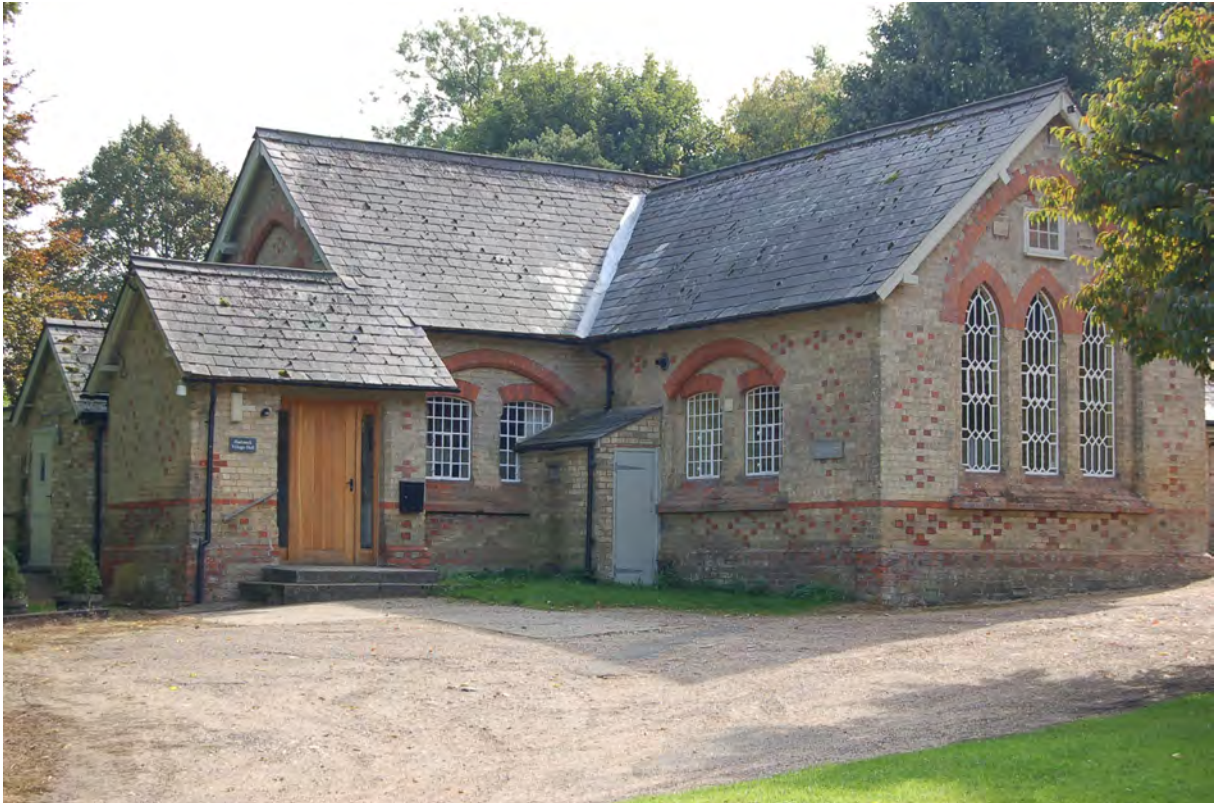
with contrasting decoration and arched dressing detail in red brick, it owes something to both the Gothic tradition and that of solid industrial architecture. The tall three window range on the south wing are particularly notable for their Gothic arches and elaborate lozenge glazing. The roof is slate and is finished simply. An Article 4 Direction to provide protection for windows and selected architectural detailing may be appropriate subject to further consideration and notification.

Picture 1.19 The Village Hall, formerly the local school is a building of undoubted quality

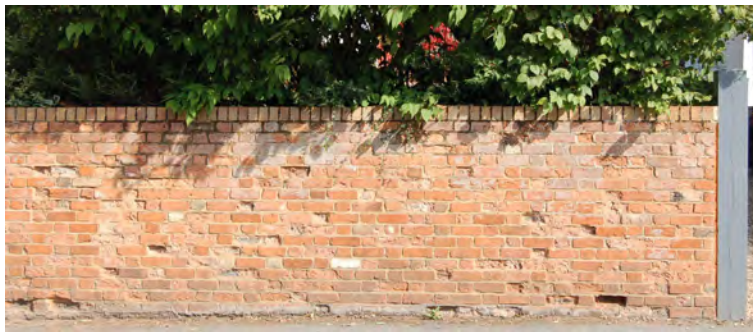
**1.124** The length of brick walling extending between Chestnut House and No. 2 The Cottages on Linton Road is most prominent in the street scene. This probably late 19th century wall, about 1.25m high is now exhibiting several areas of degradation with blown pointing and spalled brickwork. Appropriate remedial action would be desirable.

Picture 1.20 Spalled brickwork on the wall between Chestnut House and No.2 The Cottages detracts from the overall quality of the streetscene. Remedial action would be desirable
