# Donald Insall Associates

Uttlesford District Council  
Heritage Impact Assessments

Draft 11th May 2018

Commissioned by - Uttlesford District Council

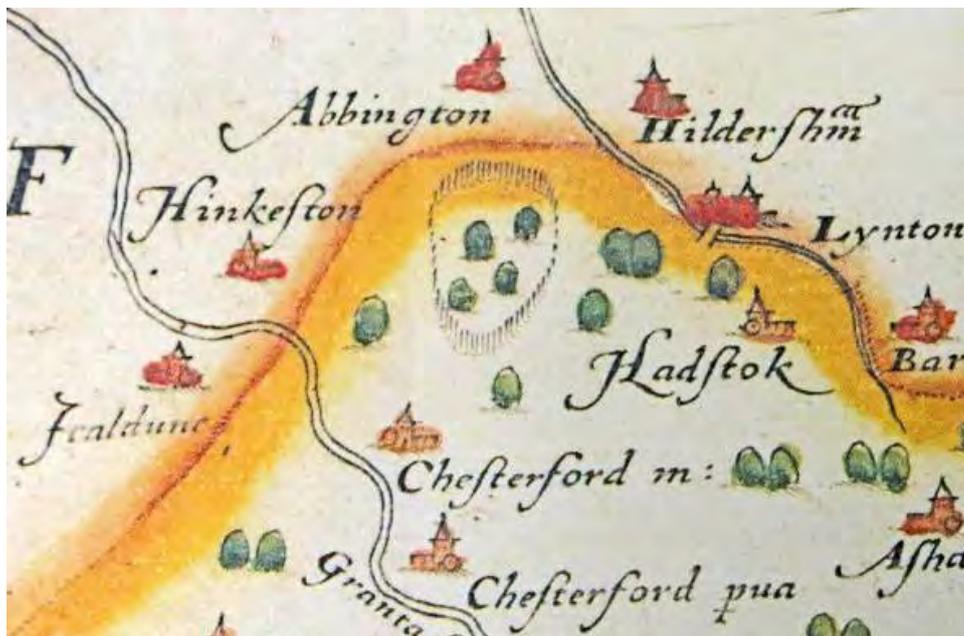
Fig. 1: Chesterford Park from Christopher Saxton's Map of Essex 1574.

- 7.3.3 Anglo Saxon occupation continued in the area, as evidenced by an extensive Anglo-Saxon cemetery excavated immediately to the north of the Roman town. During the Medieval period settlement of the area consisted of the villages of Great and Little Chesterford and Littlebury, together with more dispersed settlement in the form of small hamlets, isolated farms, manors, moated sites along with a large medieval park at Chesterford Park. This park was still in existence in the 18<sup>th</sup> century and was depicted 16<sup>th</sup>, 17<sup>th</sup> and 18<sup>th</sup> century maps (Figs. 1 to 4).

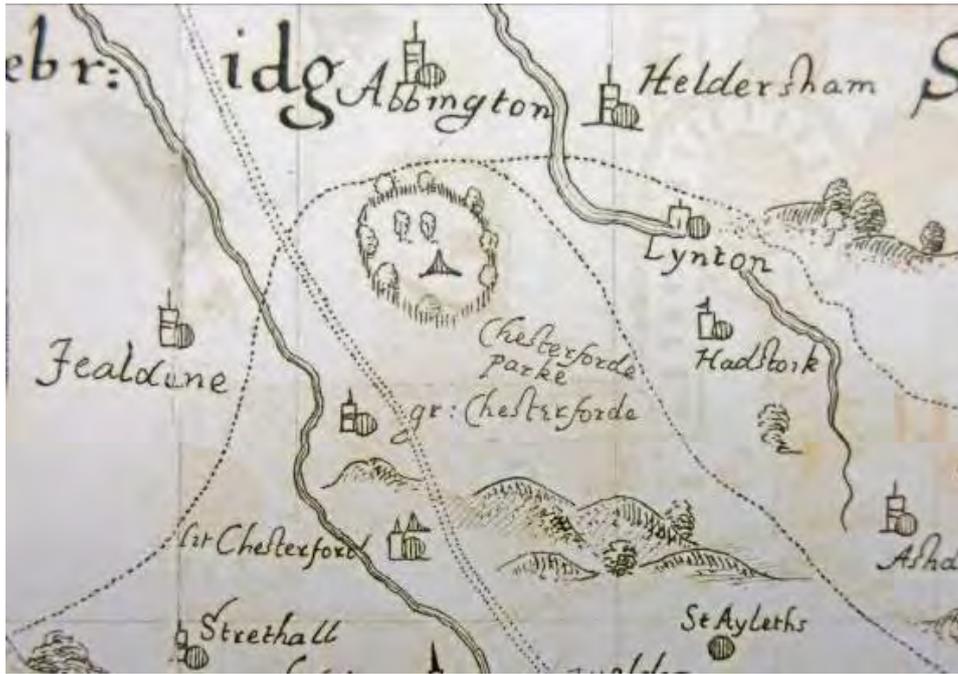
Fig. 2: Chesterford Park from John Norden's Map of Essex 1594

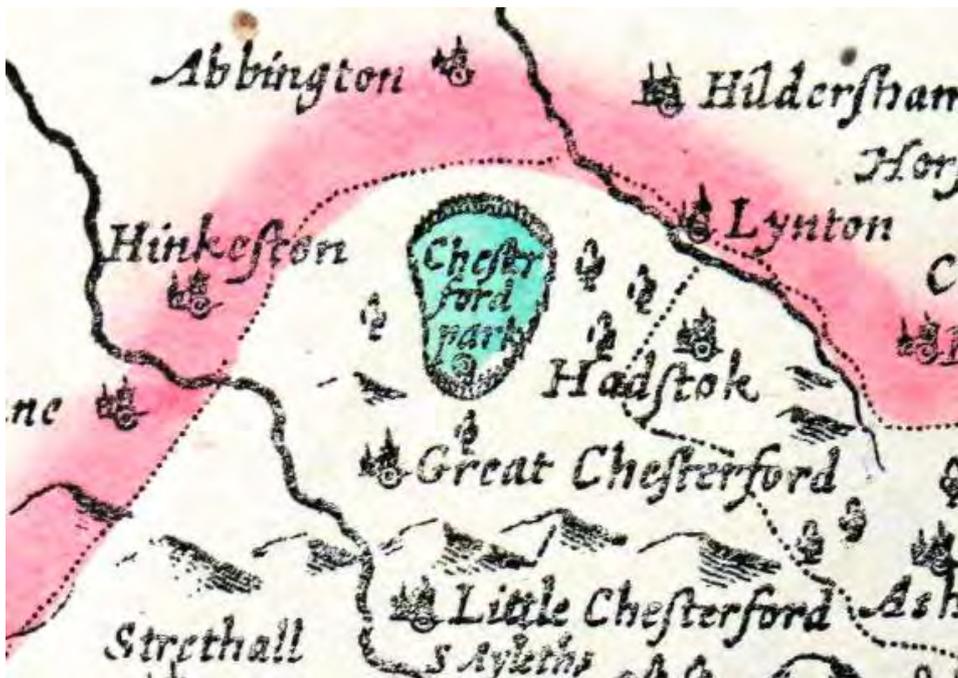
Fig. 3: Chesterford Park from J Speed's Map of Essex 1610.

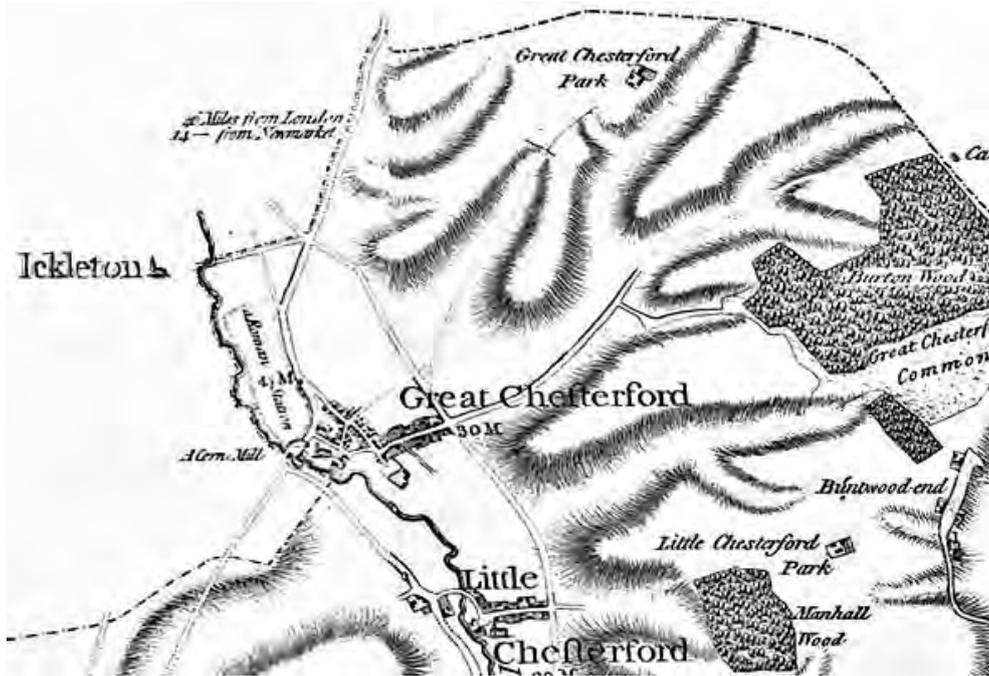
Fig. 4: Chesterford Park from J Chapman and Peter André's Map of Essex 1777.

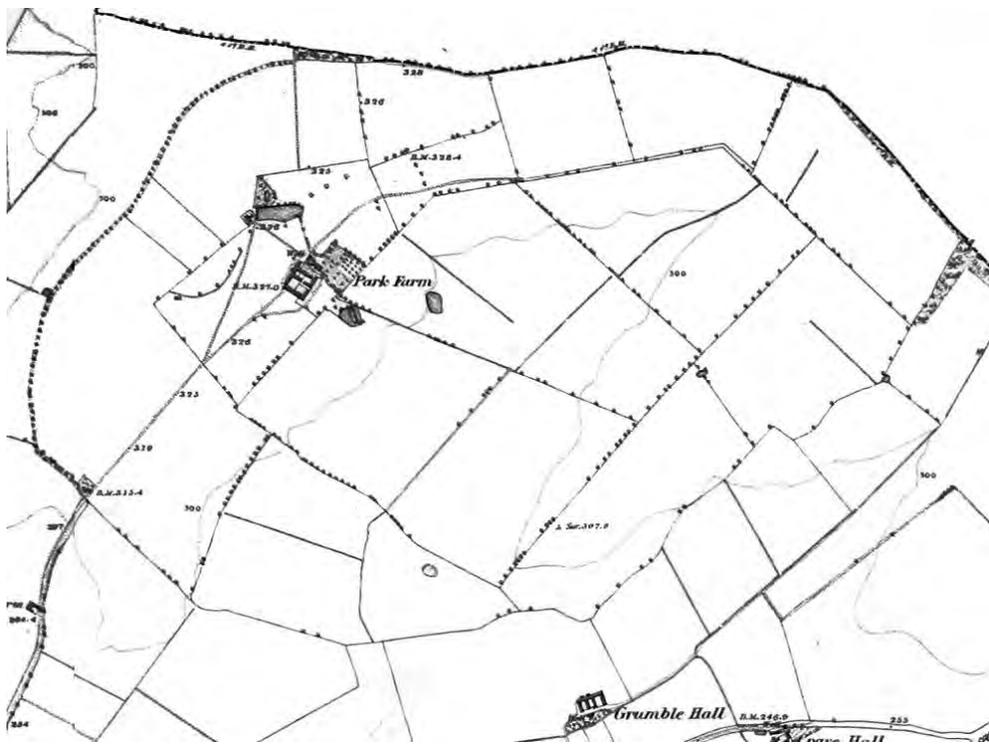
Fig.5: Chesterford Park subdivided with field boundaries. 6" to 1 Mile OS Map 1879 Edition (surveyed 1877).

7.3.4 During the post-medieval period, the changing design of farm complexes mirrored revolution in agricultural production cumulating with the development of the 'Victorian High Farming' tradition and the Enclosure in the 18th and 19th centuries of the former common fields. Chesterford Park did not escape these changes in farming practice with the introduction of a regular pattern of fields being introduced into the enclosed boundary of the park (Fig. 5).

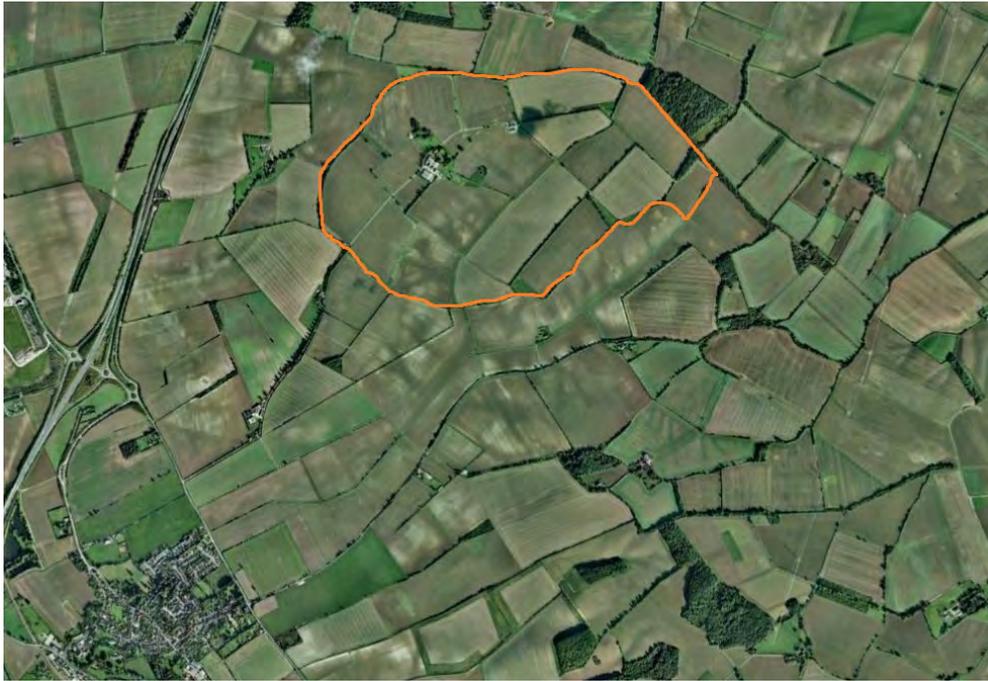
Fig.6: Aerial photograph of development site with Deer Park boundaries (orange outline)

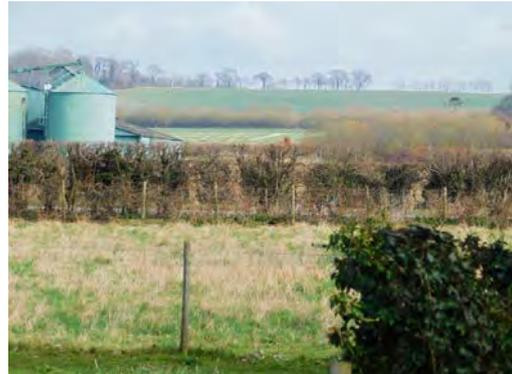
View from Hinxtton Churchyard towards the western slopes of the site

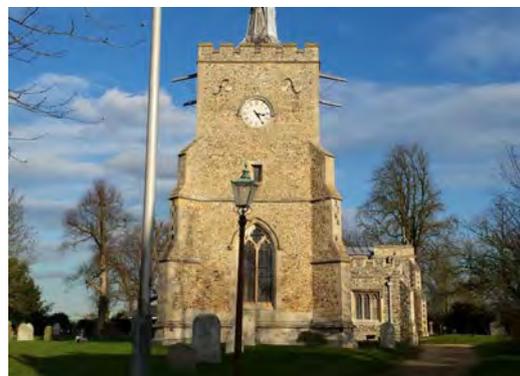
Ickleton Church on the east side of the Conservation Area

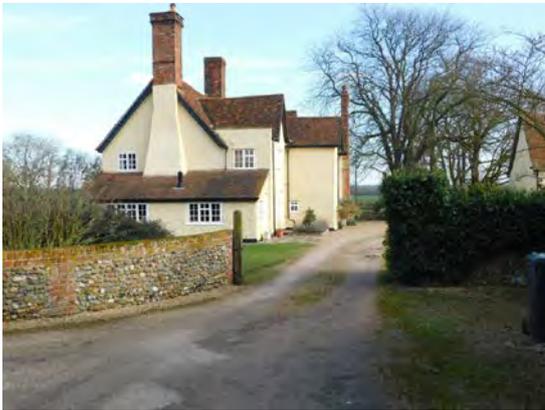
Park Farm House is the sole Listed Building (Grade II Listed 1322523 : 1951) on the development site. A detached 17<sup>th</sup> century timber framed and plastered building, of two storeys with two gables and two projecting gabled wings on the south west elevation. Roofs are plain tiled with a central square chimney stack and two end external stacks.

Park Farm House viewed from the north west

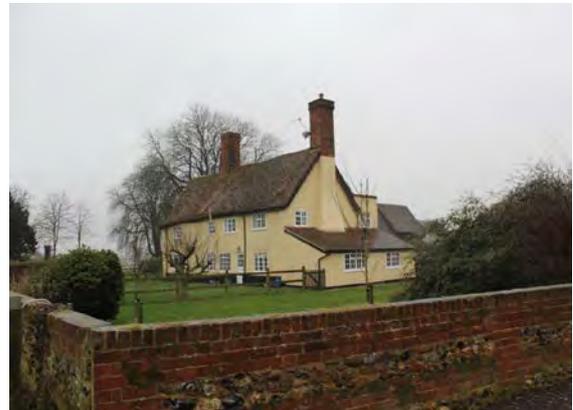
Park Farm House viewed from the north east

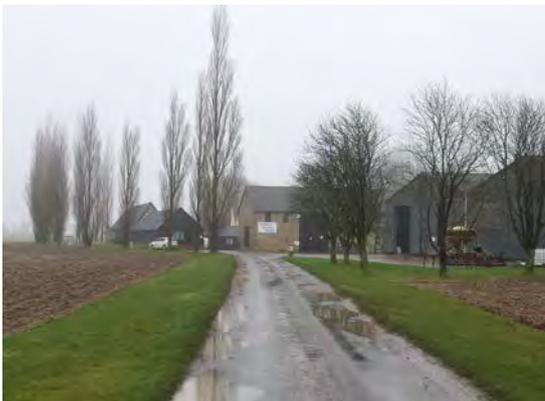
Approach to Farm Buildings ranging from historic buildings of timber and brick and modern sheds.

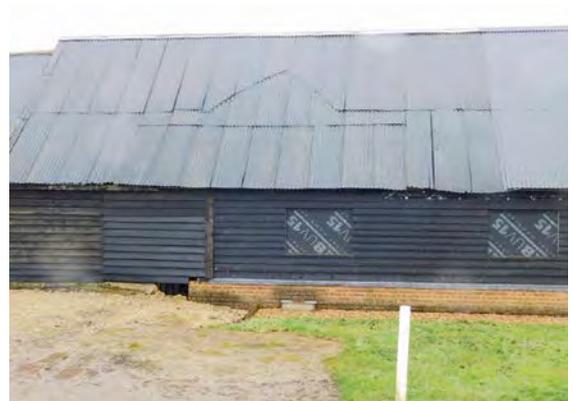
Single storey outbuilding (curtilage listed) of stained horizontal timber boarding on gault brick plinth (during refurbishment)

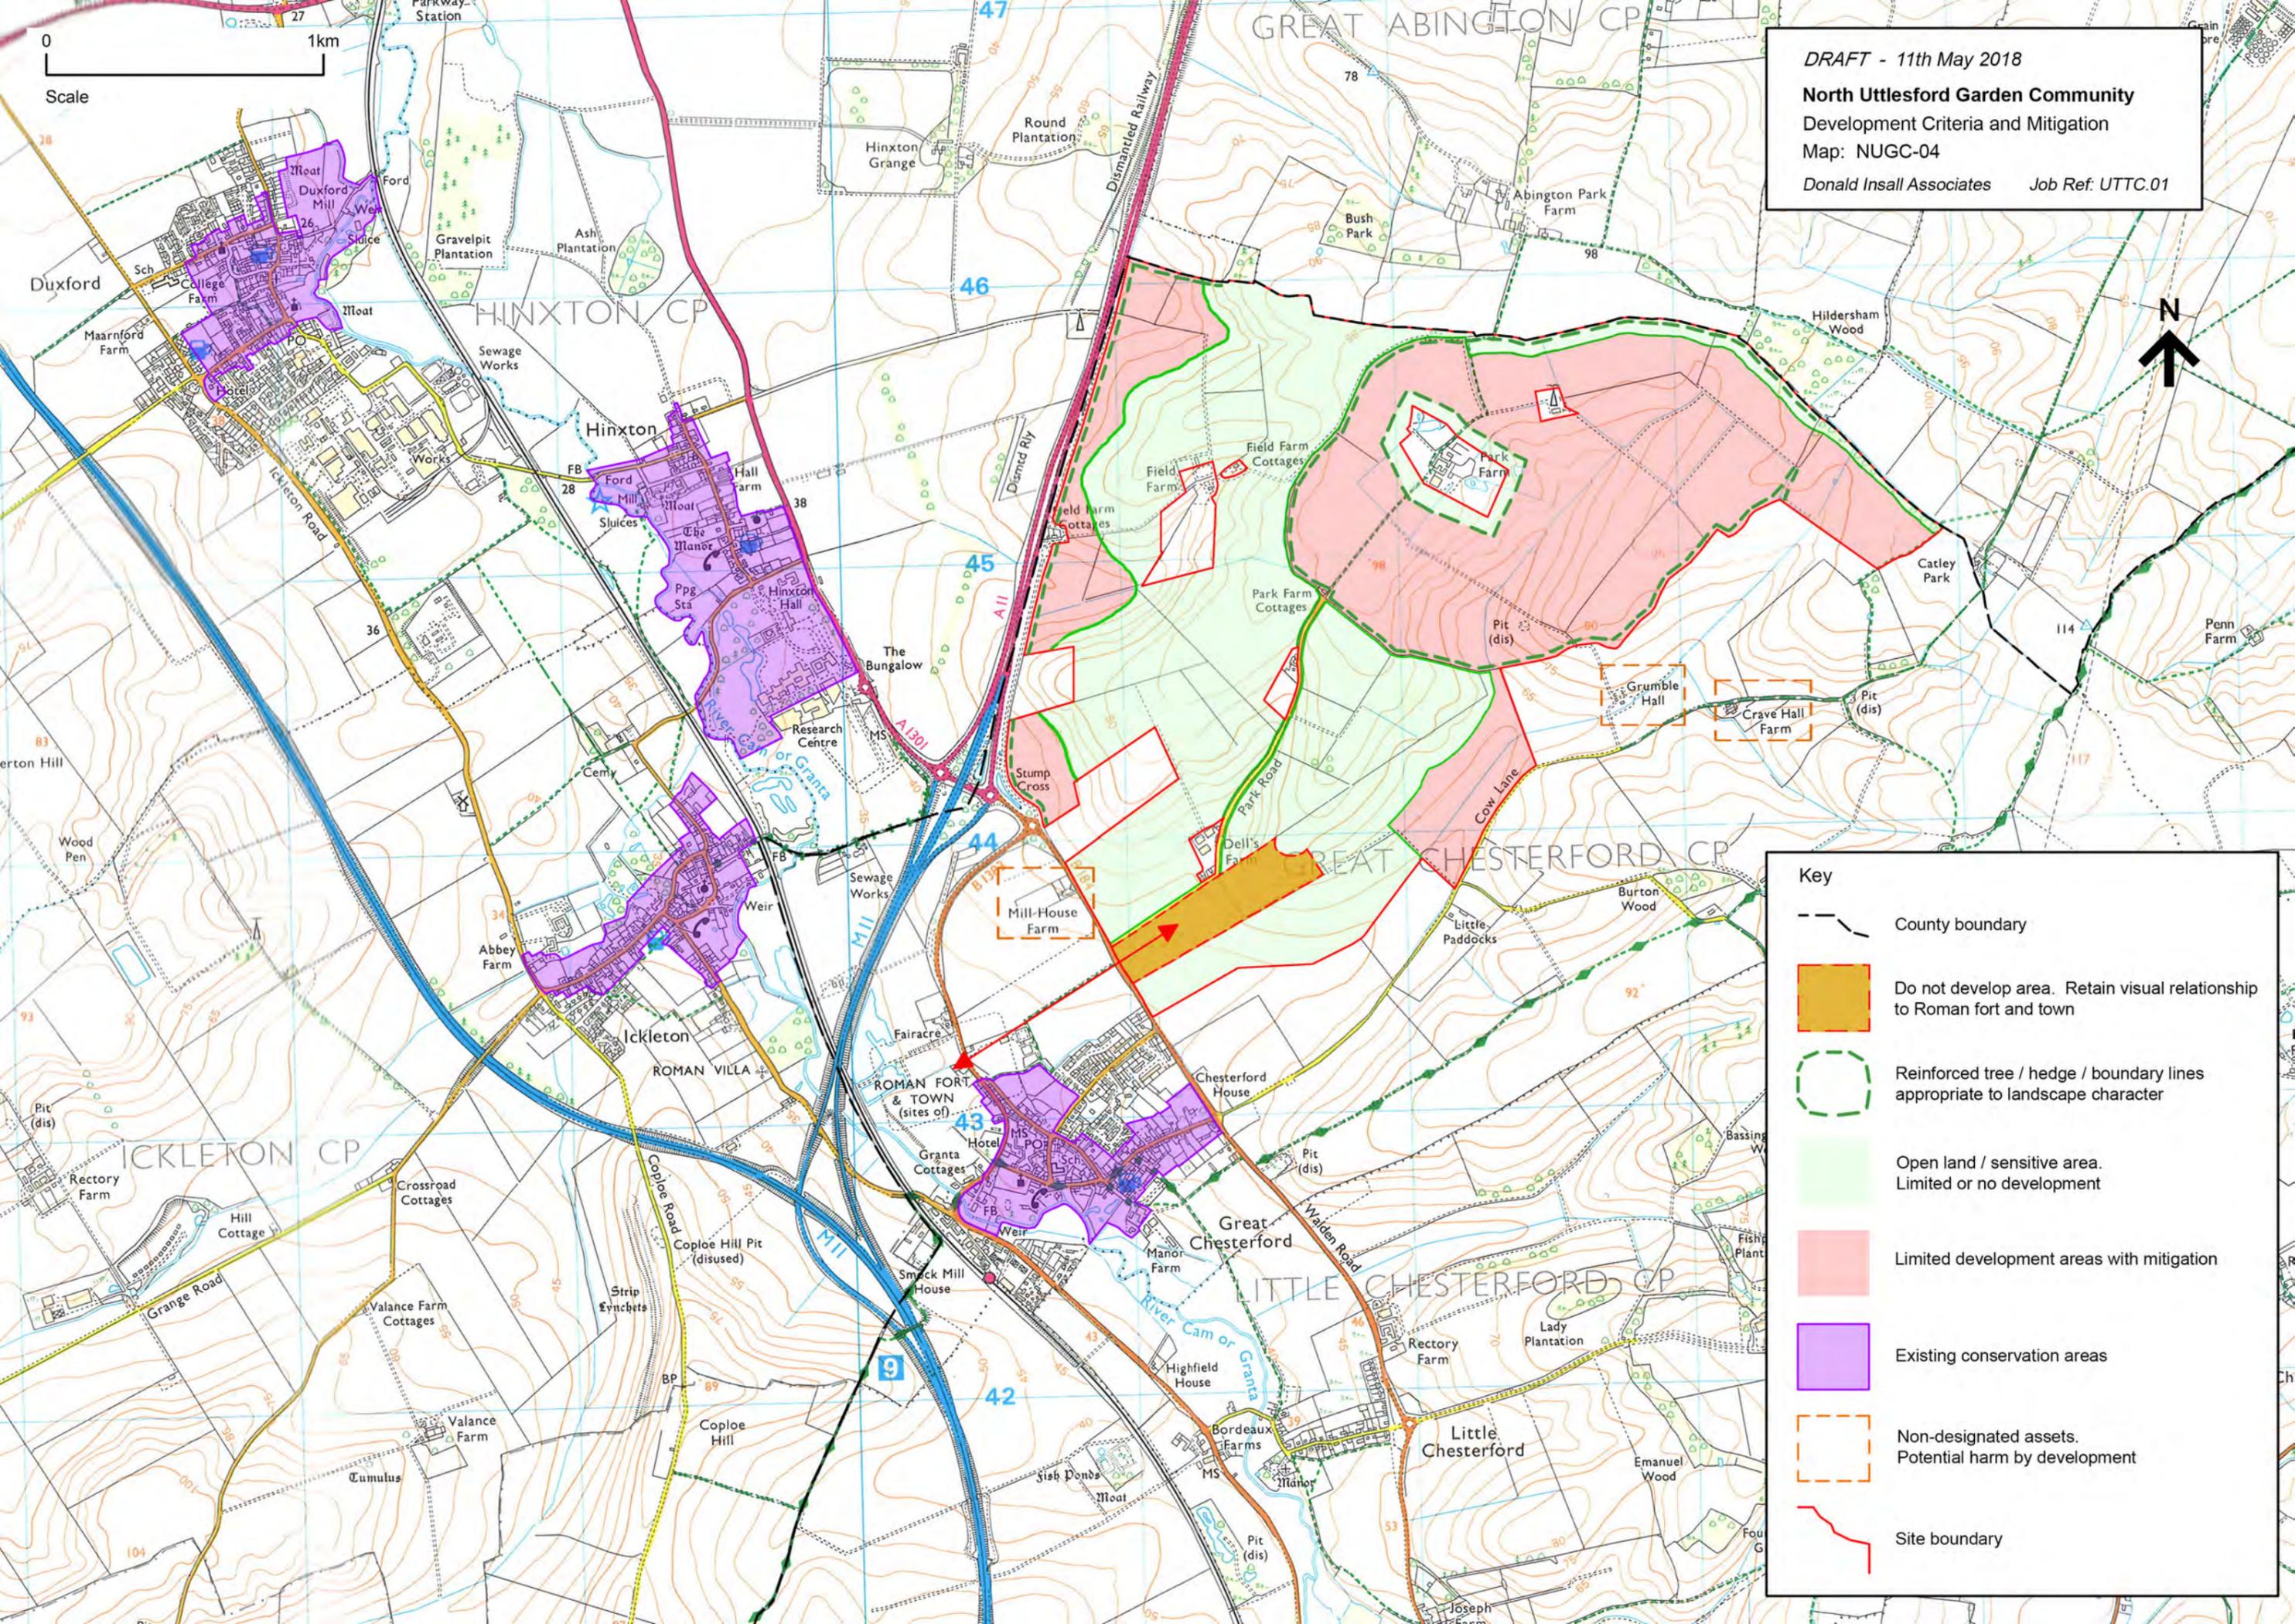
*DRAFT - 11th May 2018*  
**North Uttlesford Garden Community**  
 Development Criteria and Mitigation  
 Map: NUGC-04  
 Donald Insall Associates Job Ref: UTTC.01

- 7.5.9 Map NUGC04 : Development criteria and mitigation identifies measures that may mitigate the visual impact of a new development on heritage assets within the park, surrounding the park; the transition between rural and urban settings. There are many factors that are outside the scope of this study that may cause harm to the wider setting of heritage assets and identified non-designated heritage assets, not necessarily close to the site. These include noise and light pollution.

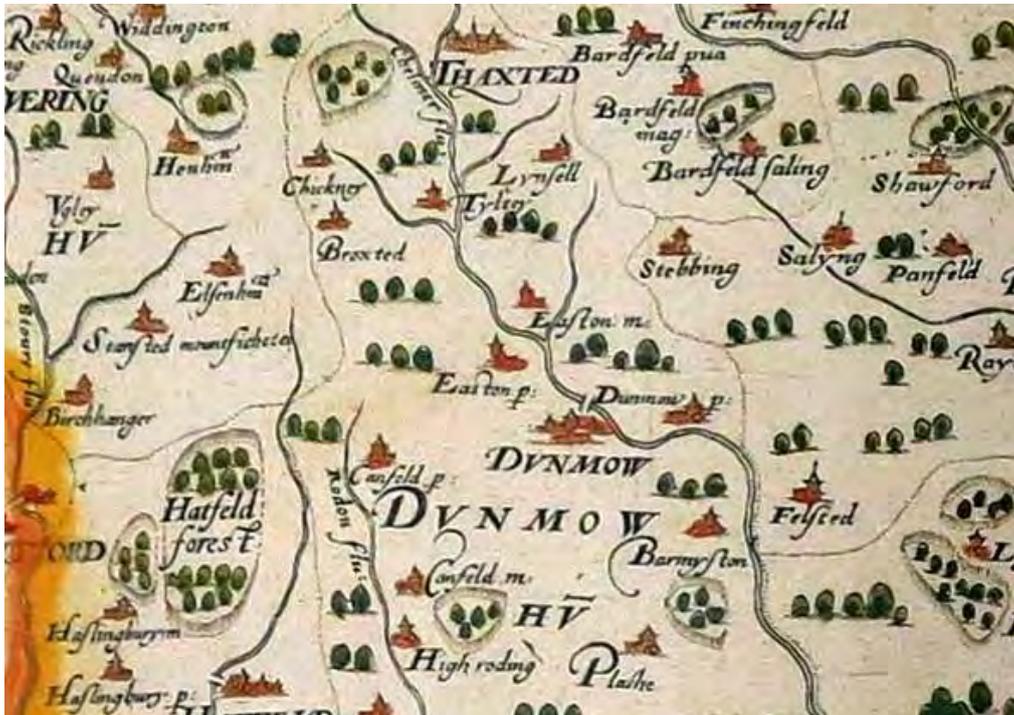
Fig. 1: Little Easton from Christopher Saxton's Map of Essex 1579. The site is surrounded by the parks at Hatfield Forest, Henham, Thaxted, Bardfield Saling, Shalford, Great Leighs, Pleshy and High Roding

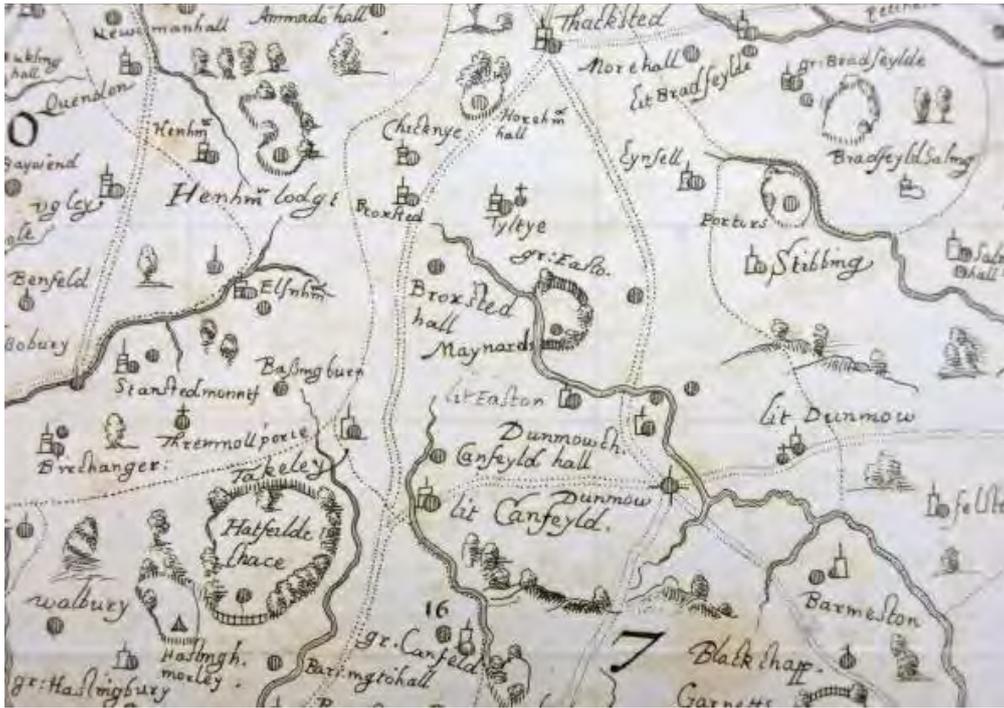
Fig. 2: Little Easton from John Norden's Map of Essex 1594. The site is surrounded by the parks at Hatfield Forest, Henham, Thaxted, Bardfield Saling, Stebbing, Great Canfield and Great Easton.

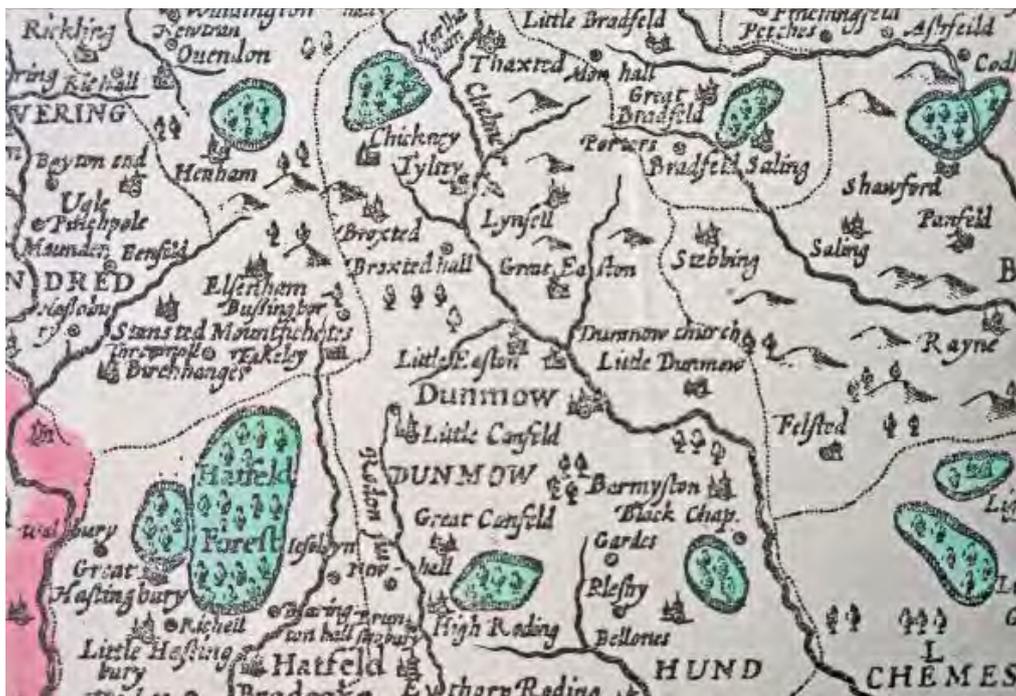
Fig. 3: Little Easton from J Speed's Map of Essex 1610. The site is surrounded by the parks at Hatfield Forest, Henham, Thaxted, Bardfield Saling, Shalford, Great Leighs, Pleshy and High Roding. No park at Great Easton is shown.

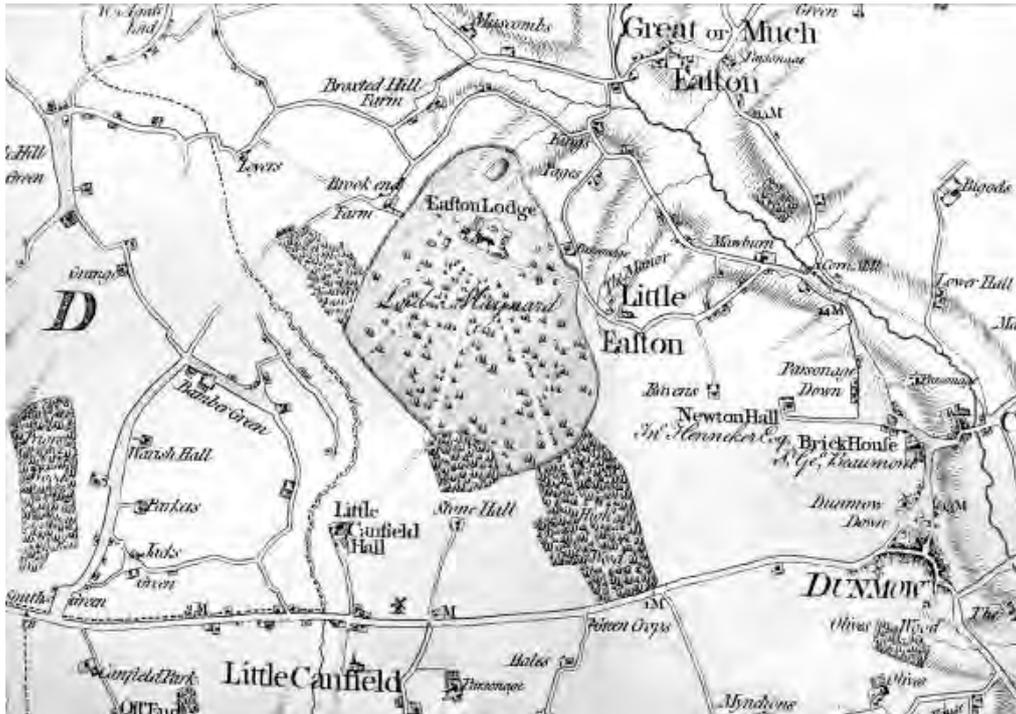
Fig. 4: Little Easton from J Chapman and Peter André's Map of Essex 1777. Easton Lodge shown with an enclosed park, Eaton Lodge in the possession of Lord Maynard to the west.

- 8.3.5 Towards the latter half of the 18<sup>th</sup> century the Tudor estate was redeveloped as Easton Lodge with an enclosed park to the east of Little Easton (Fig. 4). The OS map of 1880 6" to 1 mile and the 1898 25" to 1 mile detail the extent and changes to the park layout at the end of the 19<sup>th</sup> century (Figs. 5 and 6)

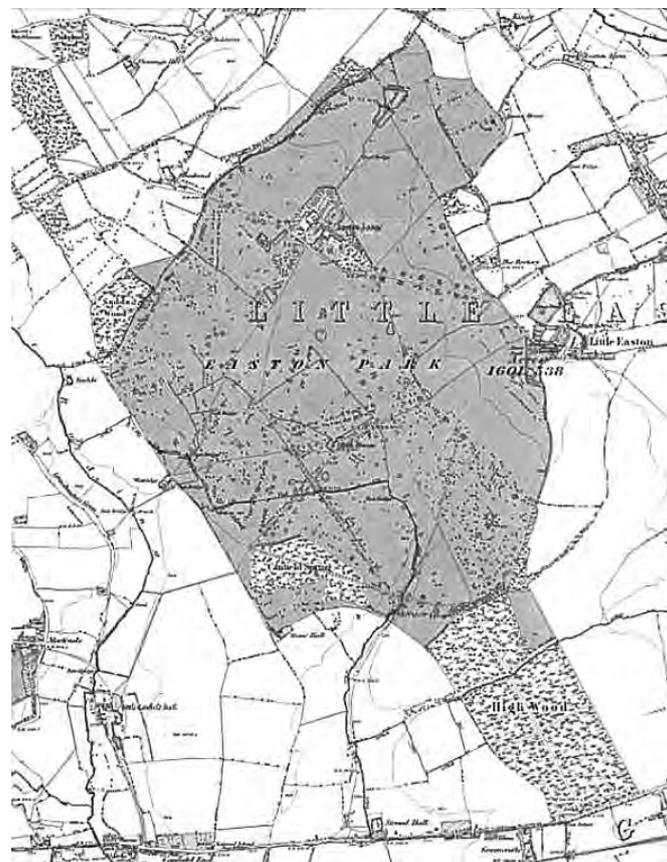
Fig.5: Easton Park on OS 6" to 1 Mile map of 1880.

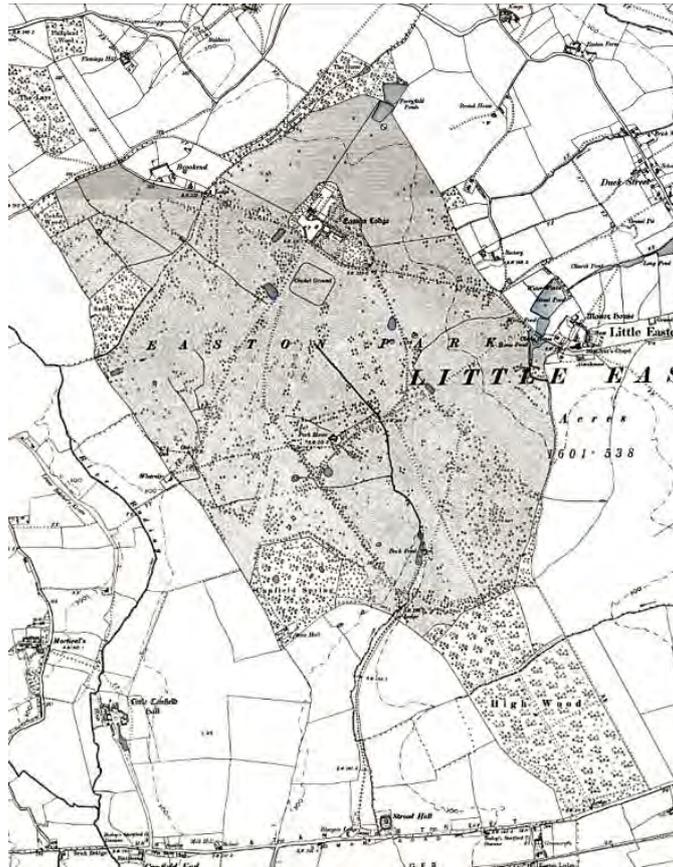
Fig.6: Easton Park on OS 25" to 1 Mile map of 1898 depicting a change in the park boundary in the north-west and north east corner of the park.

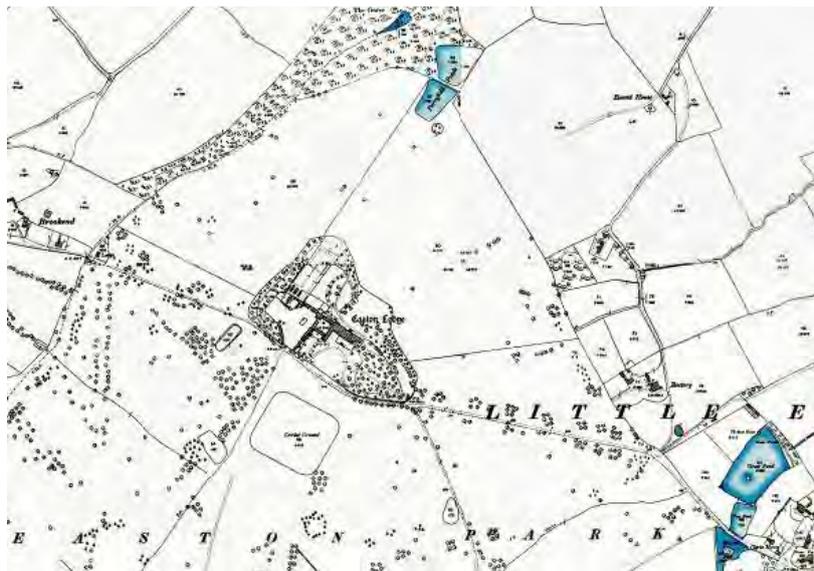
Fig. 7: Easton Lodge on OS 25" to 1 Mile map of 1898 showing the extent of the gardens around the main house.

- 8.3.6 In 1865 Frances Evelyn Grenville, the Countess of Warwick, inherited Easton Lodge from her grandfather the Viscount Maynard and in 1902 she commissioned architect and landscape designer Harold Peto to create new gardens in the grounds of Easton Lodge. His creations are the only ones to be found in East Anglia (Figs. 7 and 8).

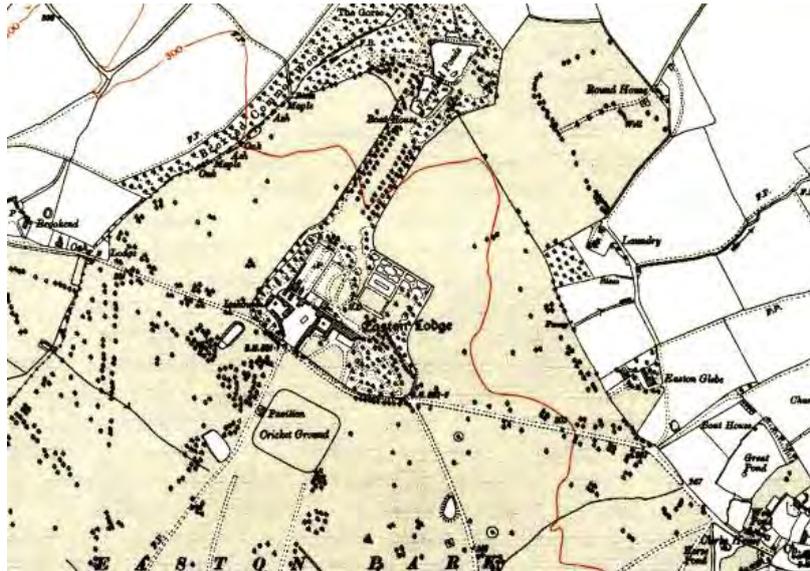
Fig. 8: Easton Lodge on the OS 6" to 1 Mile map of 1923 showing the extent of Peto's 1902 redesigned gardens to the main house.

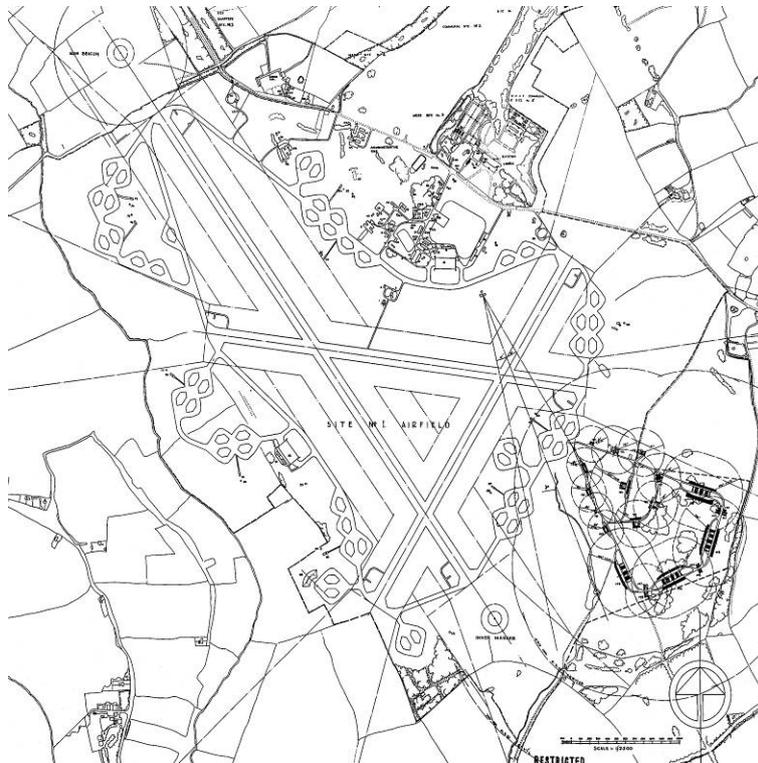
Fig 9: Plan of RAF Great Dunmow aerodrome in 1943 showing location of the three runways, perimeter track with dispersal hardstandings and munitions dump in the park lands.

- 8.3.7 In 1940 Sir Archibald Sinclair, the Secretary of State for War, deemed that large private estates and large parklands 'would be suitable for landing grounds, if not aerodromes', however, Easton Lodge was the only landed estate to be requisitioned for use as an aerodrome. In July 1942 work began on RAF Great Dunmow, Station 164, requiring the removal of all the some 10,000 trees including 200 mature oak trees from the parkland. The aerodrome was completed in July 1943 and becoming operational station for the United States Army Air Force in September 1943 (Fig 9 and 10).

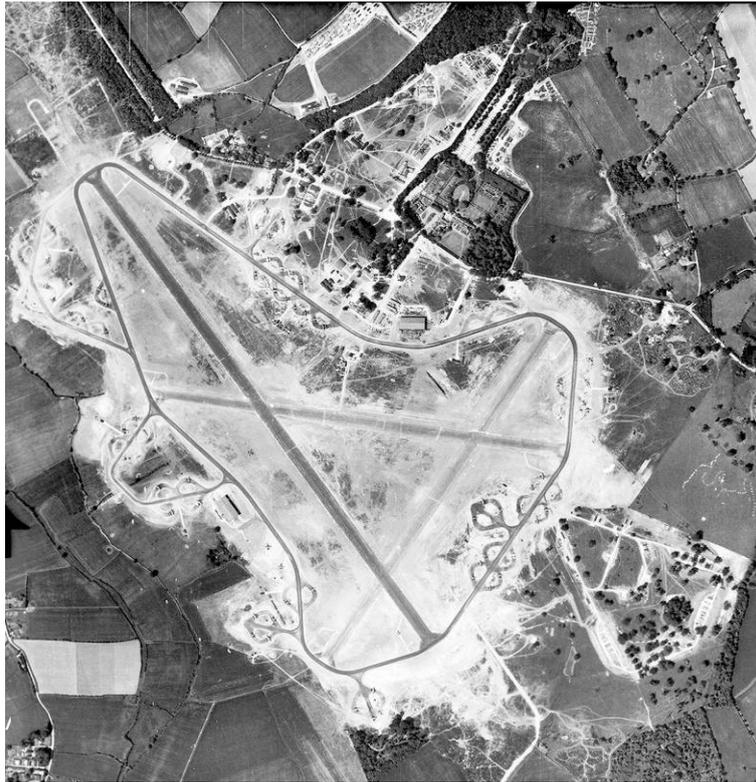
*Fig 10: Aerial photograph of RAF Great Dunmow aerodrome in May 1944. The Lodge with Peto's gardens is clearly visible top centre of the photograph. With the end of the war in 1945, the aerodrome was used for Care and Maintenance (Fig. 11).*

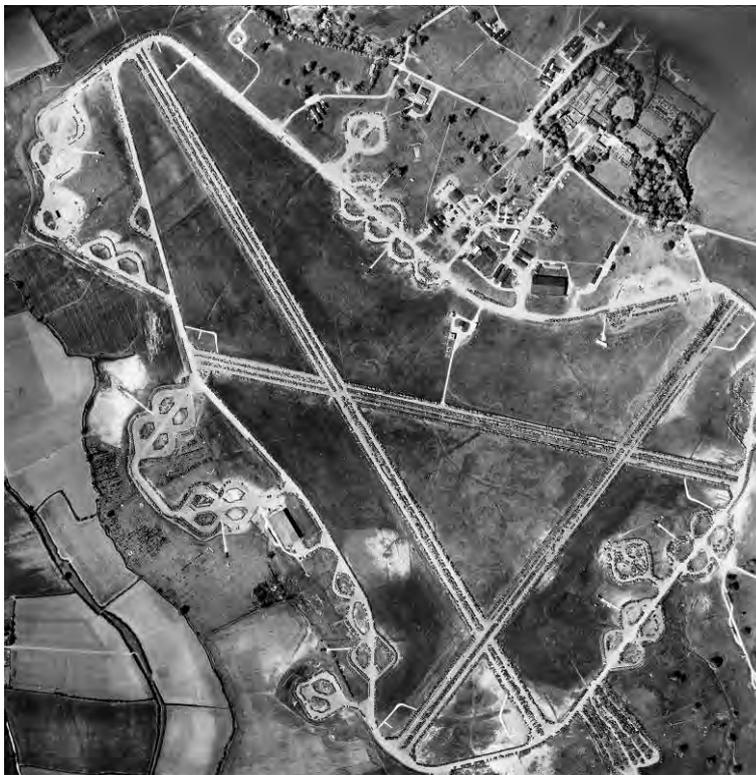
*Fig 11: Aerial photograph of RAF Great Dunmow aerodrome in May 1948. The runways, perimeter track and hard standings are being used for storage of now redundant military vehicles*

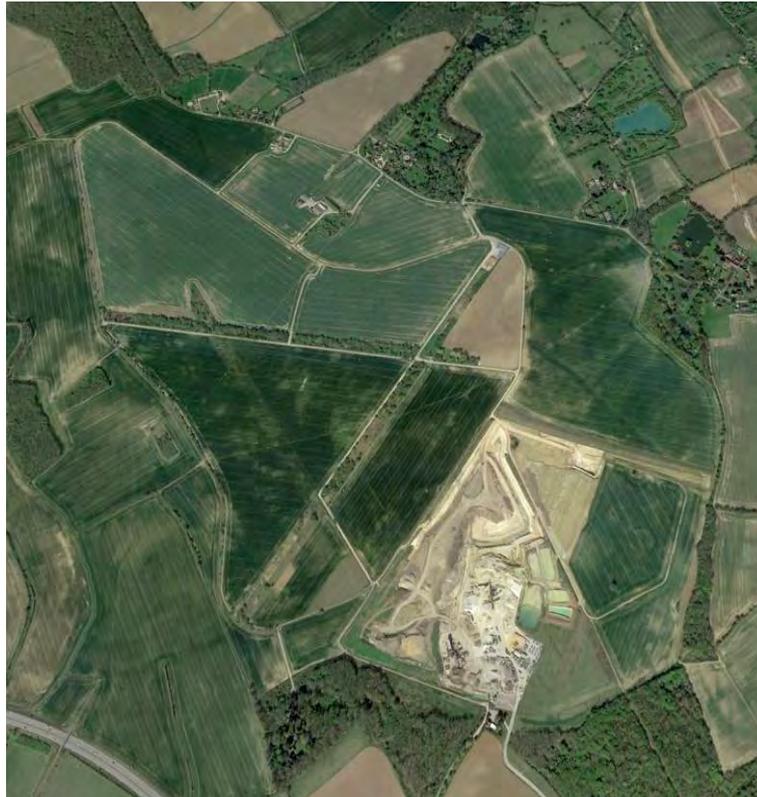
*Fig 12: Aerial photograph of RAF Great Dunmow aerodrome in 2017 showing the remains of the runways and the perimeter track. The location of the runways is clearly visible as crop marks in the fields. The south –east corner of the site has been lost to quarrying.*

- 8.3.9 In April 1958 the aerodrome ceased to be required for military purposes and was sold for agricultural use, with farming operations commencing in 1960 and in 1965/66 the concrete areas were broken up for aggregates for use in the construction as part of the new A12 road.
- 8.3.10 Very little of the aerodrome still exists except some single track agricultural roads remaining from the perimeter track and a blister hangar with a four Nissen huts and electrical generator shed near Easton Lodge. Although the runways have been removed their locations are still discernible. The north-eastern end of runway 04-22 still exists and is currently used for manure storage. From 2012 the south-east corner of the aerodrome has been the site of gravel extraction (Fig. 12).

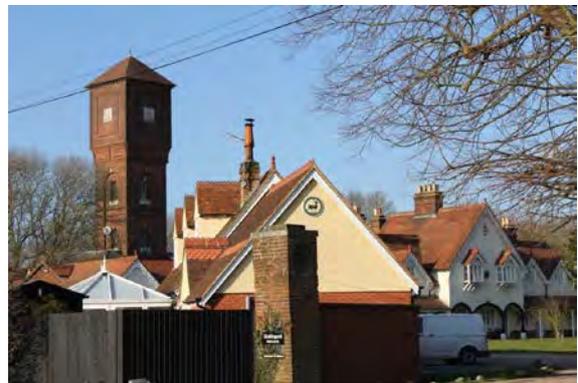
The principal house is dated C17 extensively altered in C20, brick and timber frame, rendered. There are additional listed buildings related to the house within its curtilage. These include a terrace of six cottages 1896, and water tower 1902.

View of Water Tower and Terrace, right

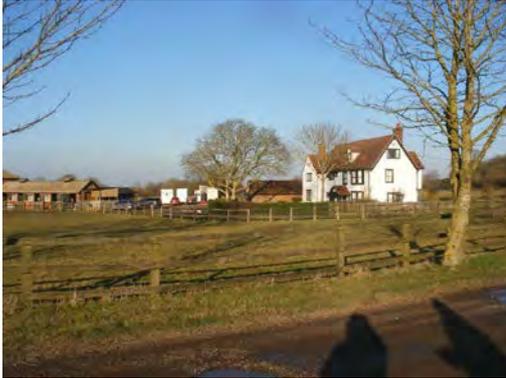
Brookend Farmhouse

The farmhouse is dated 1500 and late C16, timber framed and plastered with gabled peg tiled roof.

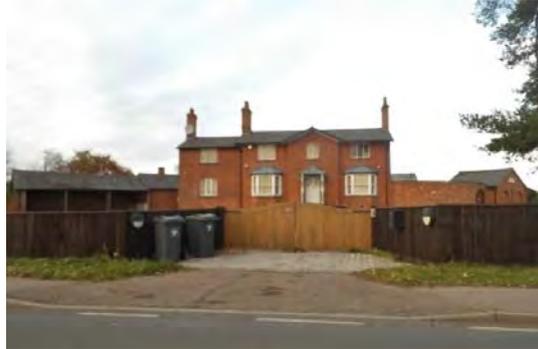
The hall is dated C19, red brick with grey slate roof.

Strood Hall from Stane Street

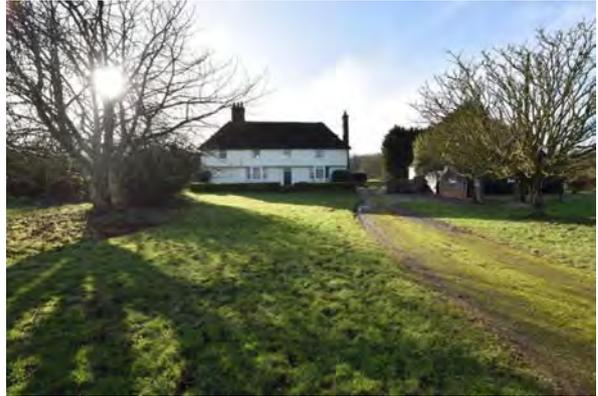
Fleming Hill Farmhouse

Fleming Hill Farm is located north of the site on the boundary of the proposed allocation site. It is surrounded on three sides by the proposed allocation site. It is Grade II listed (List Entry No. 1168672). The principal farmhouse is dated C16 with later additions, timber framed and plastered with plain clay tile roof. There are additional listed buildings related to the farmhouse within its curtilage. The barn is built on the site of a C15 house.

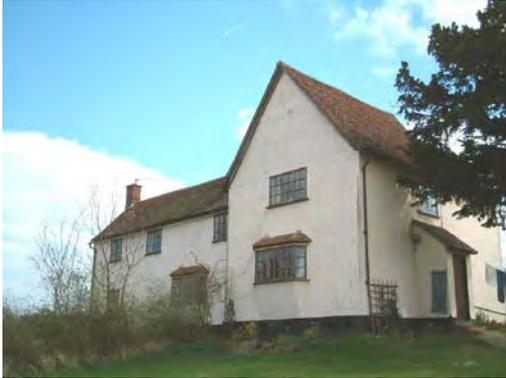
Baldwins

The house is dated C16 or earlier with attached early C19 range. It is timber framed and plastered with red plain tile roof and grey slate roof.

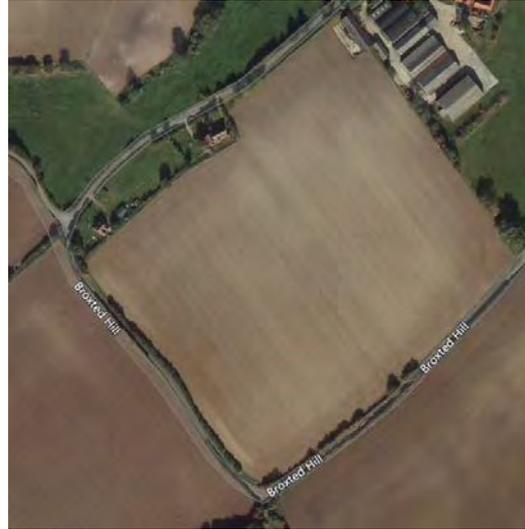
Aerial view of Baldwins

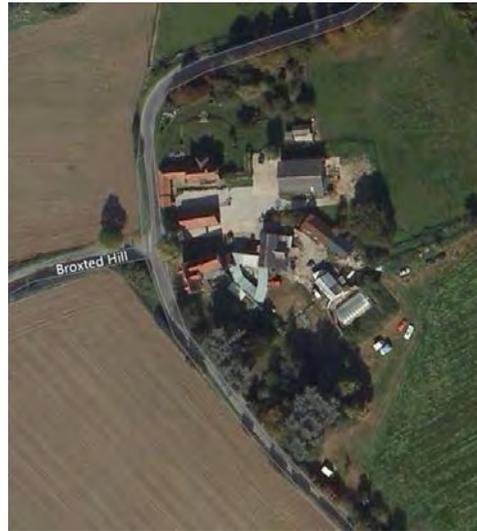
The farmhouse is dated late C18 with later alterations. It is timber framed and plastered and painted brick with a red plain tile roof.

There are potential non-designated farm buildings within the curtilage of the farmhouse (no access to assess).

Aerial view of Kings Farm House

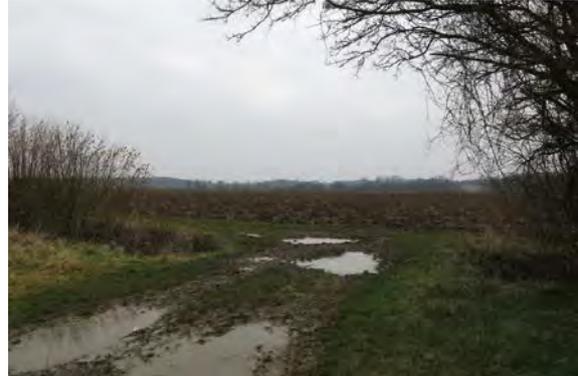
Old Thatch and Elder Cottage are located south east of the site in close proximity with views to the proposed site. They are Grade II listed (List Entry No. 1112237 and 1322568)

The cottages are dated C17, timber framed, and plastered with thatched roofs (Old Thatch) and red plain tile roof (Elder Cottage).

View towards Site from Old Thatch

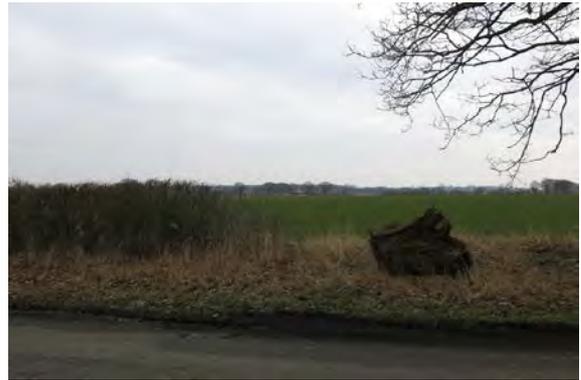
The farmhouse is on the site of a scheduled monument which includes a moated site and fish pond. (SM No. 1011467) The house is excluded from the scheduling although the ground beneath it is included.

The principal farmhouse is dated C17 or earlier, timber framed and plastered with plain clay tile roof. There are additional listed buildings related to the farmhouse within its curtilage.

View towards Site from The Grange

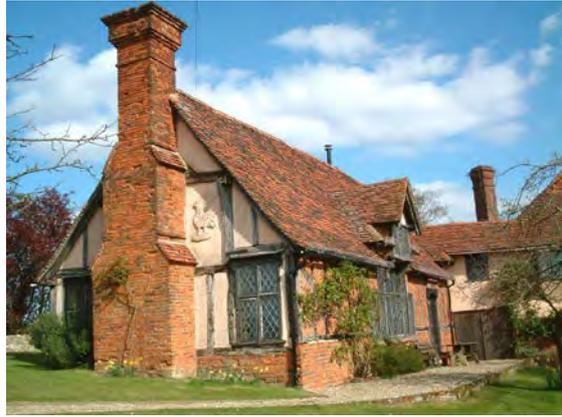
Muscombs is located north, in close proximity, with views to the proposed site. It is Grade II listed (List Entry No. 1164746).

The house is dated C16 or earlier, with later alterations. It comprises of a T shaped range of timber framed and rendered with peg tile roof.

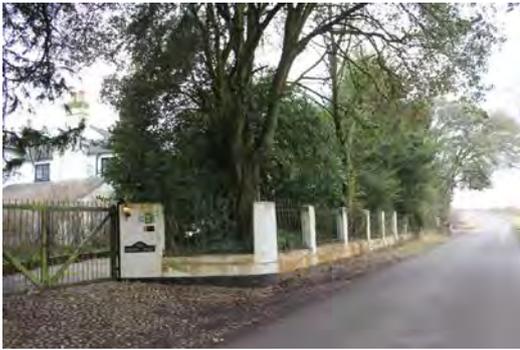
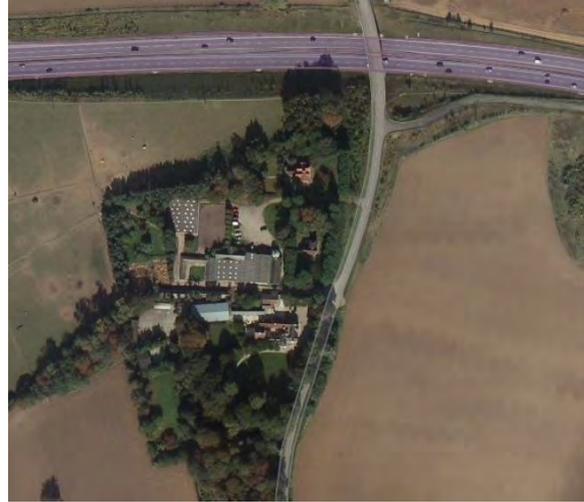
Frogs Hall is located south west of the site in close proximity and with views to the proposed site. It is Grade II listed (List Entry No. 1112188).

The house is early C17 with later alterations. It is rendered and partly slate hung timber framed with white-washed brick.

Frogs Hall boundary, view north

Aerial view of Frogs Hall with A120 highway to the north

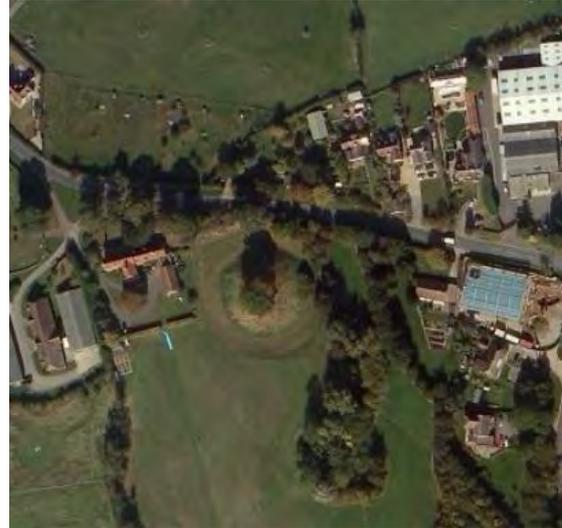
The medieval motte castle at Great Easton is situated on the broad south facing spur overlooking the valley of the River Chelmer.

Excavations suggest the date of the motte as mid 12C.

Aerial view of Great Easton Motte Castle

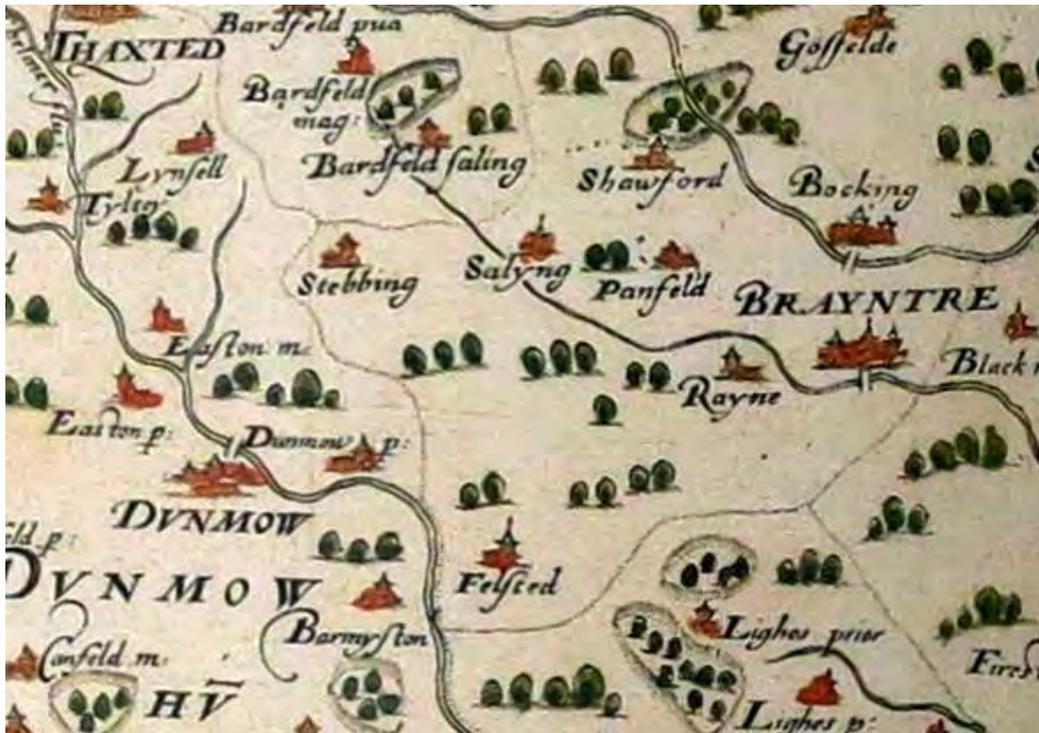
Fig. 1: Great Saling from Christopher Saxton's Map of Essex 1579 with the settlements Barnfield Sailing to the north, Panfield to the east, Rayne to the south-east and Stebbing to the west.

- 9.3.4 The maps from the 16<sup>th</sup>, 17<sup>th</sup> and 18<sup>th</sup> centuries show the proposed site as undeveloped farmland land located between the settlements of Bardfield Saling, Panfield, Rayne and Stebbing (Figs 1 to 4)
