# Donald Insall Associates

Uttlesford District Council  
Heritage Impact Assessments

Draft 11th May 2018

Commissioned by - Uttlesford District Council

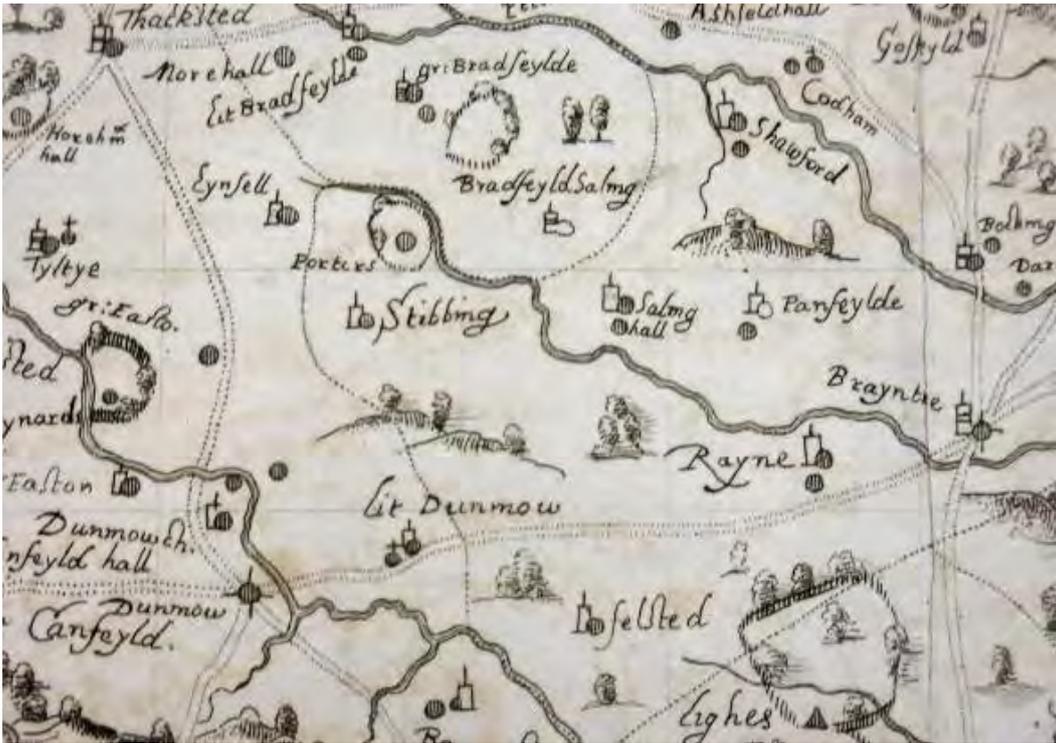
Fig. 2: Great Saling from John Norden's Map of Essex 1594 with the settlements Barnfield Sailing to the north, Panfield to the east, Rayne to the south-east and Stebbing to the west.

- 9.3.4 The maps from the 16<sup>th</sup>, 17<sup>th</sup> and 18<sup>th</sup> centuries show the proposed site as undeveloped farmland land located between the settlements of Bardfield Saling, Panfield, Rayne and Stebbing (Figs 1 to 4)

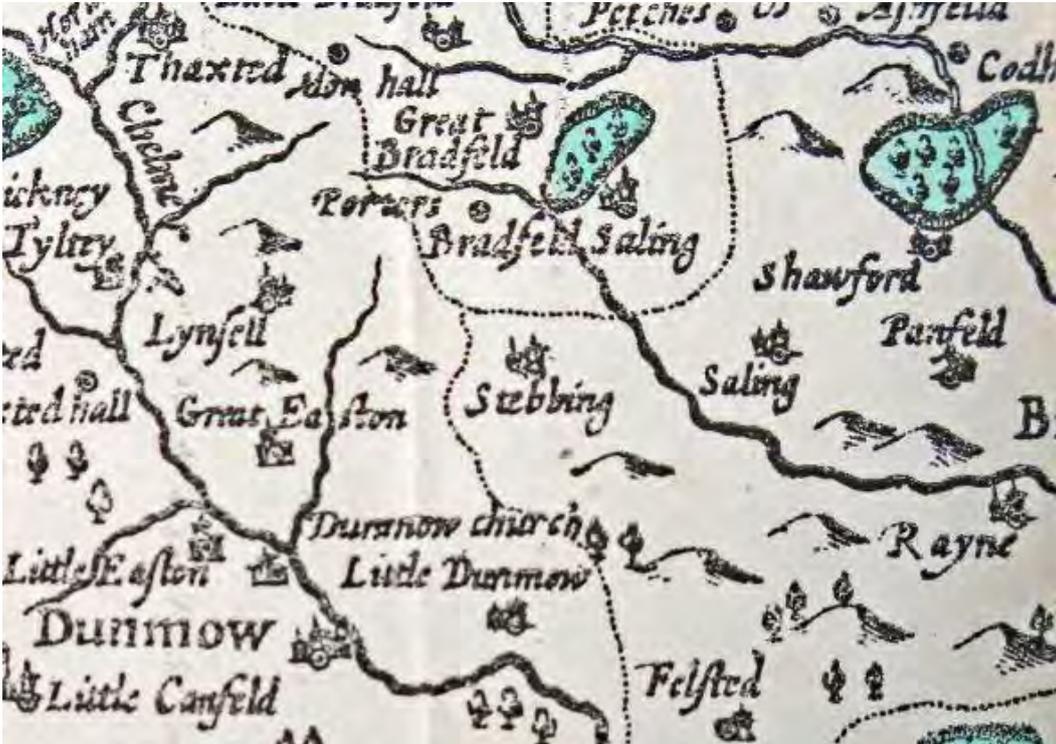
Fig. 3: Great Saling from J Speed's Map of Essex 1610 with the settlements Barnfield Saling to the north, Panfield to the east, Rayne to the south-east and Stebbing to the west.

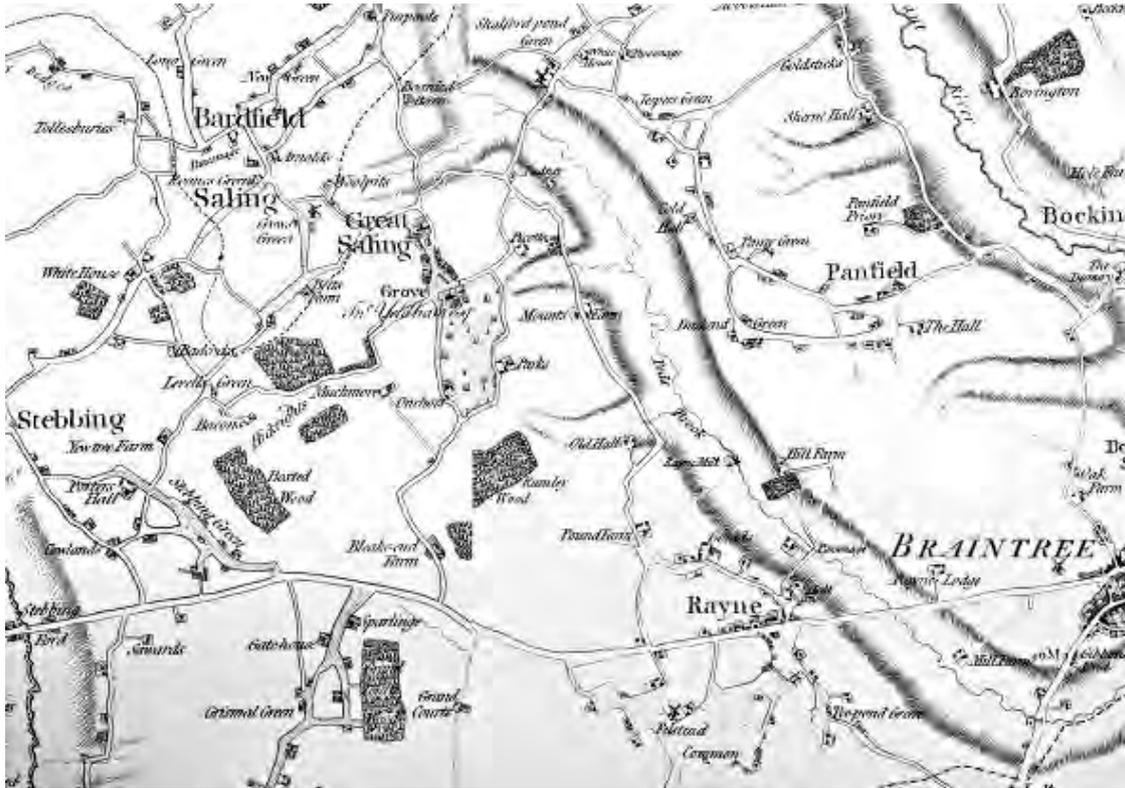
Fig. 4: Great Saling from J Chapman and Peter André’s Map of Essex 1777 with the settlements Barnfield Saling to the north, Panfield to the east, Rayne to the south-east and Stebbing to the west along with farm steads located in the proposed site.

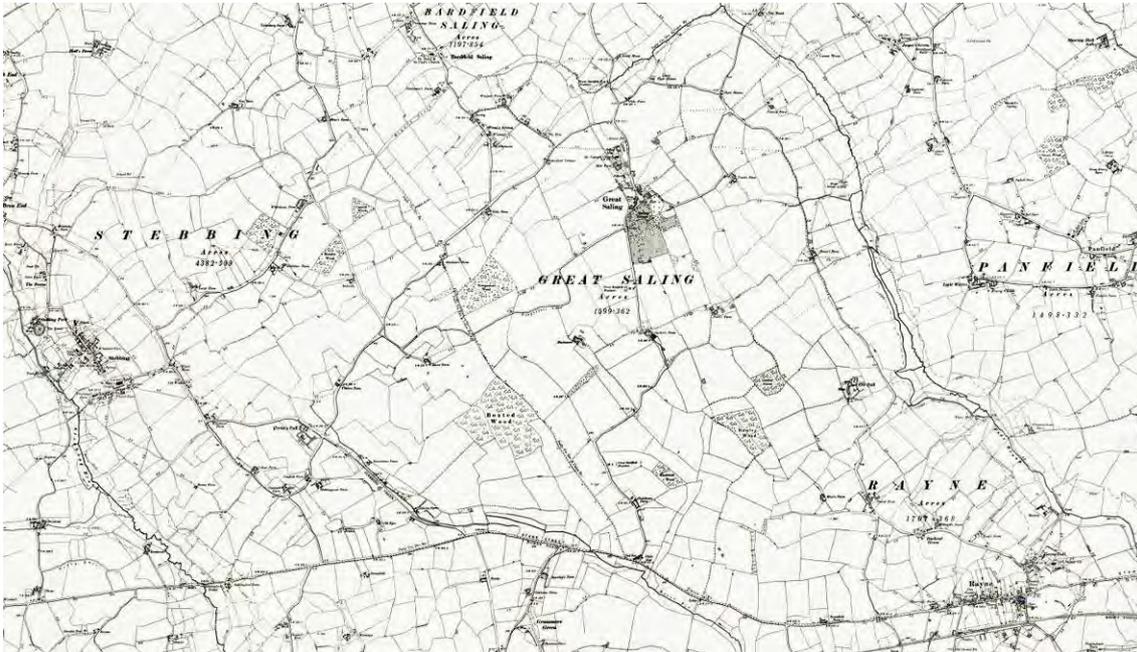
Fig.5: Great Saling and the proposed site the on OS 6” to 1 Mile map of 1897. The land has very little development that is not involved with agriculture. The major settlements are still Barnfield Saling to the north, Panfield to the east, Rayne to the south-east and Stebbing as the 1579, 1594, 1610 and 1777 maps.

9.3.5 The OS map of 1897 6” to 1 mile shows little change in land use on the site from the latter half of the 18<sup>th</sup> century with the land being employed for agriculture (Fig. 5).

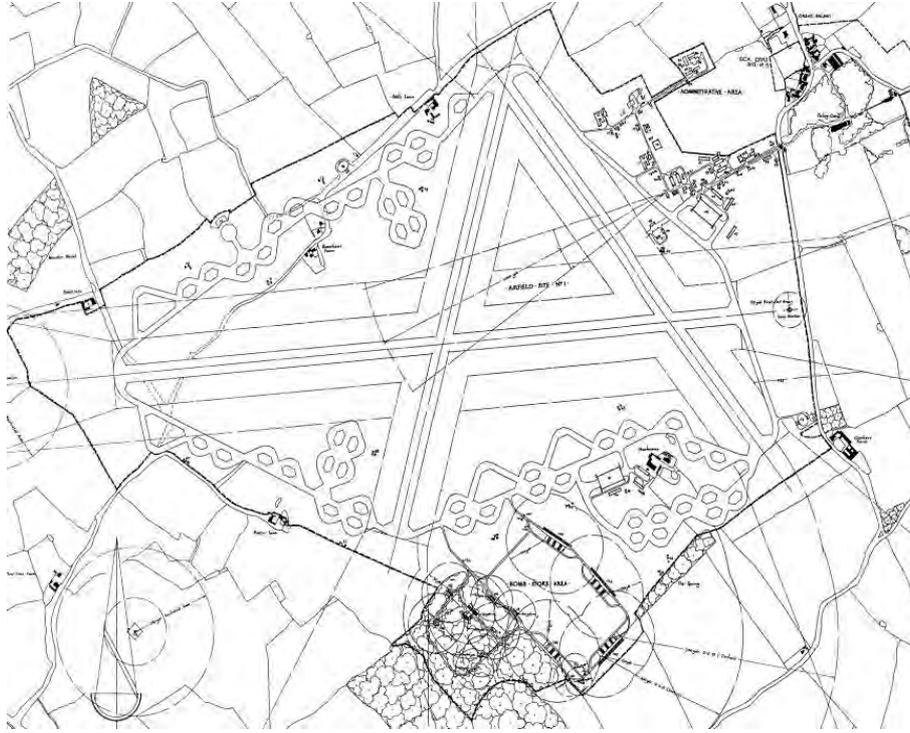
Fig. 6: Plan of RAF Great Saling / Andrewsfield aerodrome in 1943 showing location of the three runways, perimeter track with dispersal hard standings and munitions dump. Great Saling is located top right of the plan.

9.3.6 A major change in use occurred in 1942 with the construction of RAF Great Saling, Station Number 485 the construction of which began in 1942, becoming operational in April 1943 and was the first aerodrome in Europe occupied by the United States Army Air Force to become operational. On the 21<sup>st</sup> May 1943 the name changed to RAF Andrewsfield in memory of the overall Commander of American forces in Europe Lieutenant General Frank M. Andrews who had been killed in a flying accident on the 3<sup>rd</sup> May 1923. Field was the American term for an aerodrome (Figs. 6 and 7).

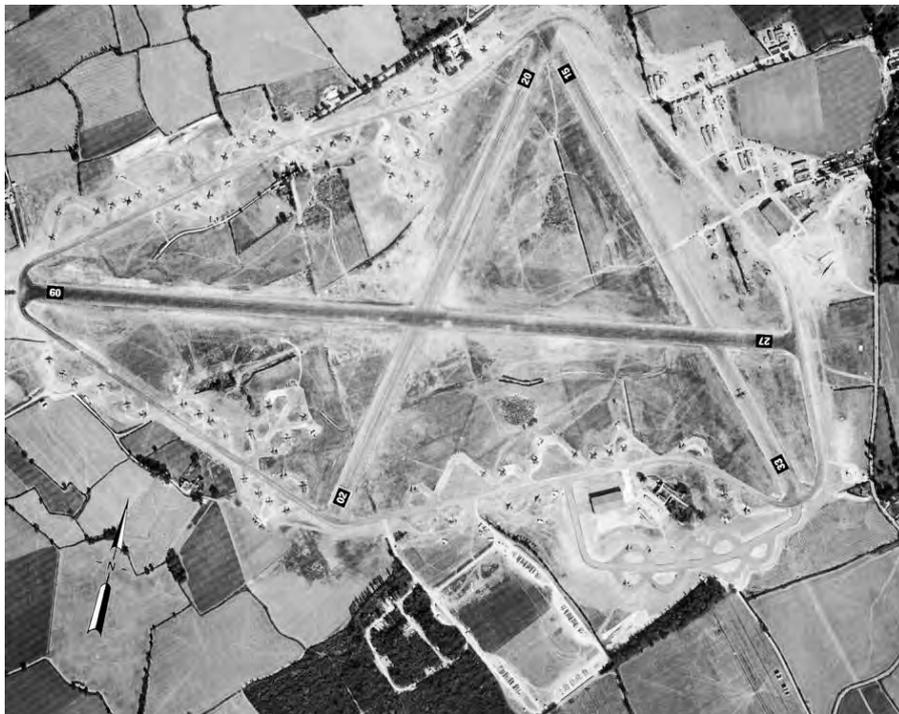
Fig. 7: Aerial photograph of RAF Great Saling / Andrewsfield in September 1943. The numbers on the ends of the runways are their compass bearings.

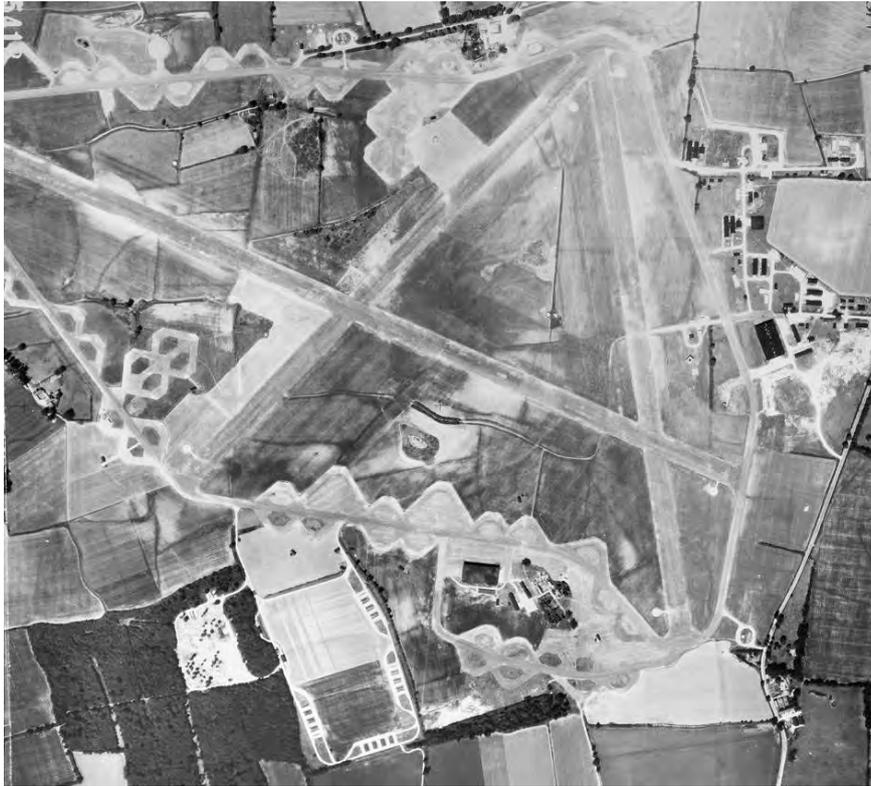
*Fig. 8: Aerial photograph of RAF Great Saling / Andrewsfield in August 1949. Although longer an operational aerodrome the runways, perimeter track, hard standings, hangers, buildings and munitions dumps are still intact.*

9.3.7 At the end of the war the aerodrome was closed in November 1945 and the site returned to agricultural use although the concrete runways and hard standings remained until the late 1960s (Fig 8.)

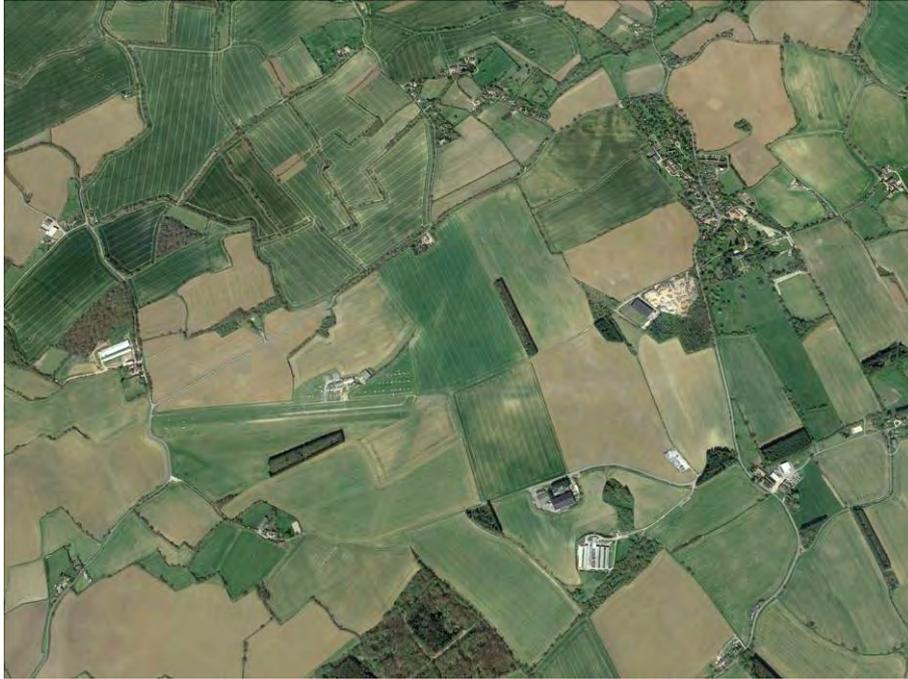
*Fig 9: Aerial photograph of RAF Great Dunmow / Andrewsfield aerodrome in 2017 showing the remains of the runways and the perimeter track. The location of the runways are clearly visible as crop marks in the fields. The runway and associated buildings of the small airfield are visible centre left of the photo.*

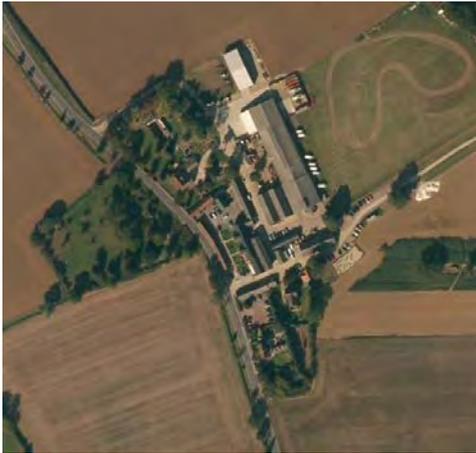
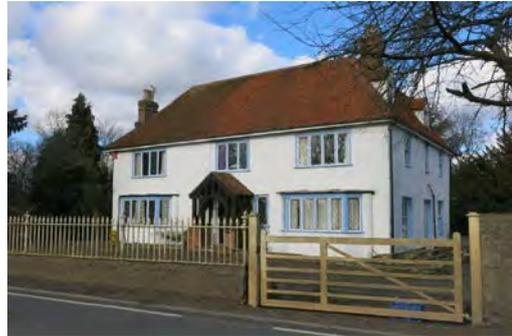
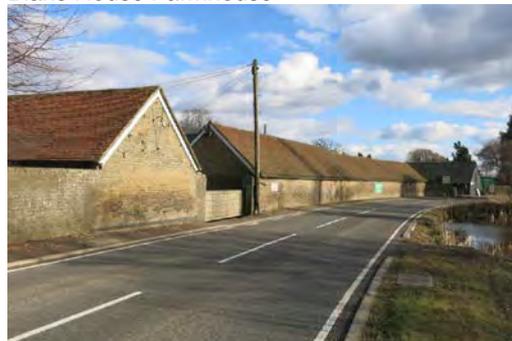
Blake House Farm is located within the central southern area of the proposed site. It is Grade II listed (List Entry No. 1122781).

The principal farmhouse is dated C17 or earlier with later alterations, timber framed and rough rendered with hipped red plain tile roof. There are additional listed buildings related to the farmhouse within its curtilage.

Aerial view of Blake House Farm

Blake House Farmhouse

Farm outbuilding range

The immediate setting is domestic for the farmhouse and commercial for the farm buildings. The change of use from agriculture to commercial use has degraded the significance of the heritage asset.

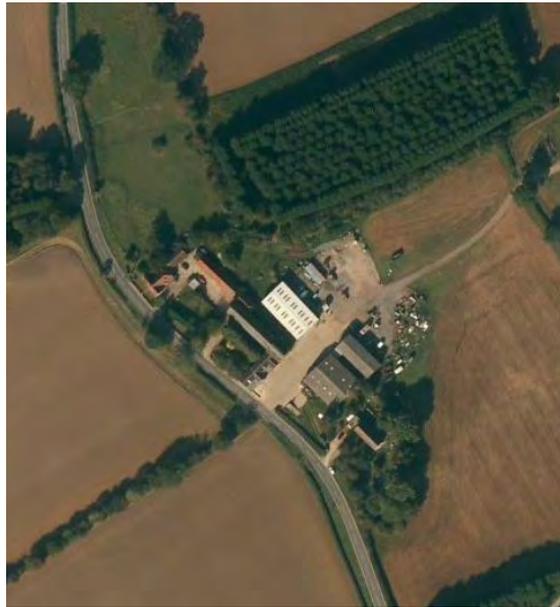
Onchor's Farmhouse is located within the central northern area of the proposed site. It is Grade II listed (List Entry No. 1122779).

The farmhouse is dated C17 or earlier with C18 facade, timber framed and panel pargetted with red plain tile roof. There are additional non-designated buildings related to the farmhouse within its curtilage (not accessible to assess if NDAs).

Aerial view of Onchor's Farm

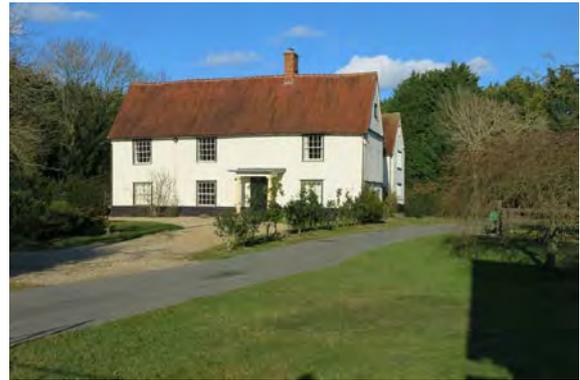
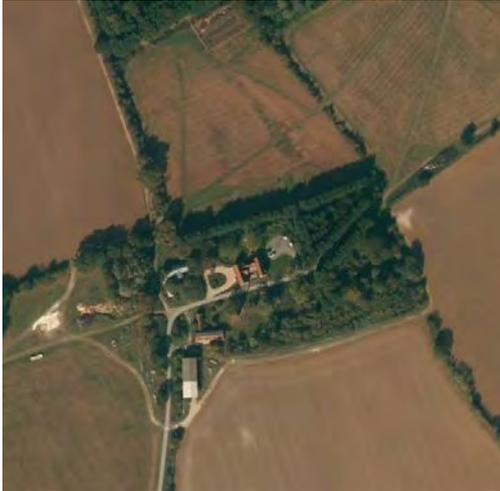
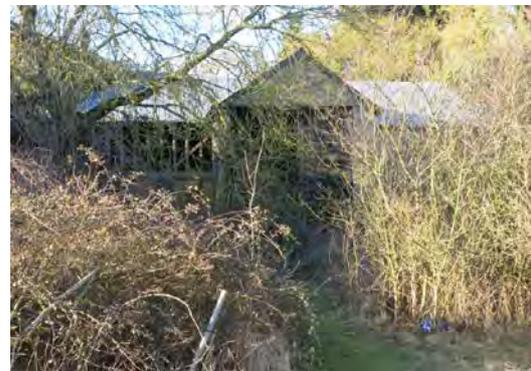
Park's Farm is located within the central northern area of the proposed site, east of Onchor's Farm. It is Grade II listed (List Entry No. 1338119).

The principal farmhouse is dated C16 or earlier with later alterations, timber framed and rough rendered with red plain tile roof. There are additional listed buildings related to the farmhouse within its curtilage.

Park's Farmhouse

Aerial view of Park's Farm

Cartlodge at Park's Farmhouse

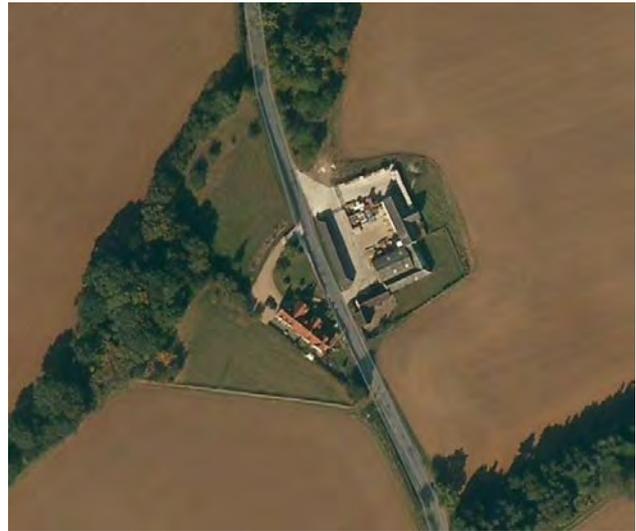
Mounts Farmhouse is located within the north east area of the proposed site. It is Grade II listed (List Entry No. 1122787)

The farmhouse is dated C17 or earlier with later alterations, timber framed and plaster with red plain tile roof.

Aerial view of Mounts Farm

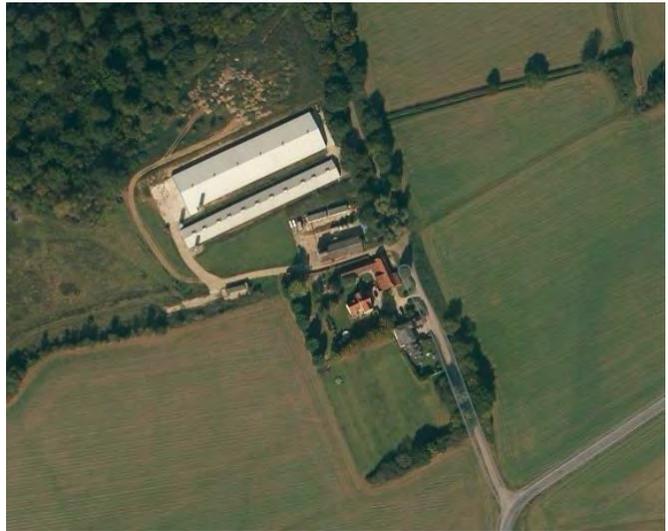
The farmhouse is dated C17 recently restored with C20 additions, timber framed and plastered with C20 pargetting.

There are additional non-designated farm buildings within the curtilage of the farmhouse (not accessible to asses).

Aerial view of Badcocks Farm

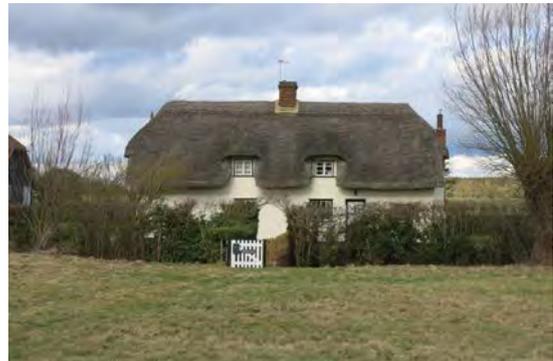
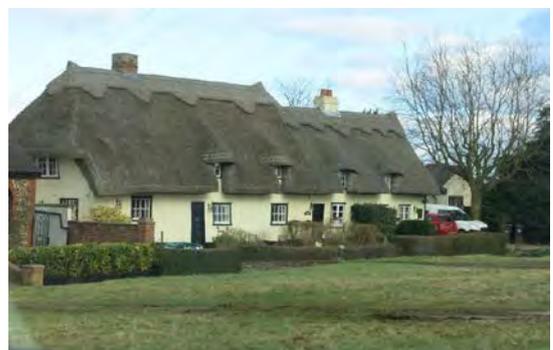
**Mayview Willow Thatch, Old Leas, St Judes, Byways and Sunnyside** are GII listed cottages located south west of the site, on the boundary, in Stebbing Green, a linear settlement.

The cottages are C17/ C18 with later additions, timber framed and plastered with plain tile or thatched roof. St Judes has flint and red brick dressed walls.

Old Leas

Byways (St Jude's off the edge of the image, left)

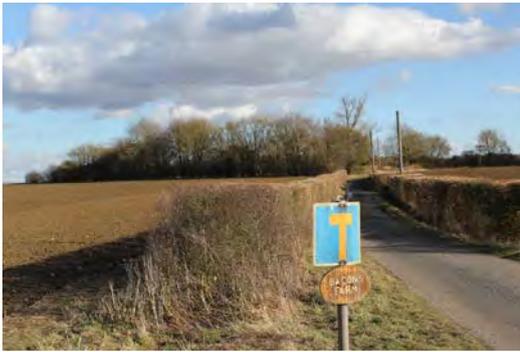
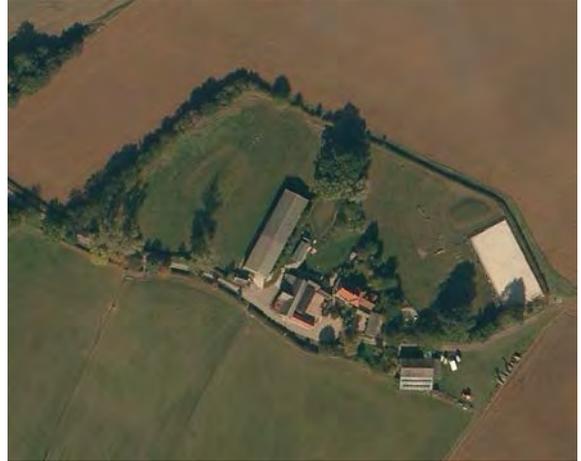
Bacons Farm is located west of the site on the boundary of the proposed site. It is Grade II listed (List Entry No. 1112733).

The principal farmhouse is dated mid C16 or earlier with later additions, timber framed and plastered with plain tile roof. There is a listed barn related to the farmhouse within its curtilage.

View of Bacons Farm from New Pastures Lane

Aerial view of Bacons Farm

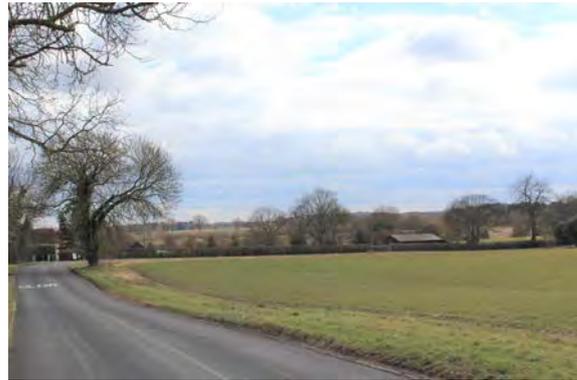
Piccot's Farm is located north of the site on the boundary of the proposed site. It is Grade II listed (List Entry No. 1147307). The farmstead includes a Grade II\* listed barn (List Entry No. 1122786)

The principal farmhouse is dated late C17, with earlier C17 rear wing, with later additions, timber framed and plastered with plain clay tile roof with gabled rear and service wings. The barn is dated late C14, early C15, timber framed and weatherboarded with some plaster, brick plinth. There is also a GII listed Byre related to the farmhouse within its curtilage.

View south from Piccotts Lane to Piccot's Farm and site beyond

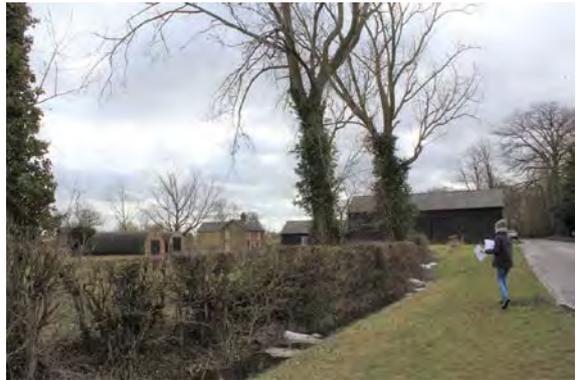
Pounds Farm is located south east of the site on the boundary of the proposed site. It is Grade II listed (List Entry No. 1338151).

The principal farmhouse is dated C16 or earlier with later additions, timber framed and plastered with plain tile roof. There are additional listed buildings related to the farmhouse within its curtilage.

View of Pound Farm

**Potential NDHAs – minor change:** Nissen huts to the north of the farmstead could be designated for their landmark status as a WWII building and their group value with other Nissen huts found in the area.

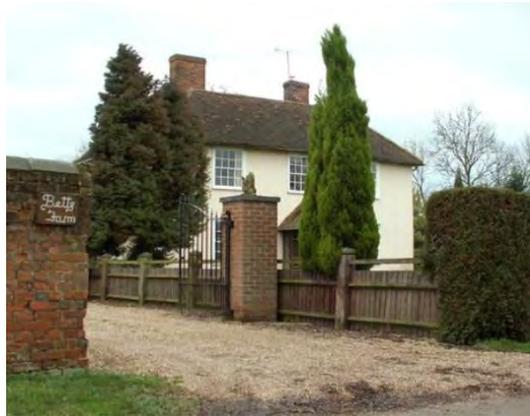
Betts Farm is located north west of the site on the boundary of the proposed site. It is Grade II listed (List Entry No. 1308769). It is surrounded on three sides by the proposed site.

The principal farmhouse is dated C17/C18, timber framed and plastered with plain tile roof. There are additional listed buildings related to the farmhouse within its curtilage. The barn has a half hipped thatched roof.

View of Betts Farm

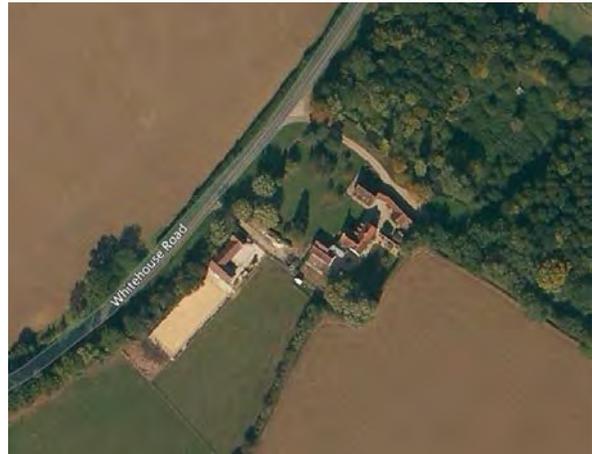
The farmhouse is dated C16 or earlier, with later additions and alterations, timber framed and plastered with plain tile roof.

There are potential non-designated farm buildings within the curtilage of the farmhouse (no access to assess).

Aerial view of Gatehouse Farm

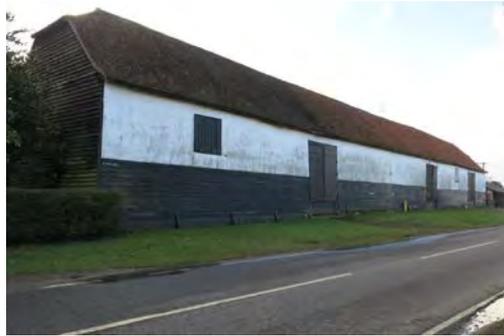
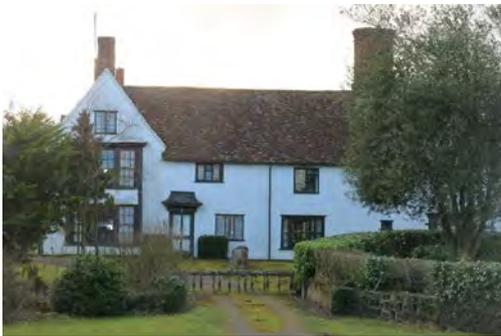
The Hall is on the site of a scheduled monument which includes a moated site. (SM No. 1008701)

The principal house is dated late C16 and earlier with later additions, timber framed and plastered with plain clay tile roof, H plan. There are outbuildings C15 to C17 associated with the Hall, within its curtilage.

View of Porters Hall Outbuilding

View of Porters Hall

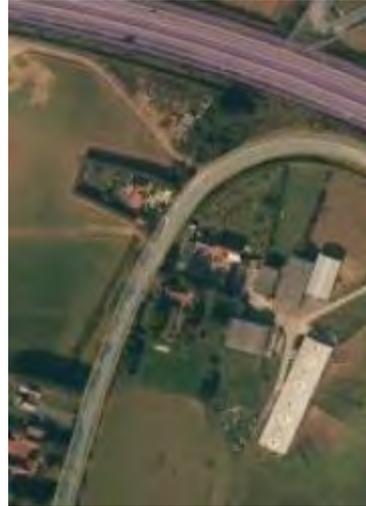
Sparling Farm is located south of the site. It is Grade II listed (List Entry No. 1147324). It is in close proximity to the site with views to site.

The principal farmhouse is dated C16 with later alterations, timber framed and plastered with pargetting, with plain tile roof. A listed C19 farm pump is within its curtilage.

Aerial View of Sparlings Farm

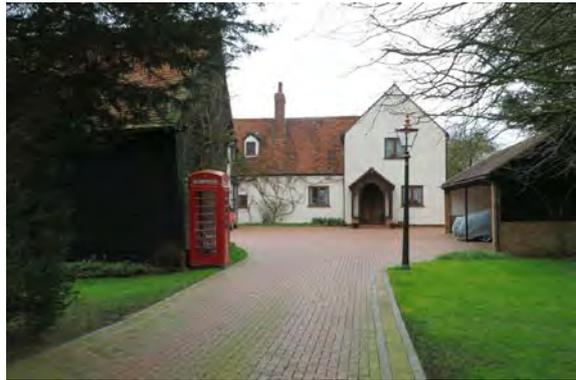
Gatehouse Farm is located south of the site. It is Grade I listed (List Entry No. 1112849). It is in close proximity to the site with views to site.

The principal farmhouse is dated C1300 with later alterations, two bay hall and two storey crosswing with mixed clay tile roof. The barn and outbuilding within the curtilage of the farmhouse are included for their group value.

View of Gatehouse Farm

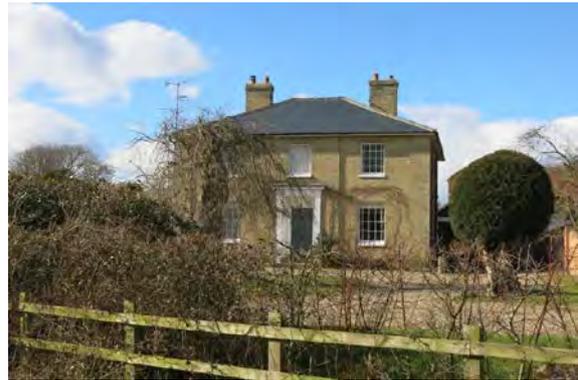
Cowlands Farm is located south west of the site with partial views to the proposed site. It is Grade II listed (List Entry No. 1306961).

The principal farmhouse is dated mid C18/19, gault brick with grey slate roof. There are additional listed buildings related to the farmhouse within its curtilage.

View of Cowlands Farm

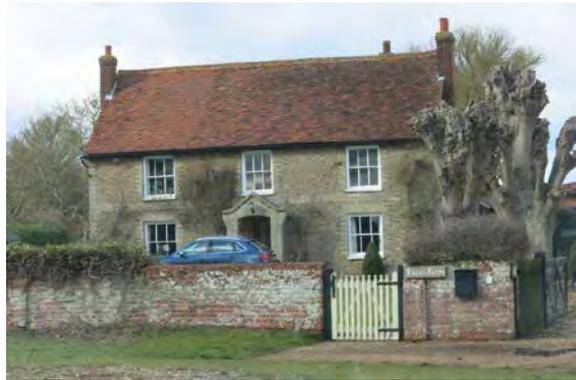
Lucas Farm is located west of the site with views to the proposed site. It is Grade II listed (List Entry No. 1112747).

The farmhouse is dated early C19, with later alterations, gault brick with plain clay tile roof with yellow brick band and window dressings.

View of Lucas Farmhouse

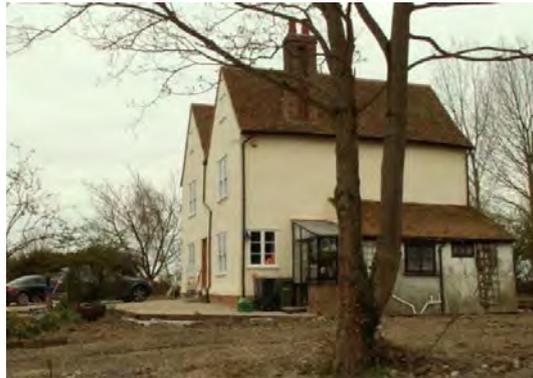
Perry Childs Farm is located north east of the site with views to the proposed site. It is Grade II listed (List Entry No. 1337832).

The farmhouse is dated C17, with later alterations, timber framed and plastered with plain clay tile roof with two parallel bays each with internal stack in the front bay against outside wall.

View of Perry Child's Farmhouse  
(Photo by Robert Edwards geography.org)
